Report of the Chief Fire Officer:

Knysna Fire and Rescue Service on the Fire origin and possible cause in the Elandskraal area:

Knysna on 07 June 2017

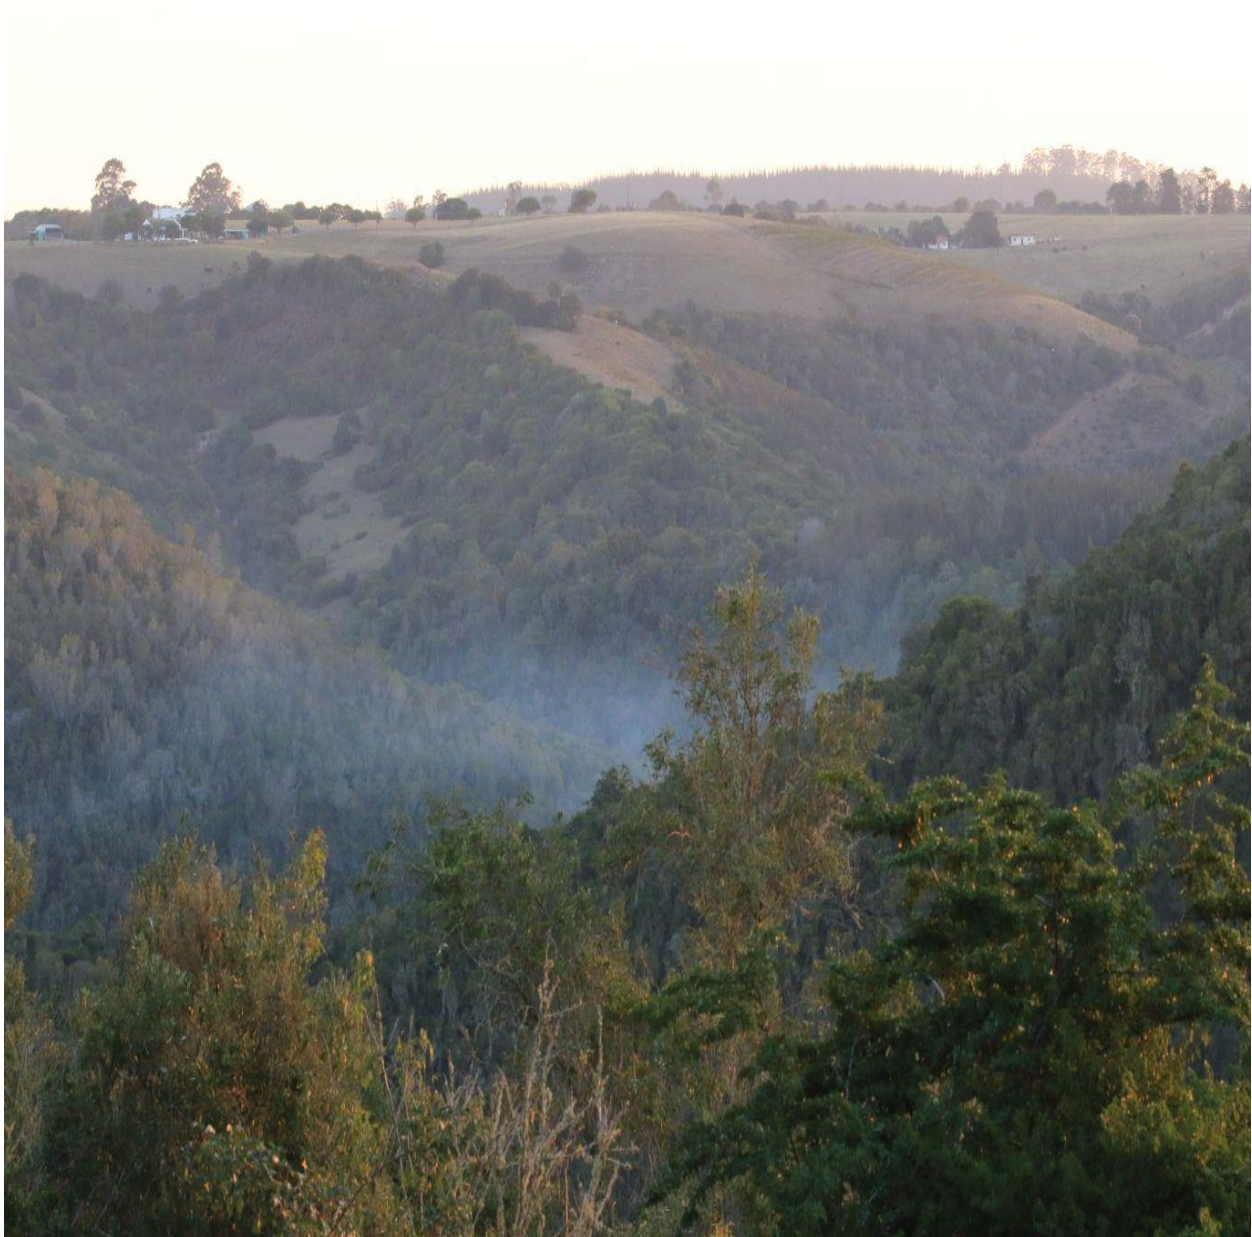
Figure 1: Photograph showing the smouldering smoke, taken on 10 May 2017 before the fire on 07 June 2017. Note the buildings in background as a point of reference. Slope to the left is the slope depicted in Figures 14 and 19 as a burn scar.

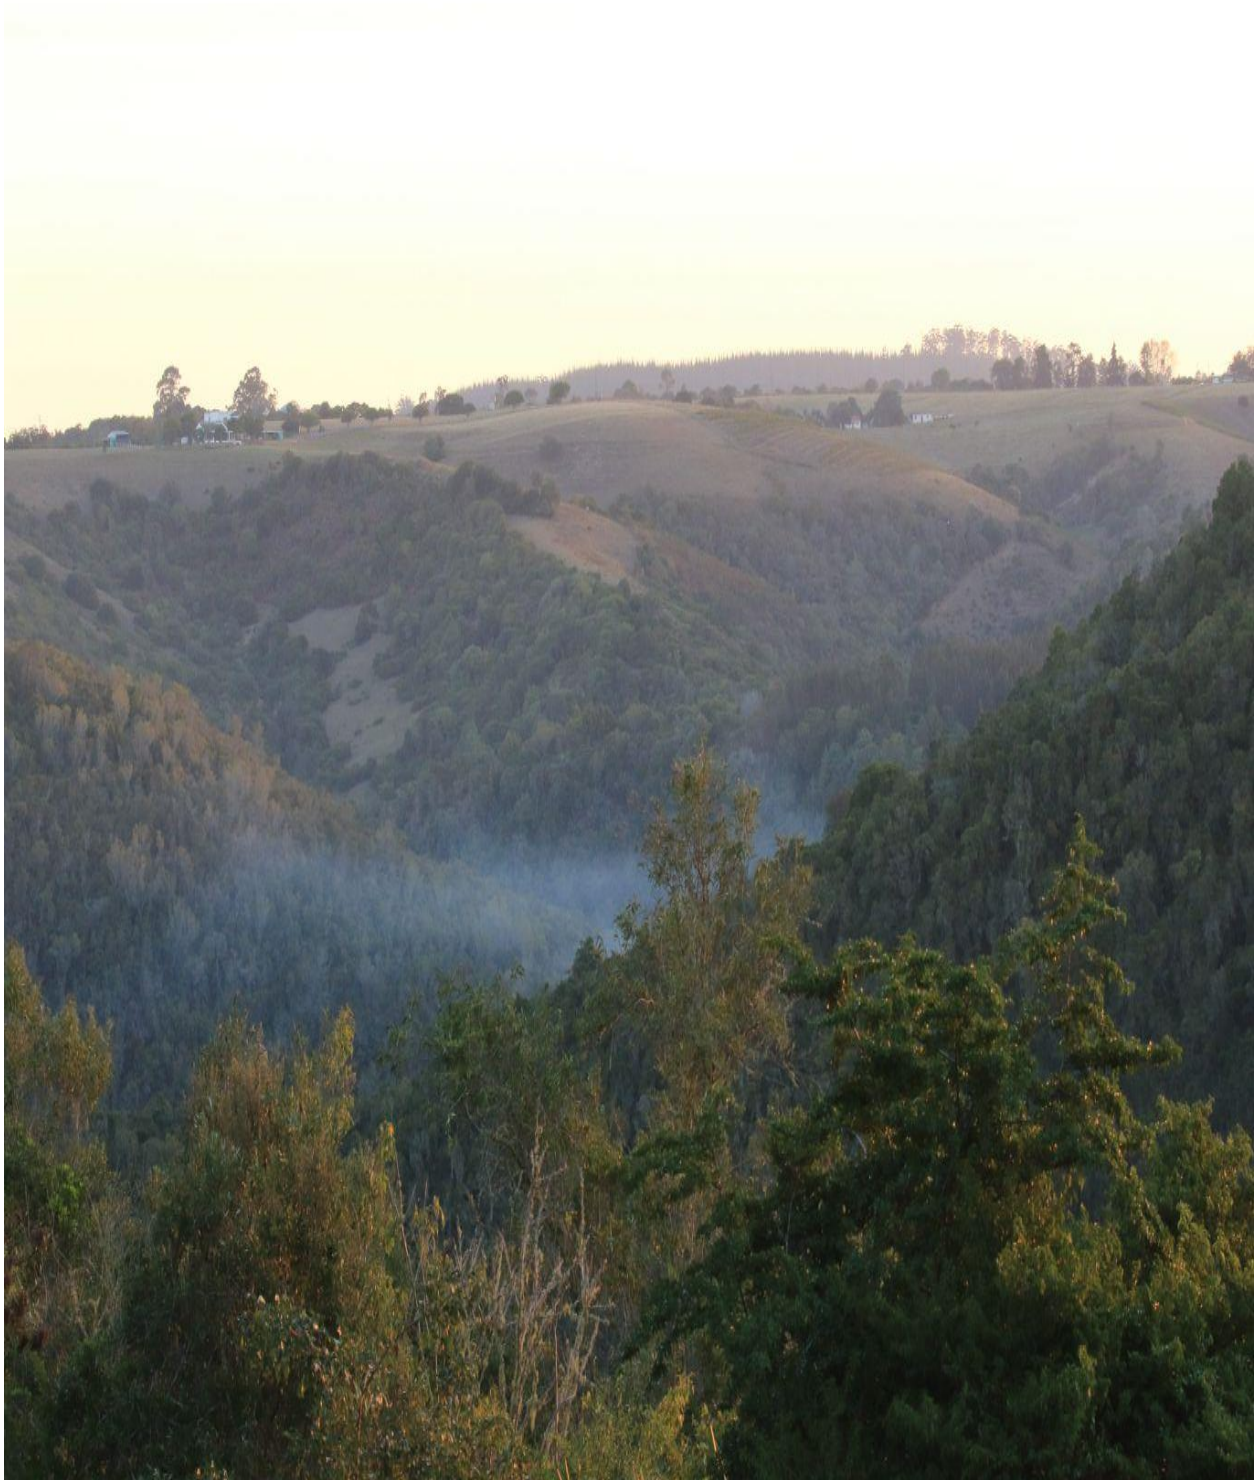
*Figure 2: Photograph taken on 10 May 2017, before the fire on 07 June 2017.
Note buildings in background as a point of reference.*

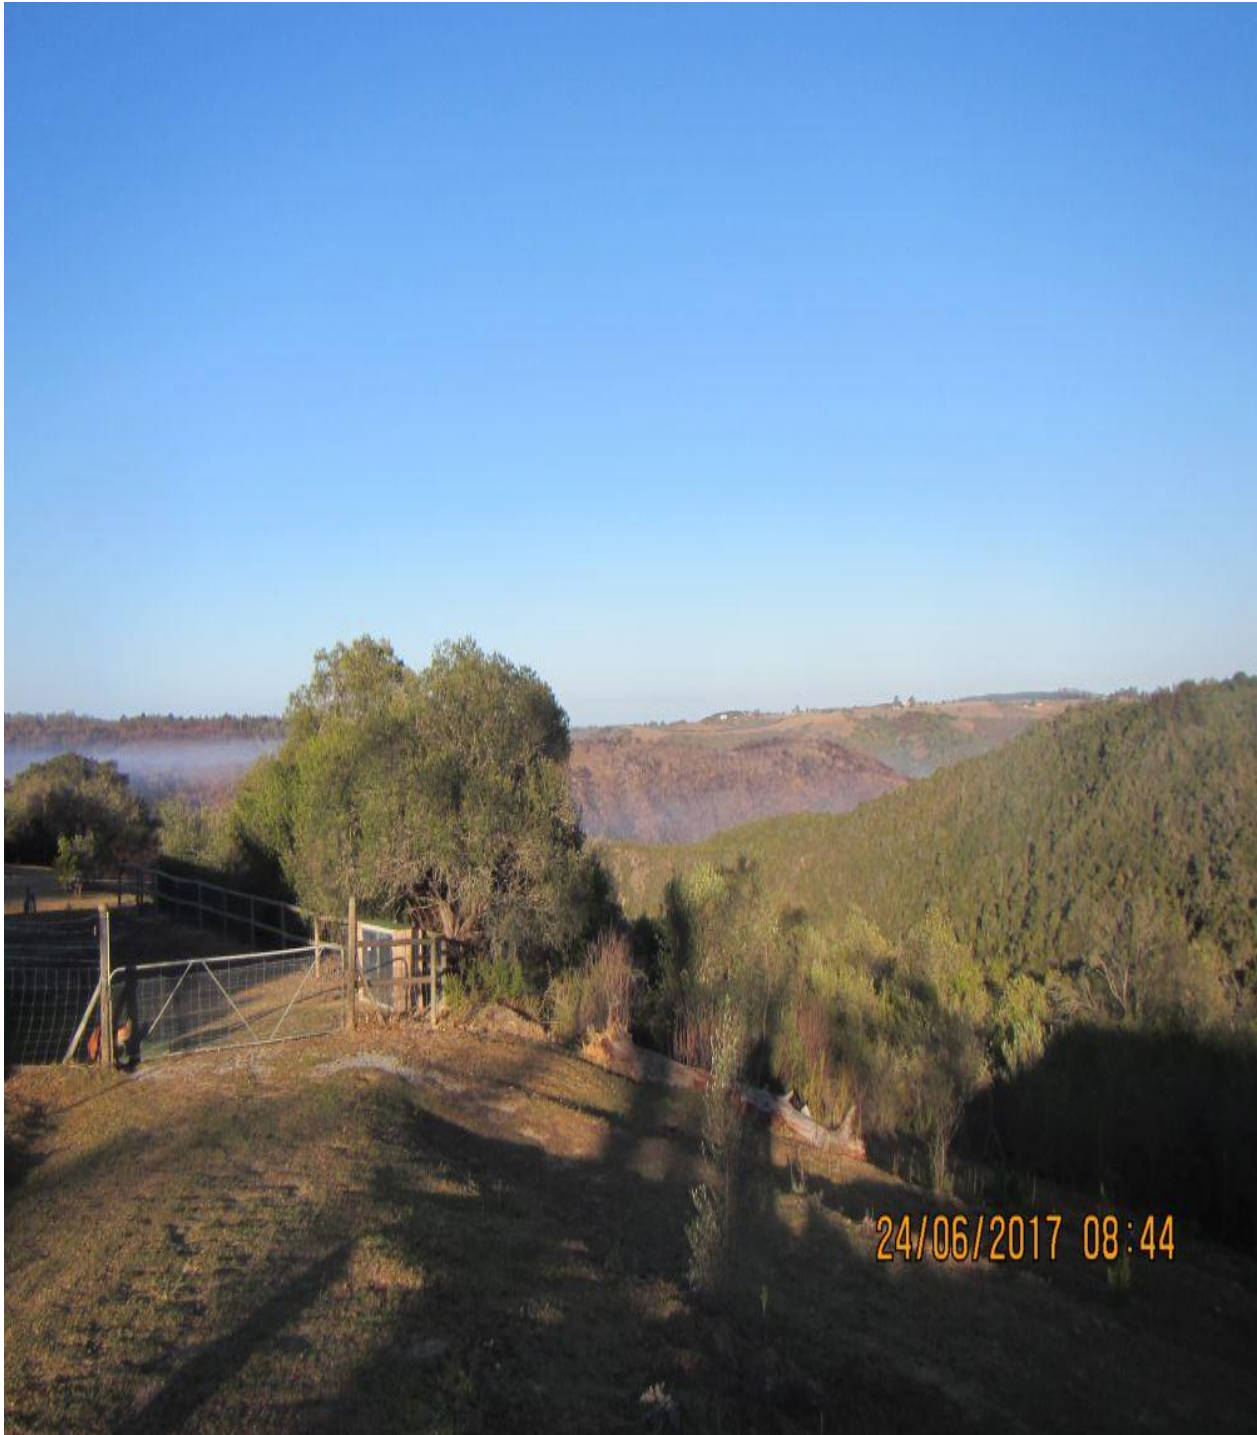
Figure 6: Smoke emitting in the same area on 24 June 2017 as Figures 1, 2 and 3. Note the burn scar on the opposite ridge and smoke coming from an unburnt area.

5. Smoulder photographs taken on 24 and 26 June 2017, (Figures 6, 7, 8 and 9). The smoke is coming from the same area as shown in Figures 1 and 2 of 10 May 2017, and Figures 4, 6, 7, 8 and 9 (after 07 June 2017). The trailing of the smoke is still visible. However, the exact location of the smoke's origin cannot be seen.
6. Figure 10 shows a red arrow which points to the origin as proposed cause by an Elandskraal resident in his report. This arrow is now in a different location than shown in Figure 5.
7. Figure 11, however, places the smoke in the area of Figure 5 by means of red circles. The insert photograph on Figure 11 is the first direct sight of the smoke's origin, which is in an unburnt area. In the foreground of this insert, the burn scar is visible.

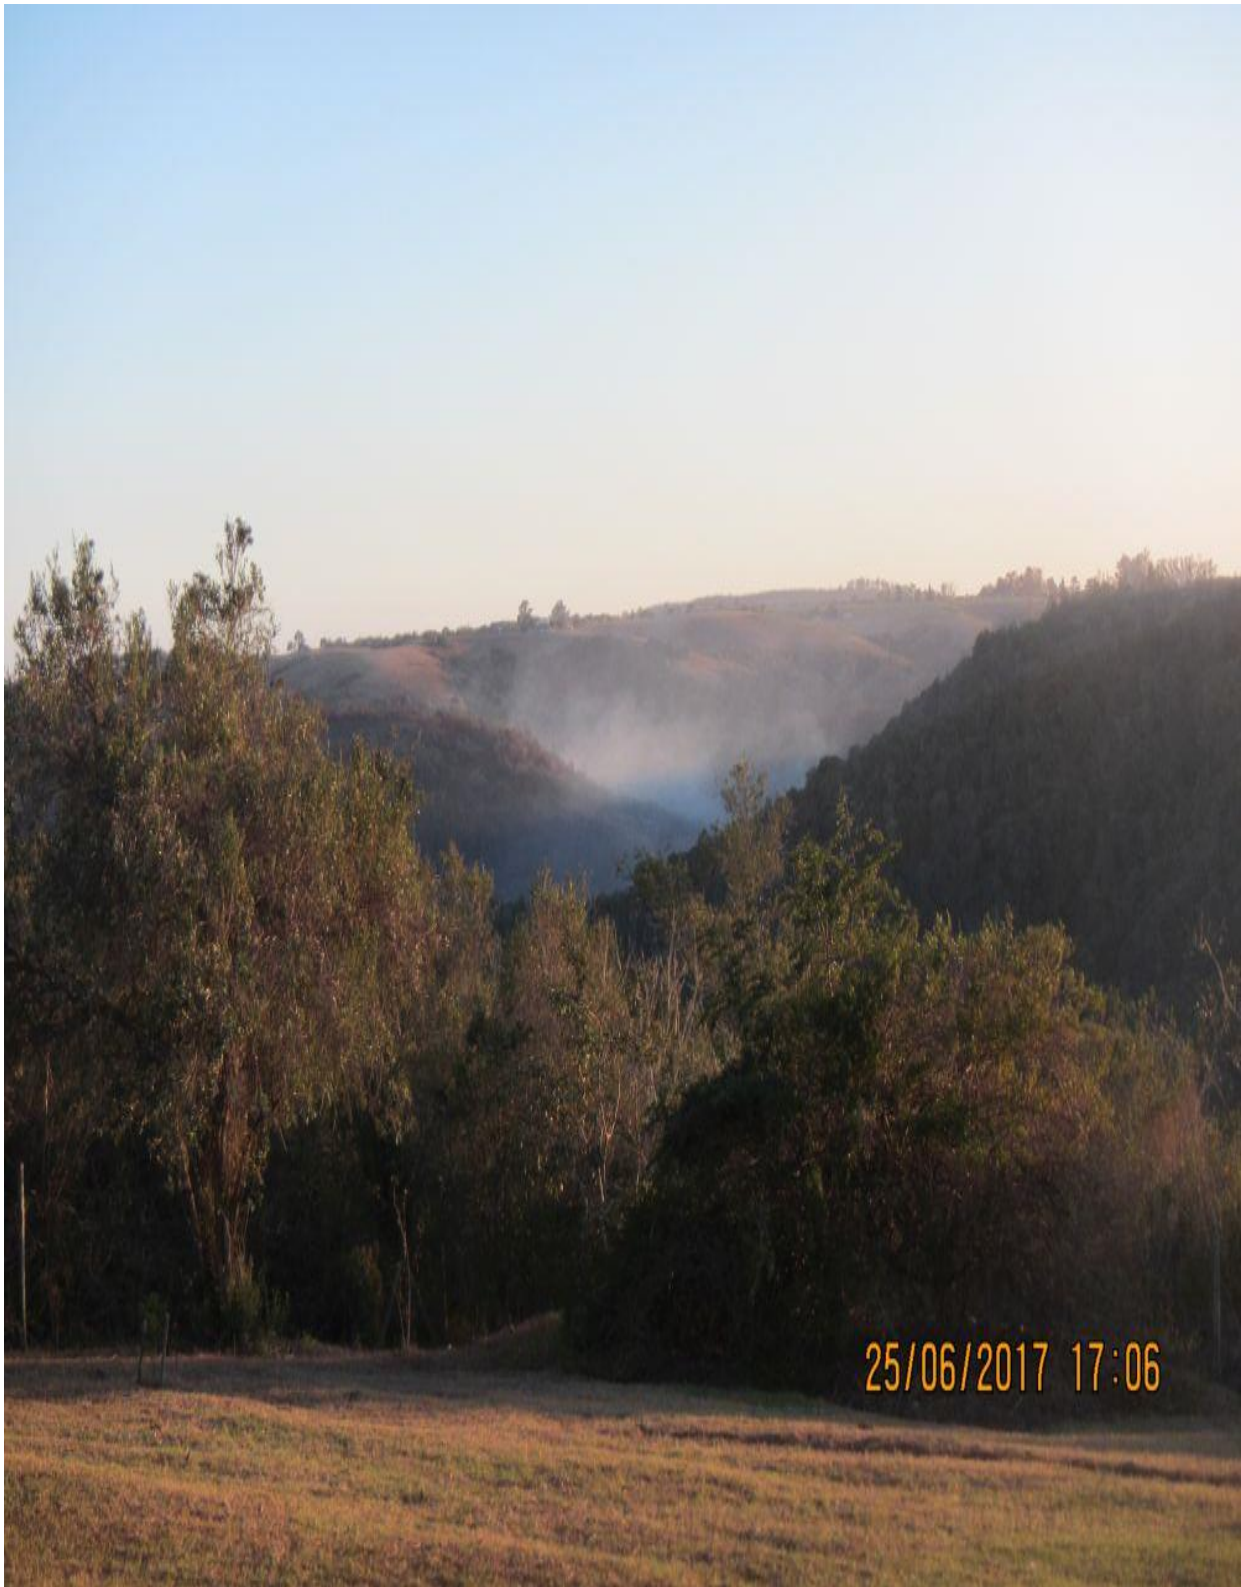
Figure 7: Photograph showing same smoke as in Figure 6.

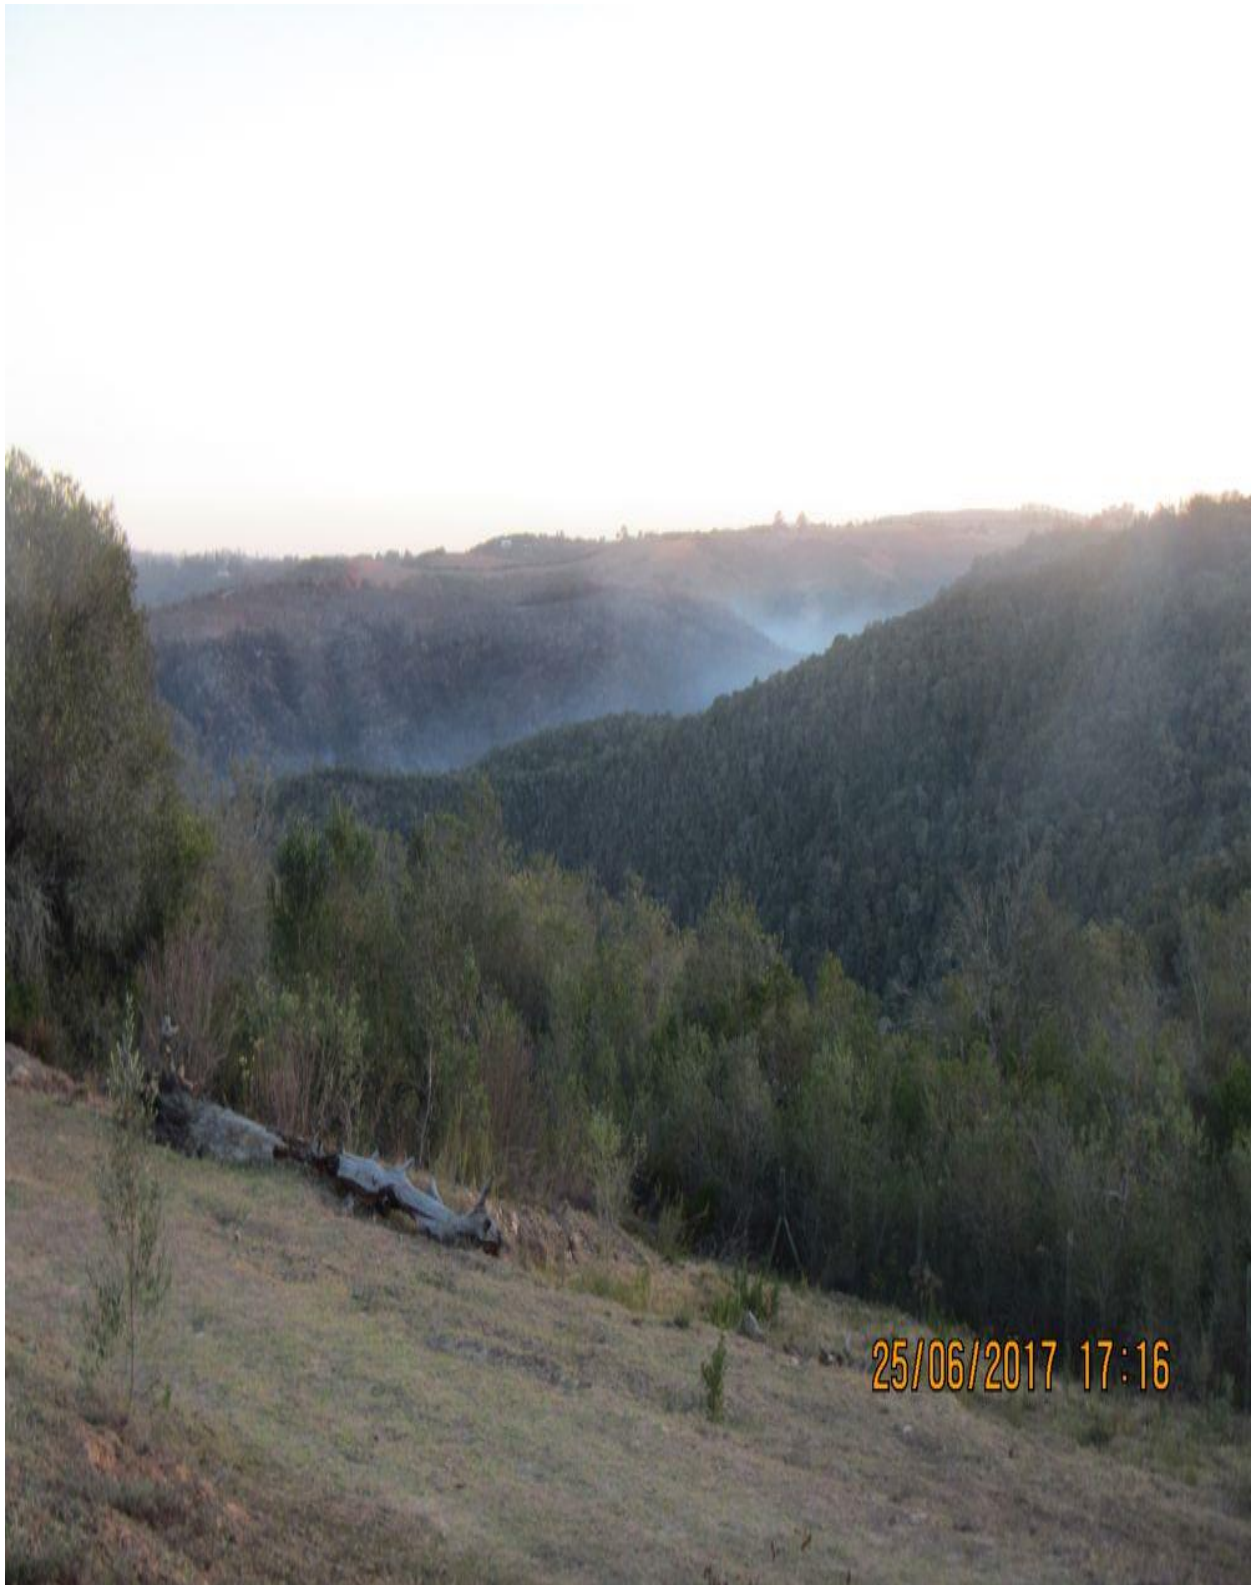
Figure 8: Photograph showing smoke in the same area as in Figures 6 and 7. Note smoke travelling between the two valleys from North West to South East.

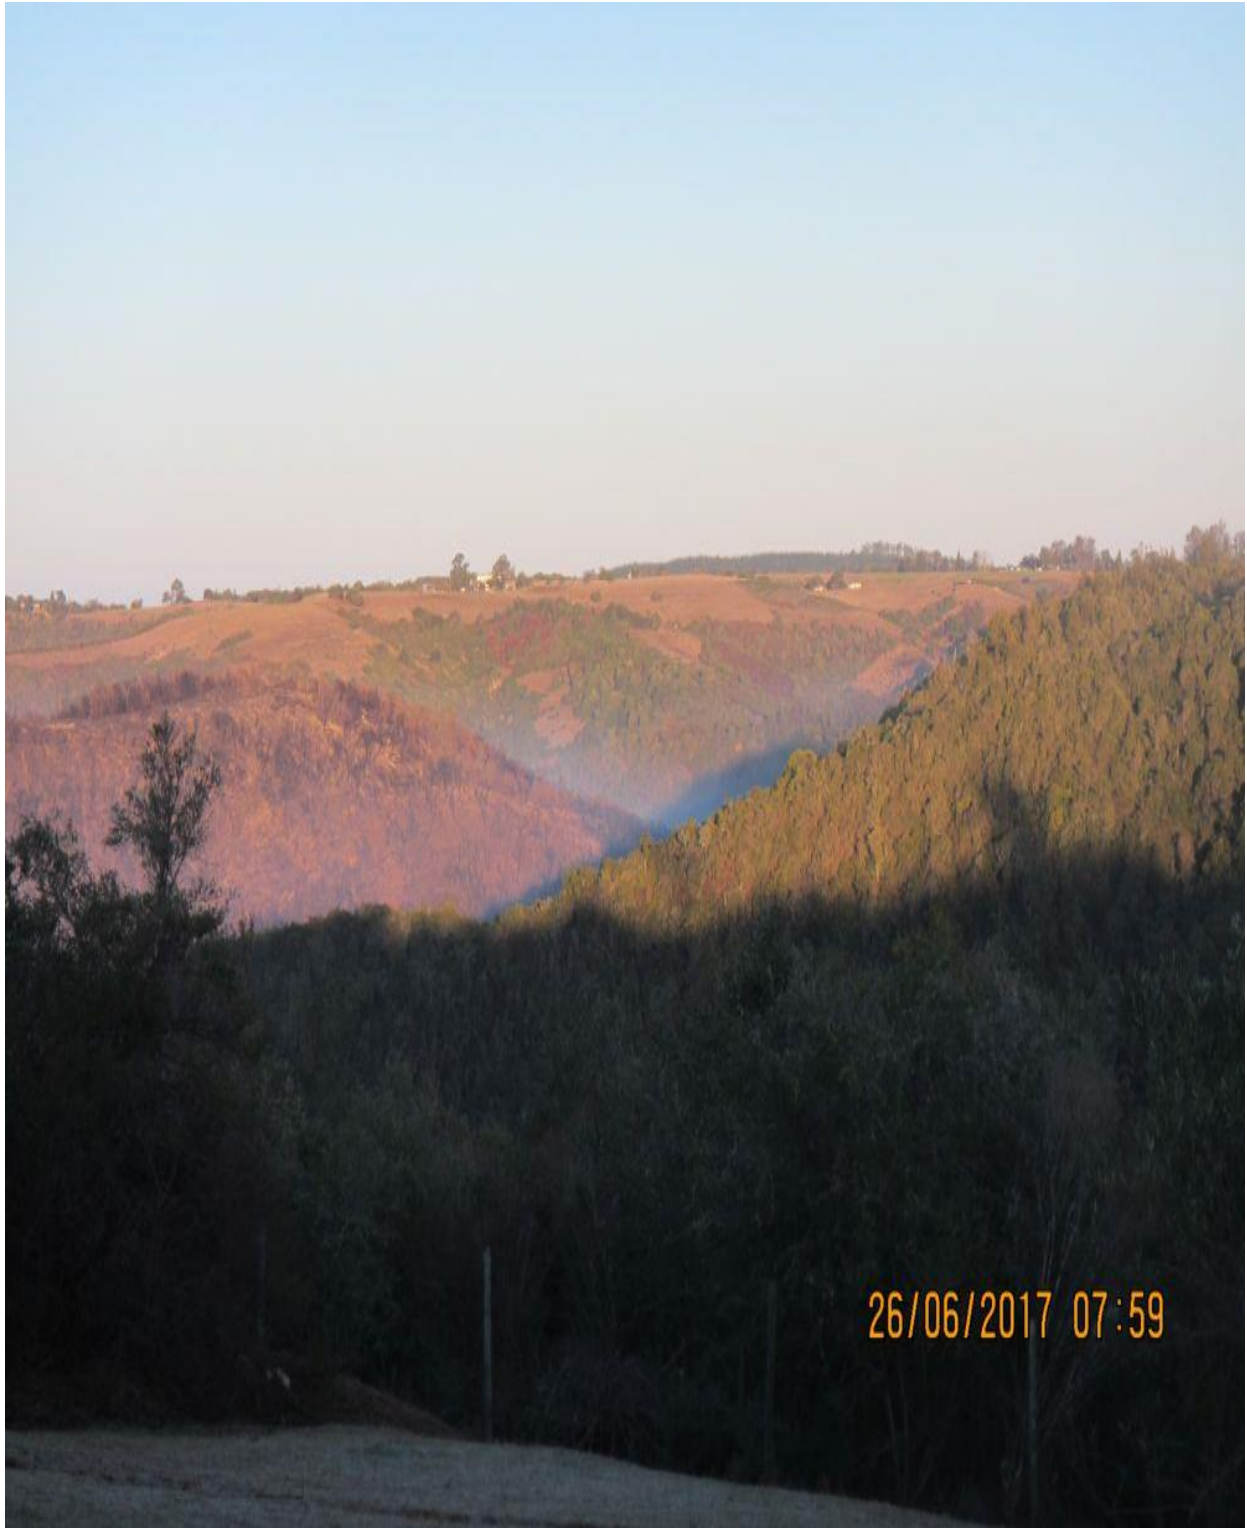
Figure 9: Photograph showing smoke in the same area as in Figures 6, 7 and 8.

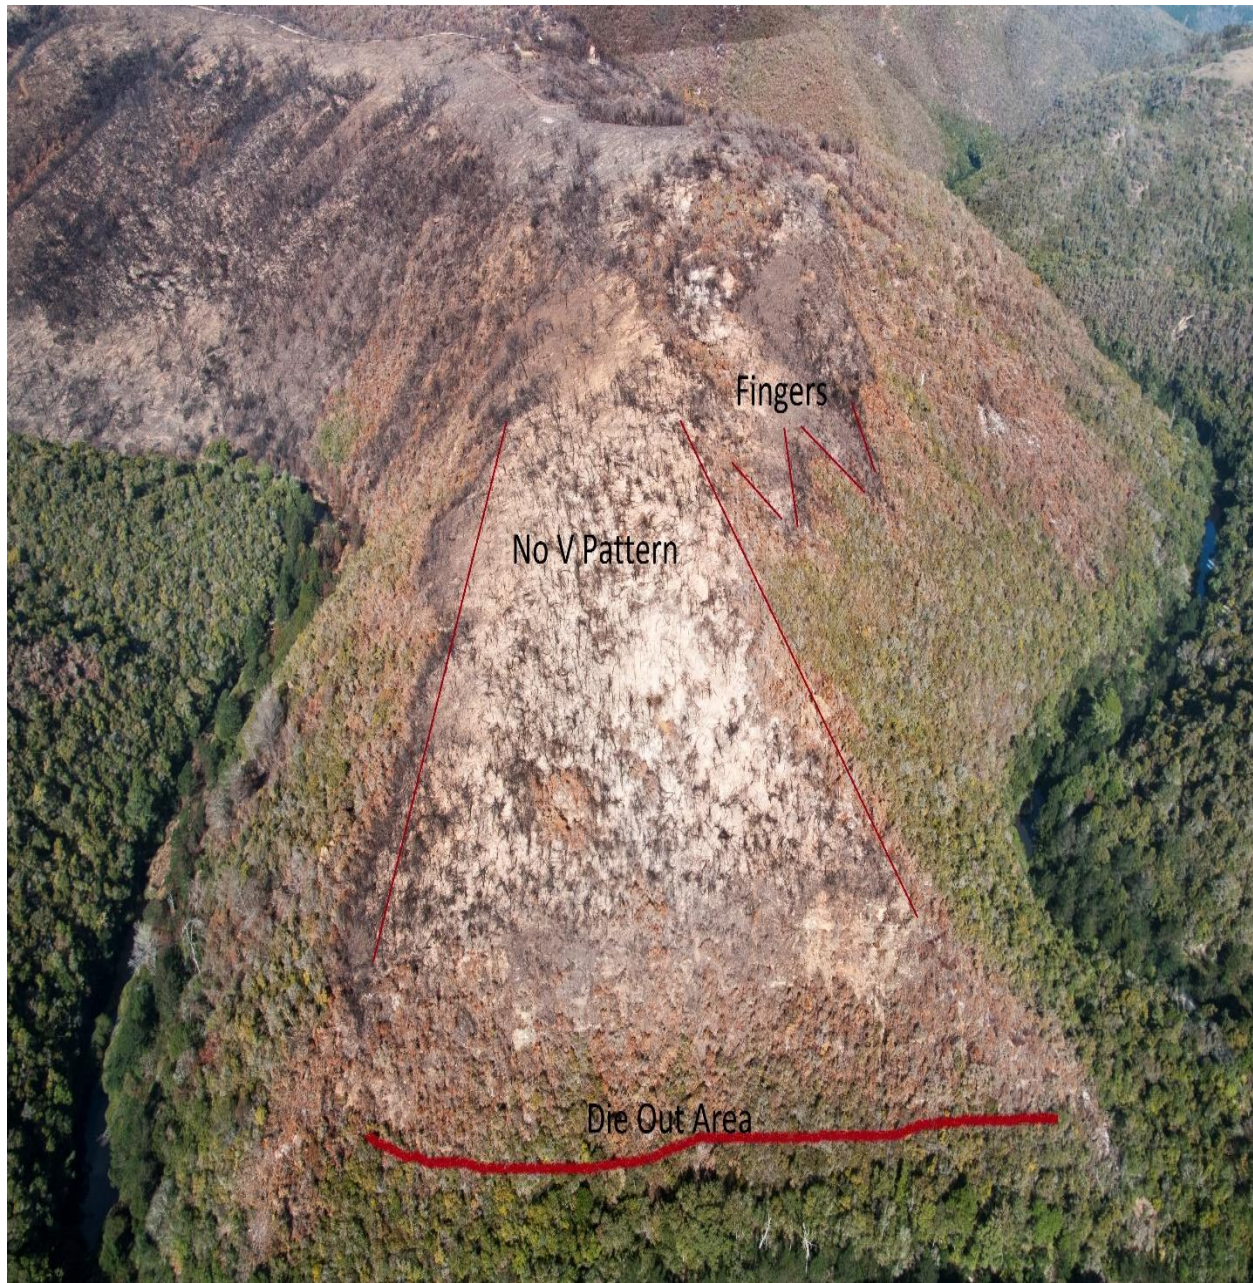
Figure 21: No "V" Pattern on burn scar.

1.1 Fire Origin by lightning, proposes that Figure 21 is the origin of the fire. This supposed origin is also indicated in Figure 88. This area does not show the “V” Pattern that is associated with the origin and spread of a wild fire. A section indicated, refers to the “Die-out” area. The burn pattern in this “die-out” area shows that the fire burnt down this slope and eventually died out.

1.4 In Figures 21 and 22, the burn scar shows no “V” Pattern. No evidence of an advancing fire (head or front of the fire) is visible. Fires spread by the distinctive V pattern. This V pattern is shown horizontally on the ground in wildland fires. The base of the V may be the point of origin.

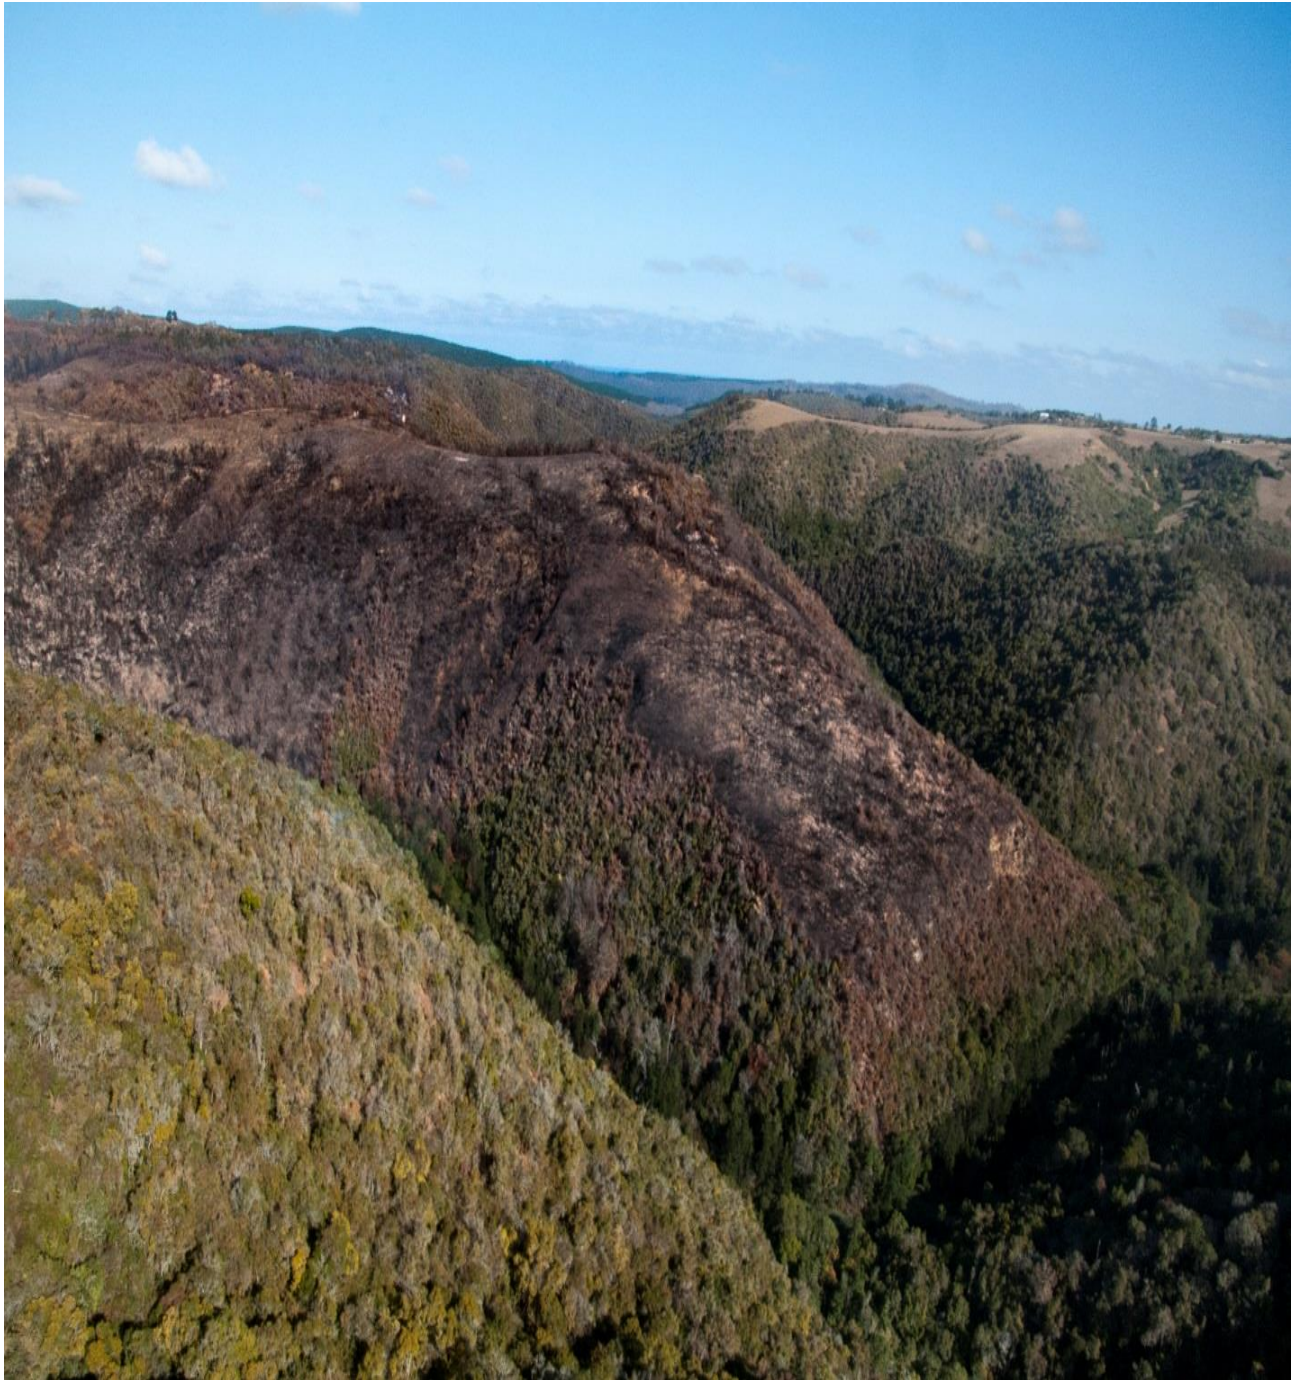
Figure 22: No "V" pattern on this burn scar. This is a different angle to Figures 12 and 21.

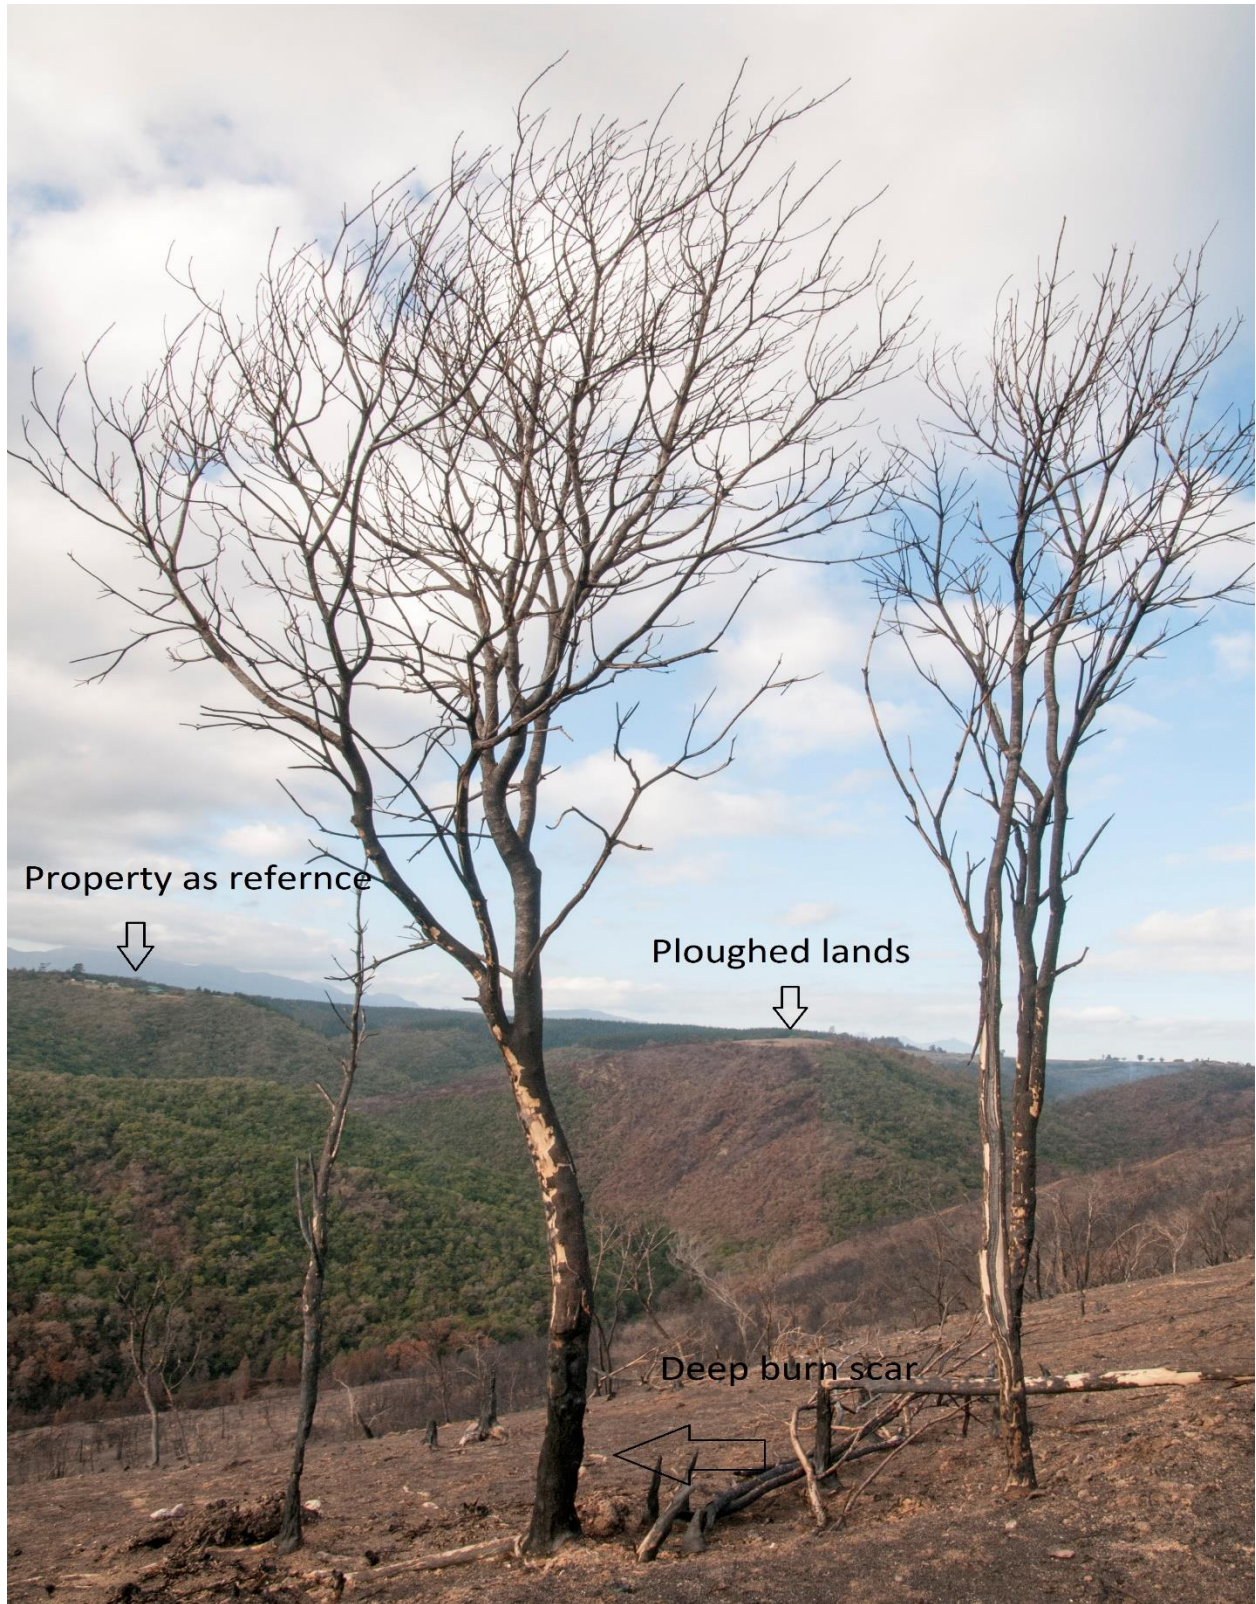
Figure 23: Deep scars from the uphill side. Note the location and use the burn scar in the background as reference.

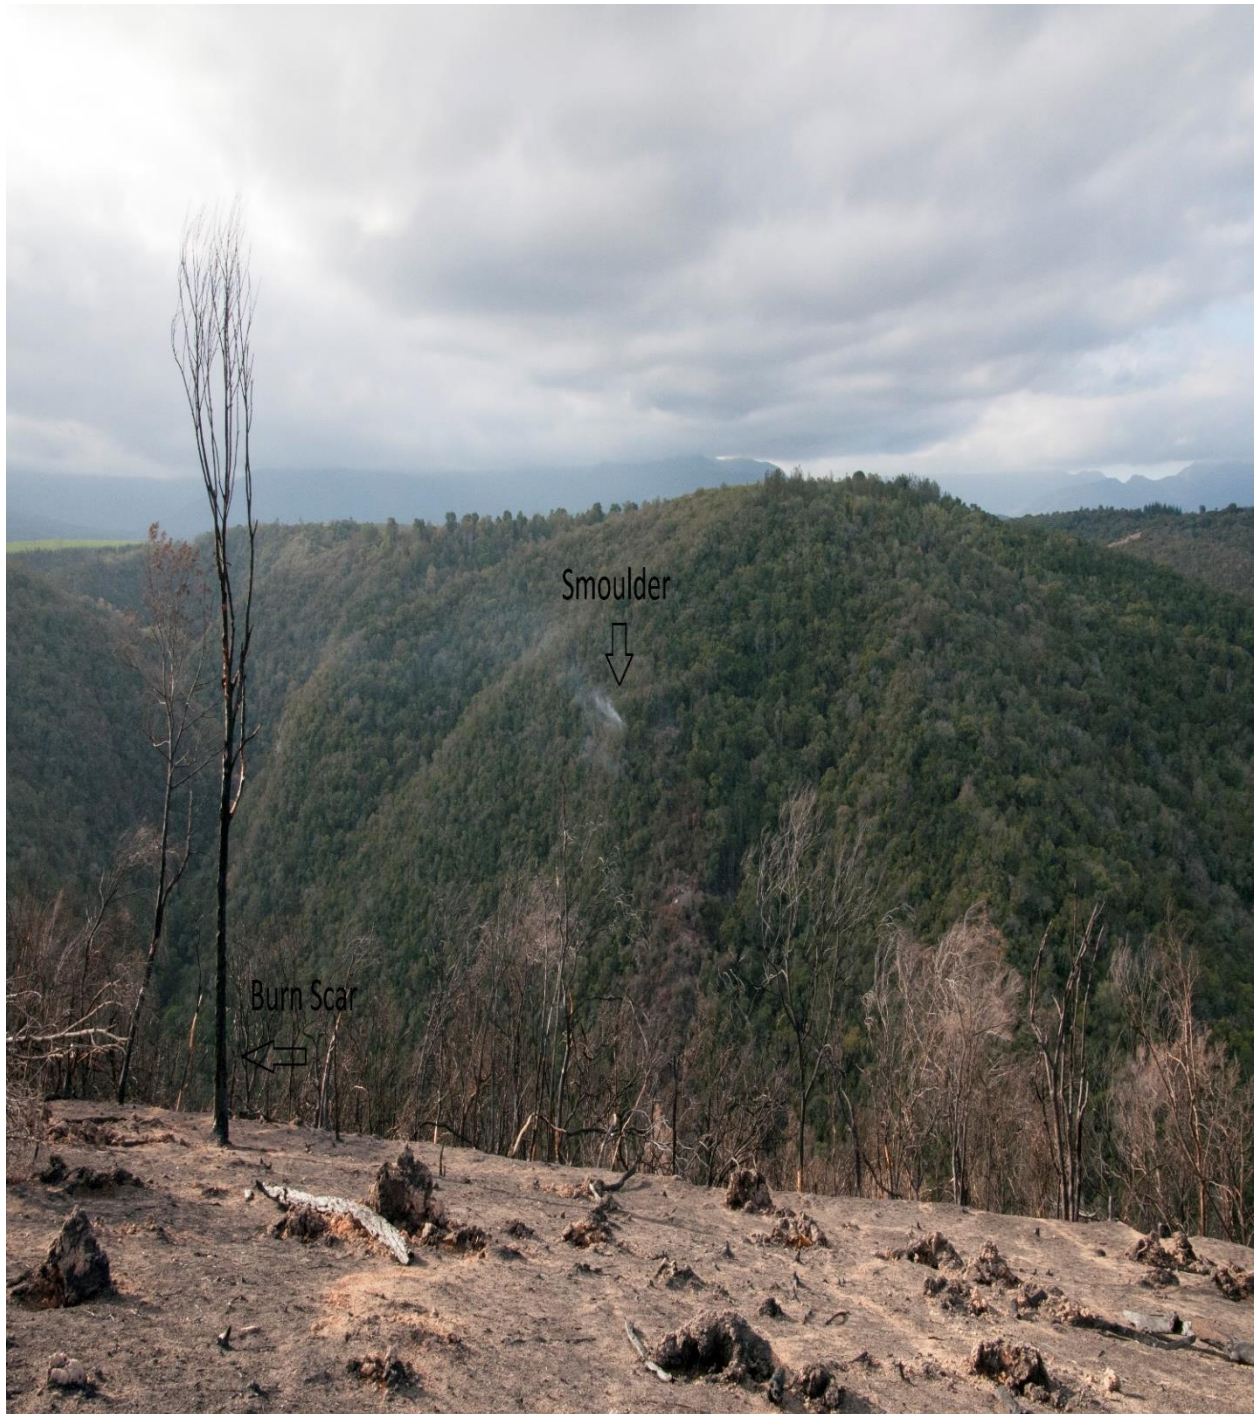
Figure 24: Burn scar on the tree trunk from the uphill side. Note the smouldering on the opposite ridge and compare this with Figure 11- photograph insert

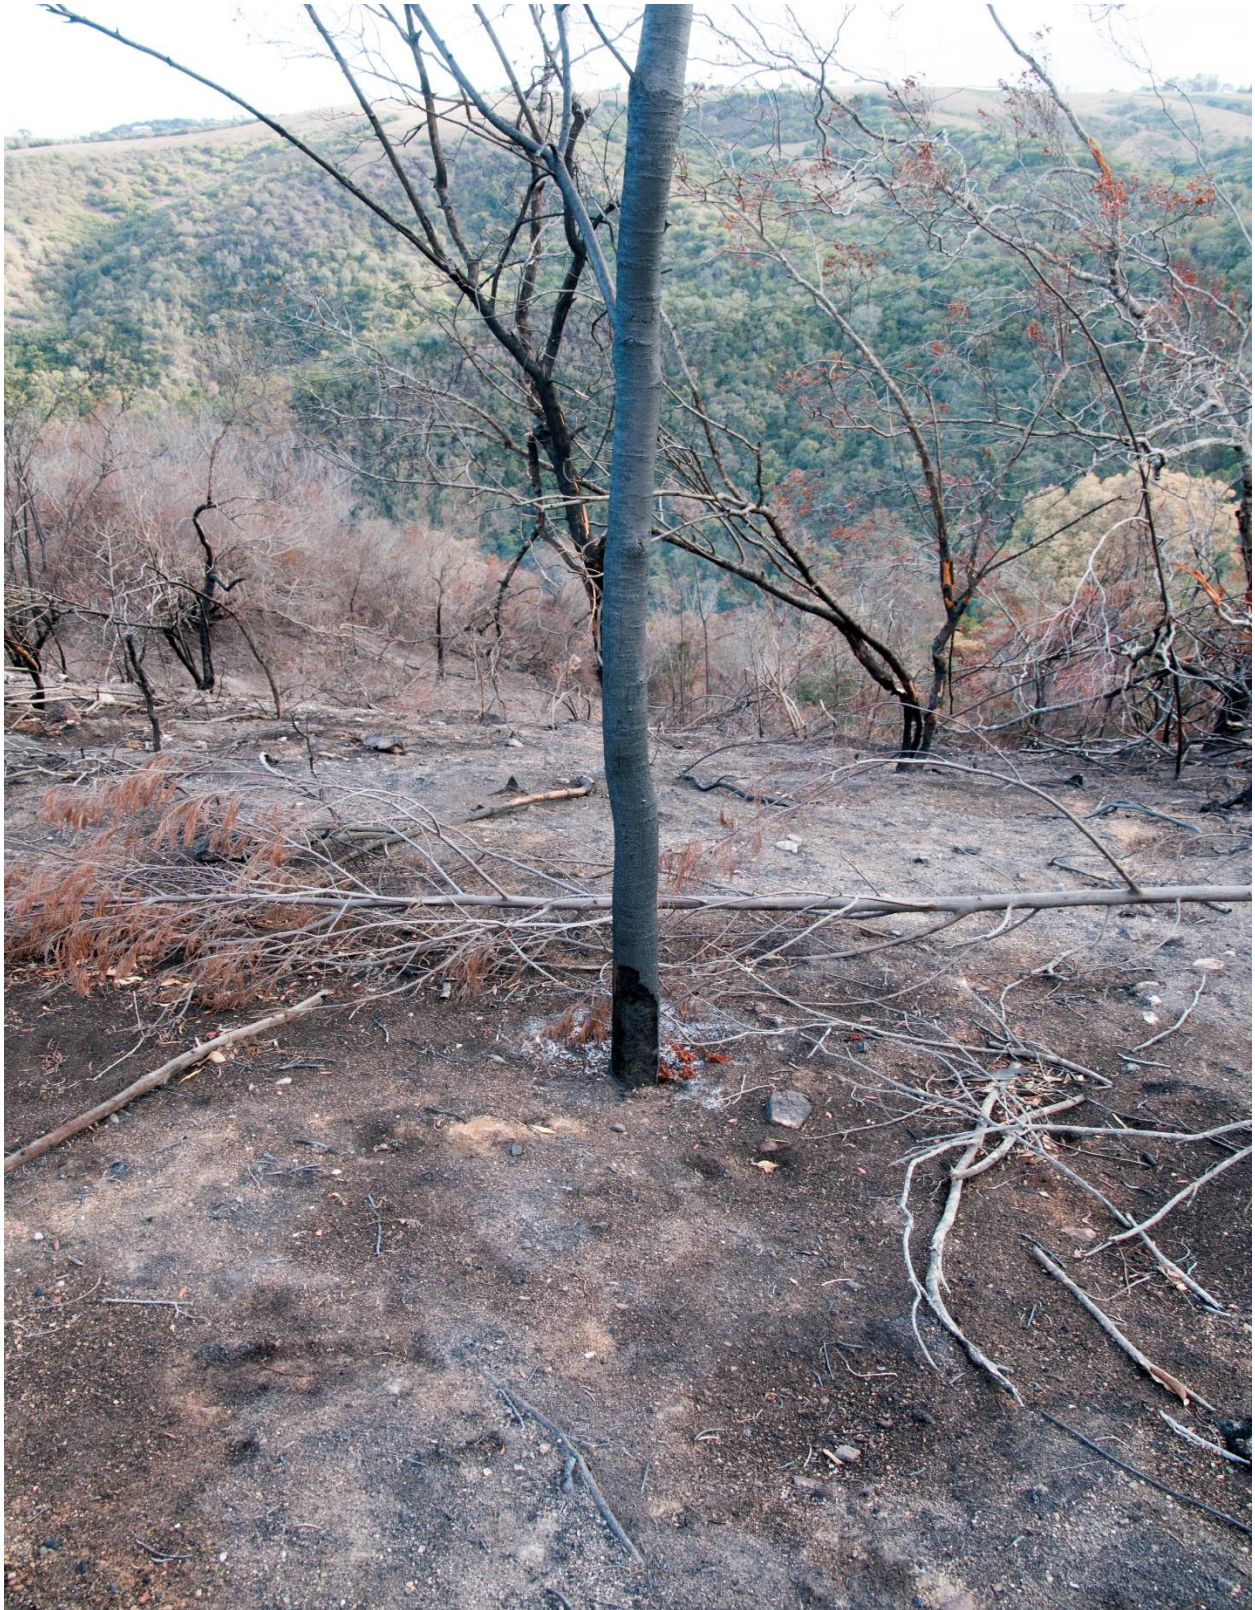
Figure 25: Burn scar on the tree trunk from uphill side

- 1.8 Figures 23 to 32 are photographs taken on the ground in the non-"V" pattern area. When a fire spreads uphill, a burn scar on the protected side of trees becomes visible. Some photographs show very deep scarring at the lower section of tree trunks, which suggest that the fire came from the direction of the char (See Figures 25 to 27).

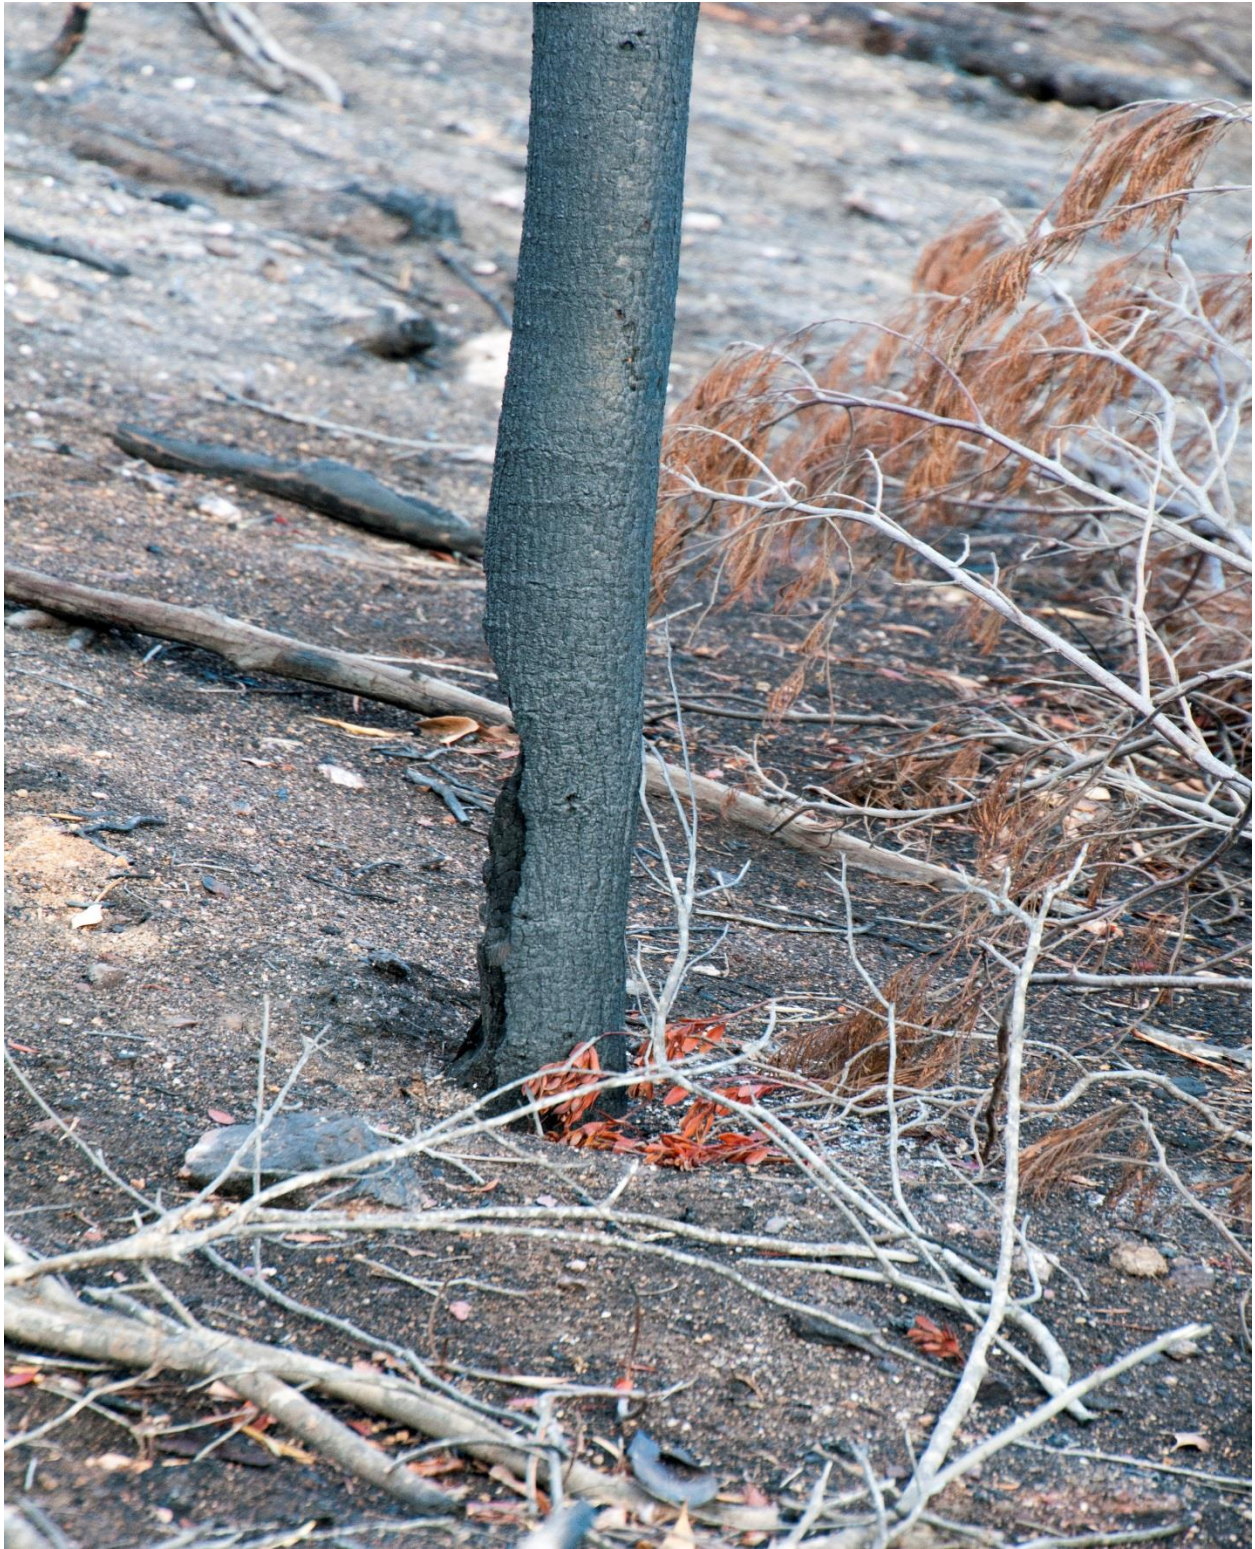
Figure 26: Side view of figure 25, showing the deep burn scar from the uphill side
