Report of the Chief Fire Officer:

Knysna Fire and Rescue Service on the Fire origin and possible cause in the Elandskraal area:

Knysna on 07 June 2017

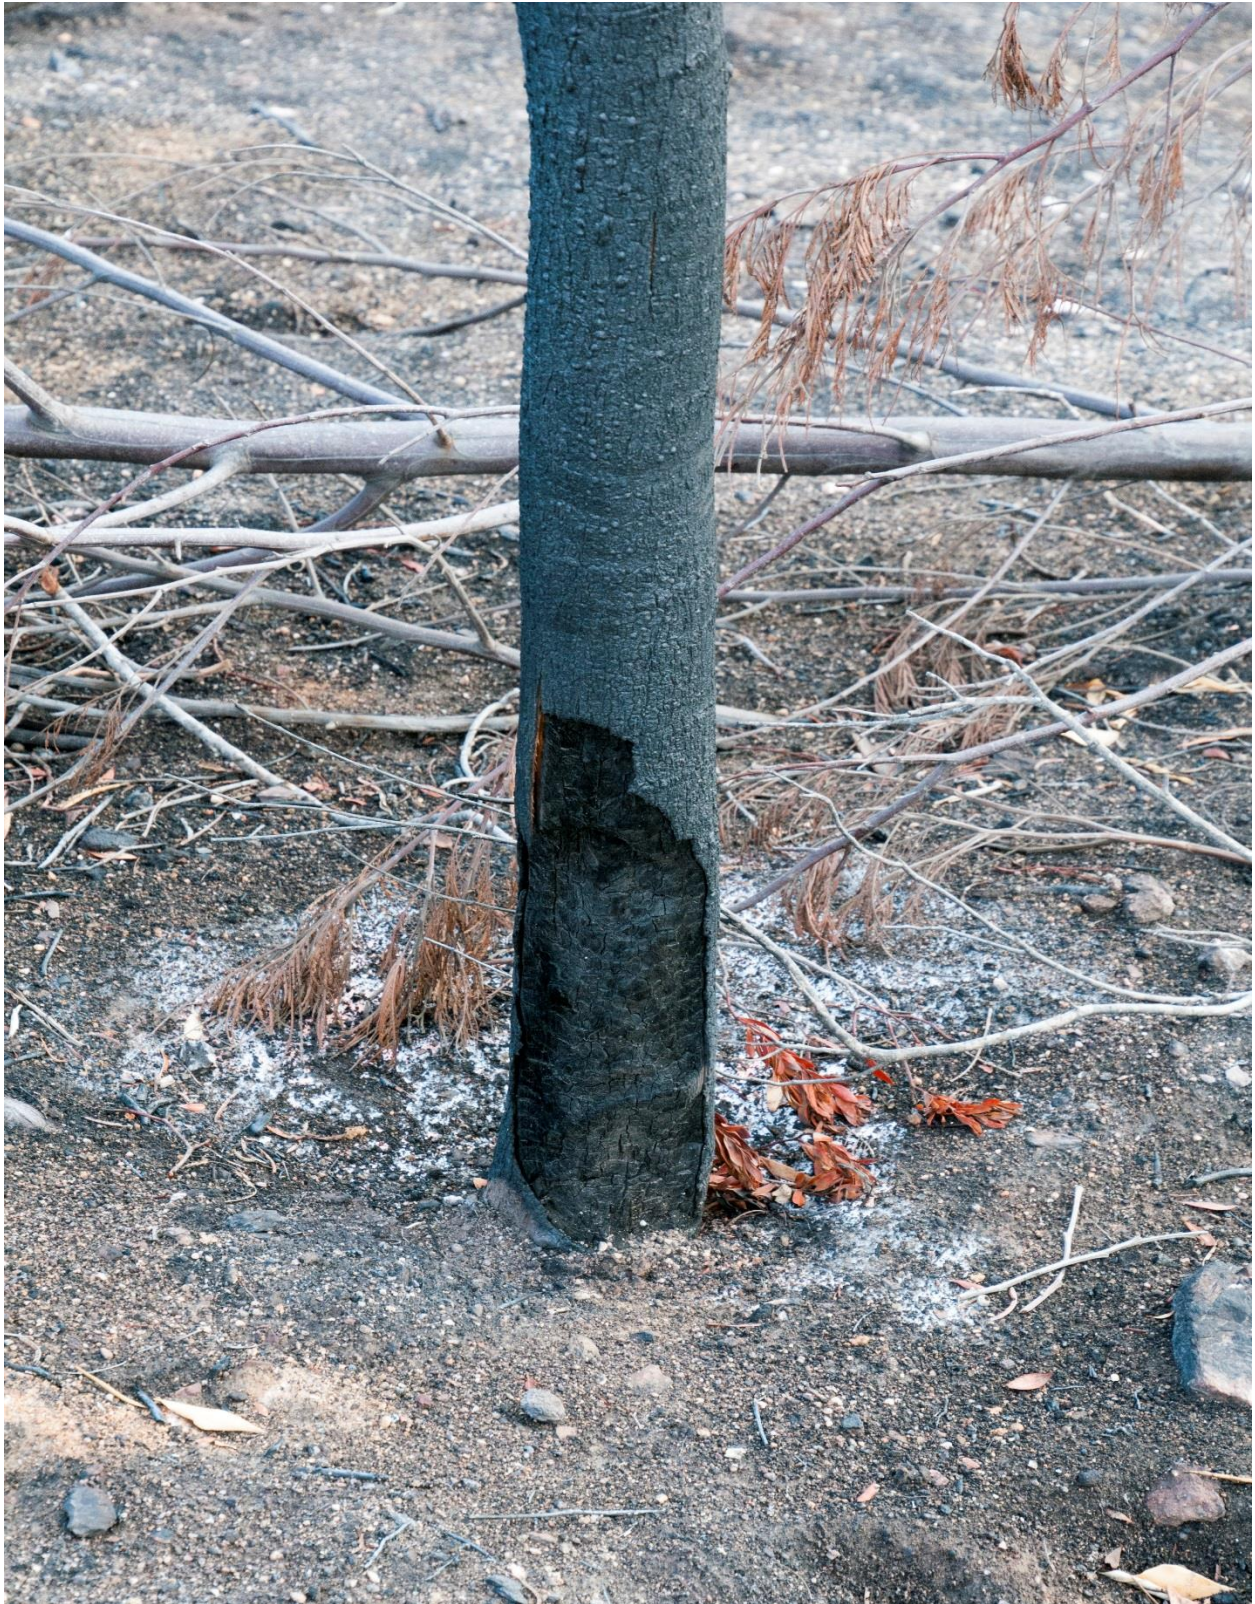
Figure 27: Enlarged deep burn scar as in Figure 25.

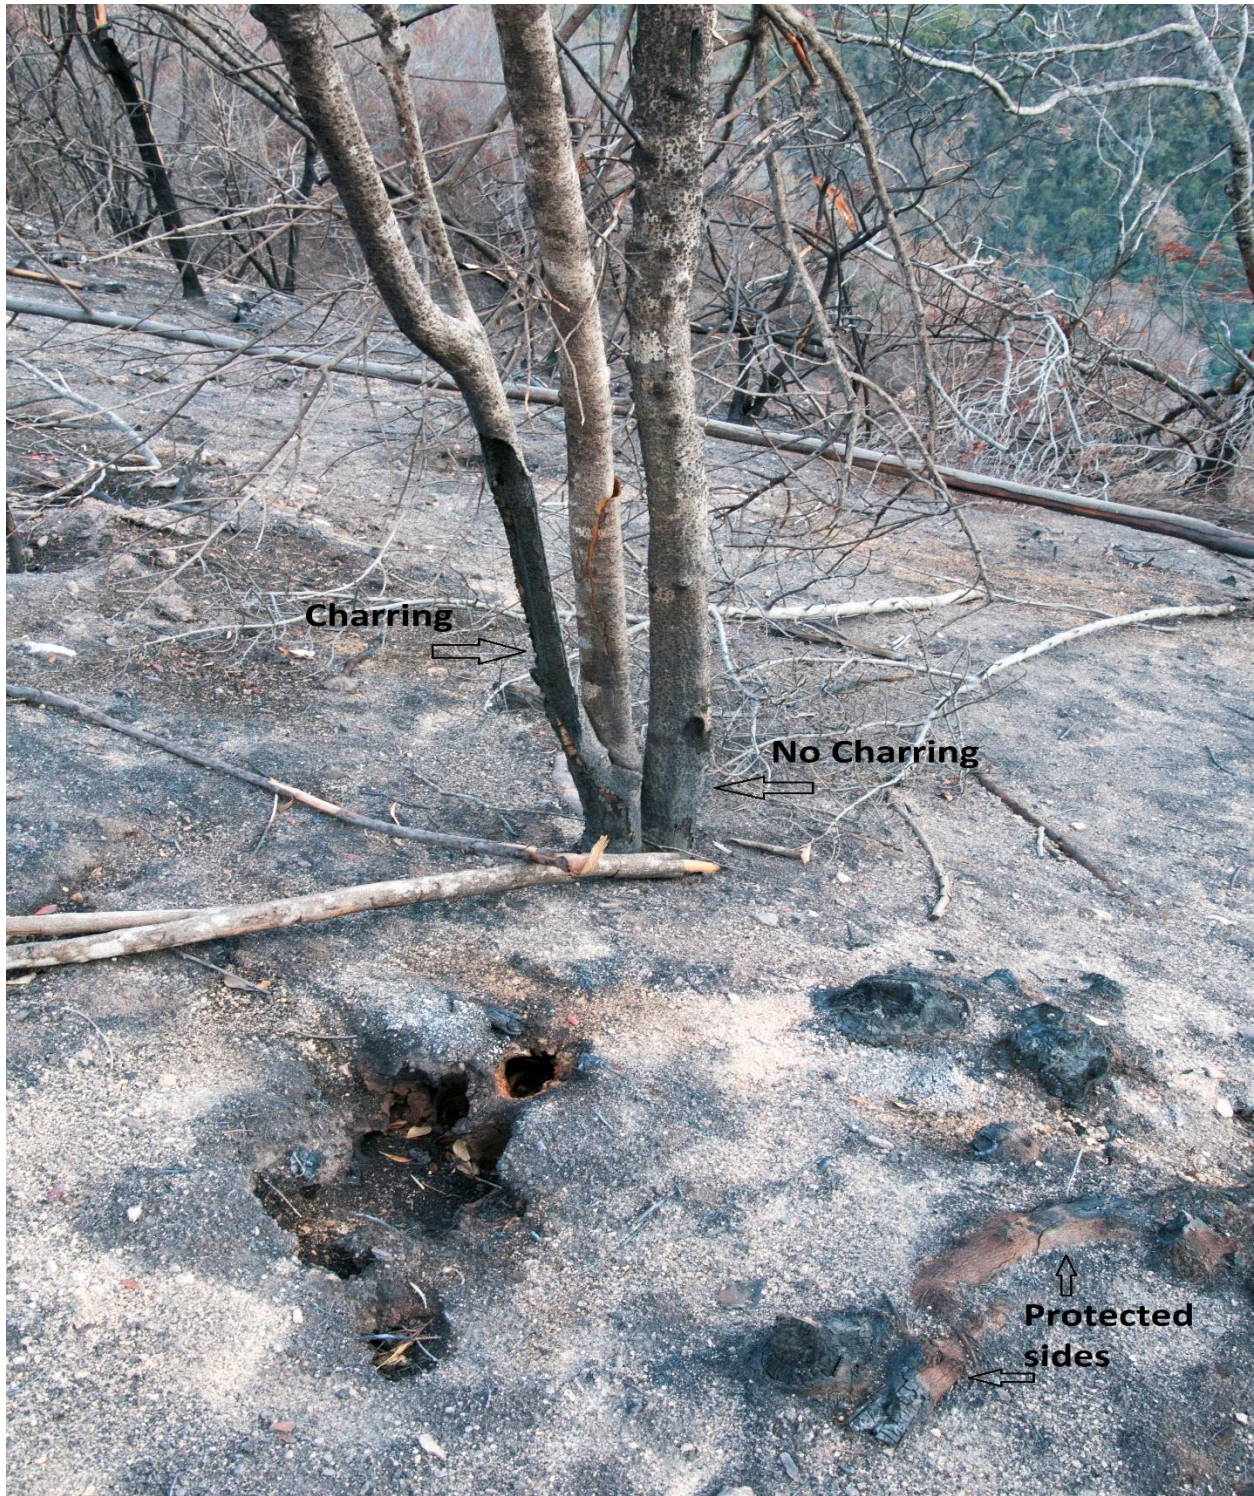
Figure 28:

- 1.9 In Figure 28, charring from the left can be seen, and no charring from the right on the tree trunk. The left is from the downslope direction. The protected sides from the upslope side can be seen on the roots. The probability is that the fire burnt from uphill down the slope.

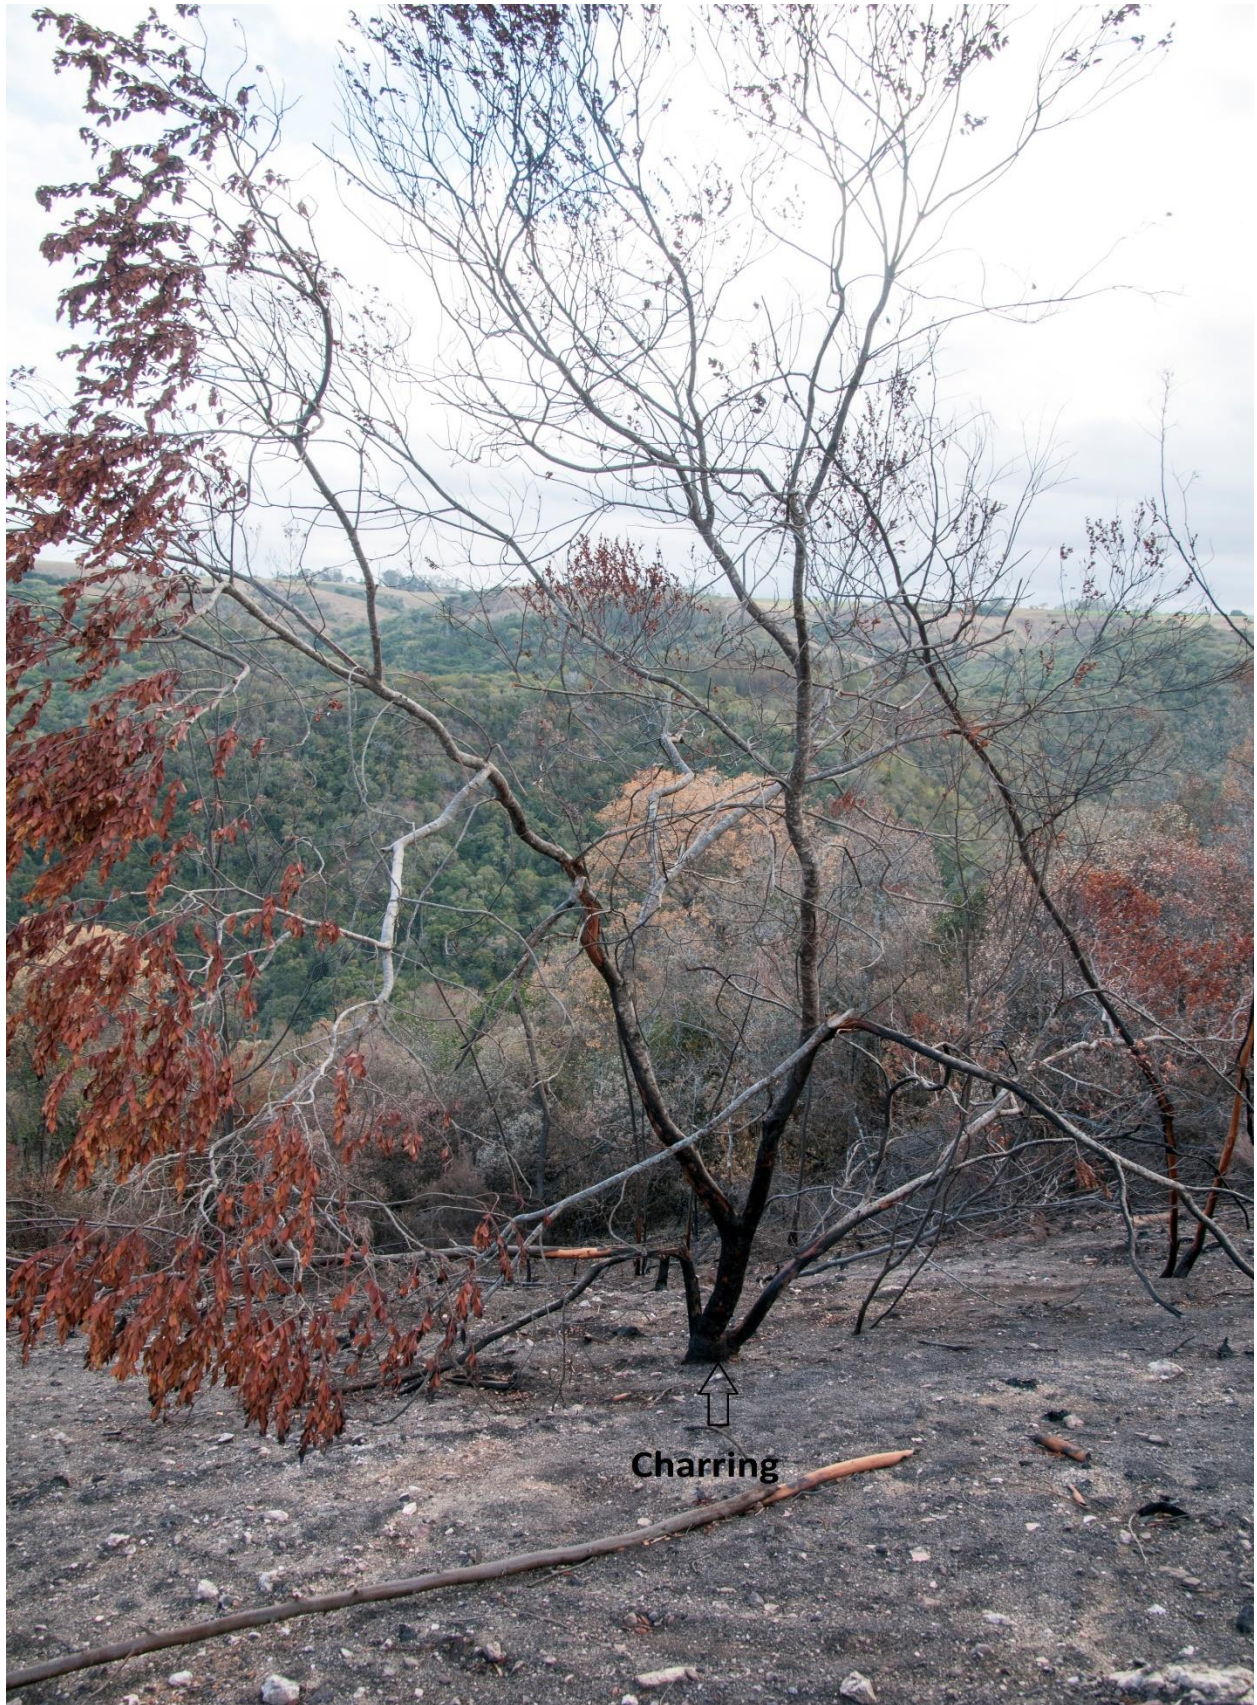
Figure 29: Note the remaining leaves on this tree. Scarring from the uphill side
Page 36 of 131

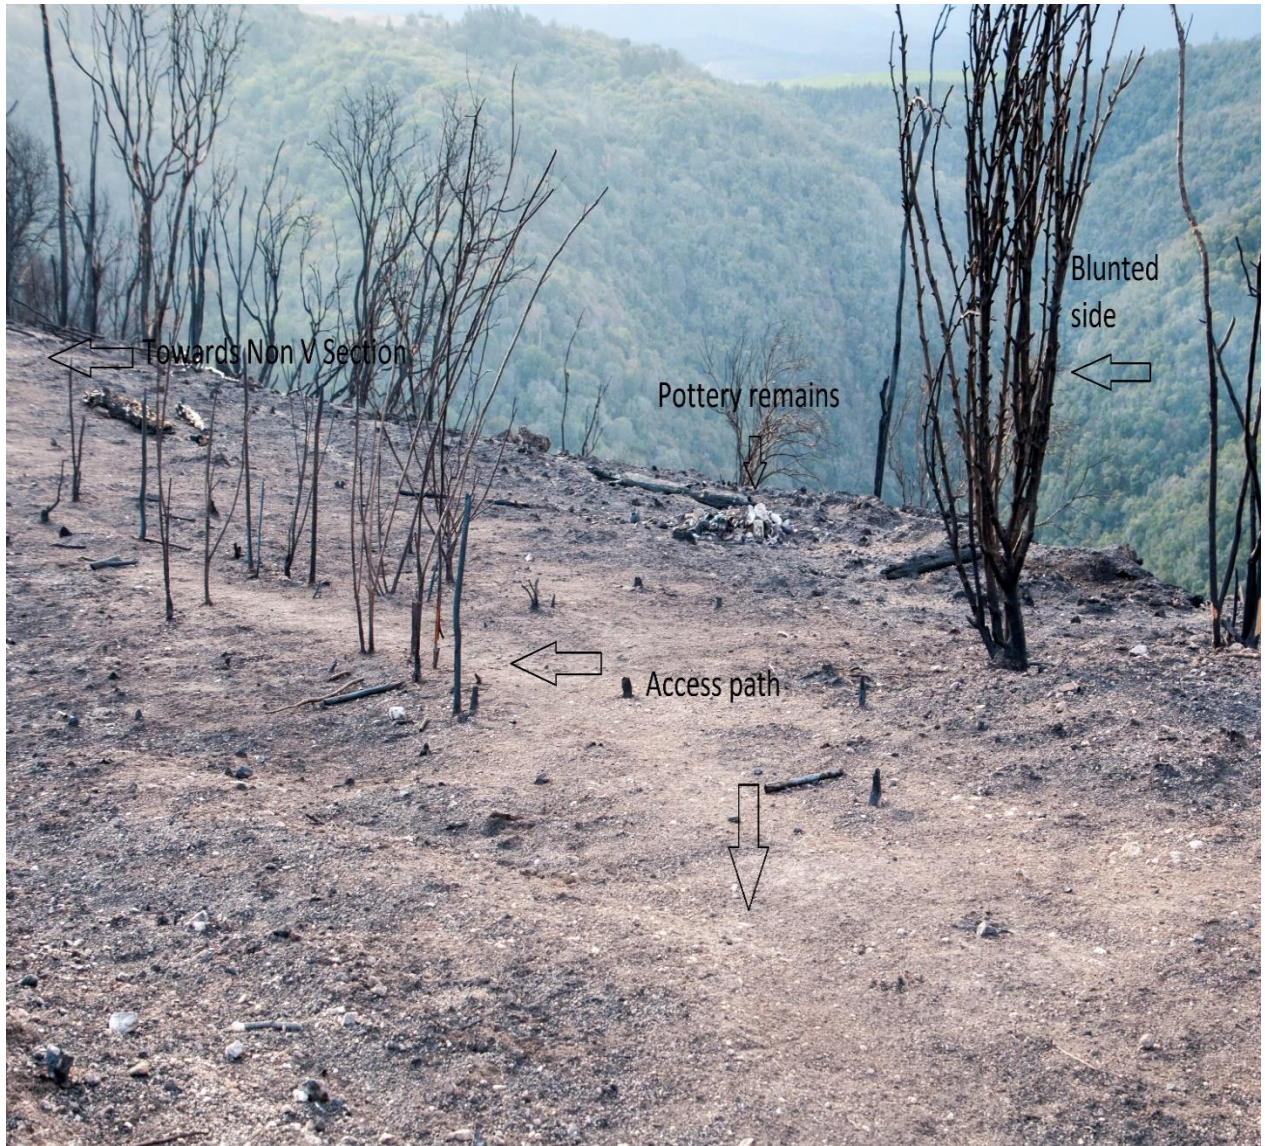
Figure 32: Charring from the right. Note the pile of broken pottery and well-worn path leading to the pottery pile. To the left are the positions of figures 23 - 31. To the right is "Noah's Ark" shown in figure 34

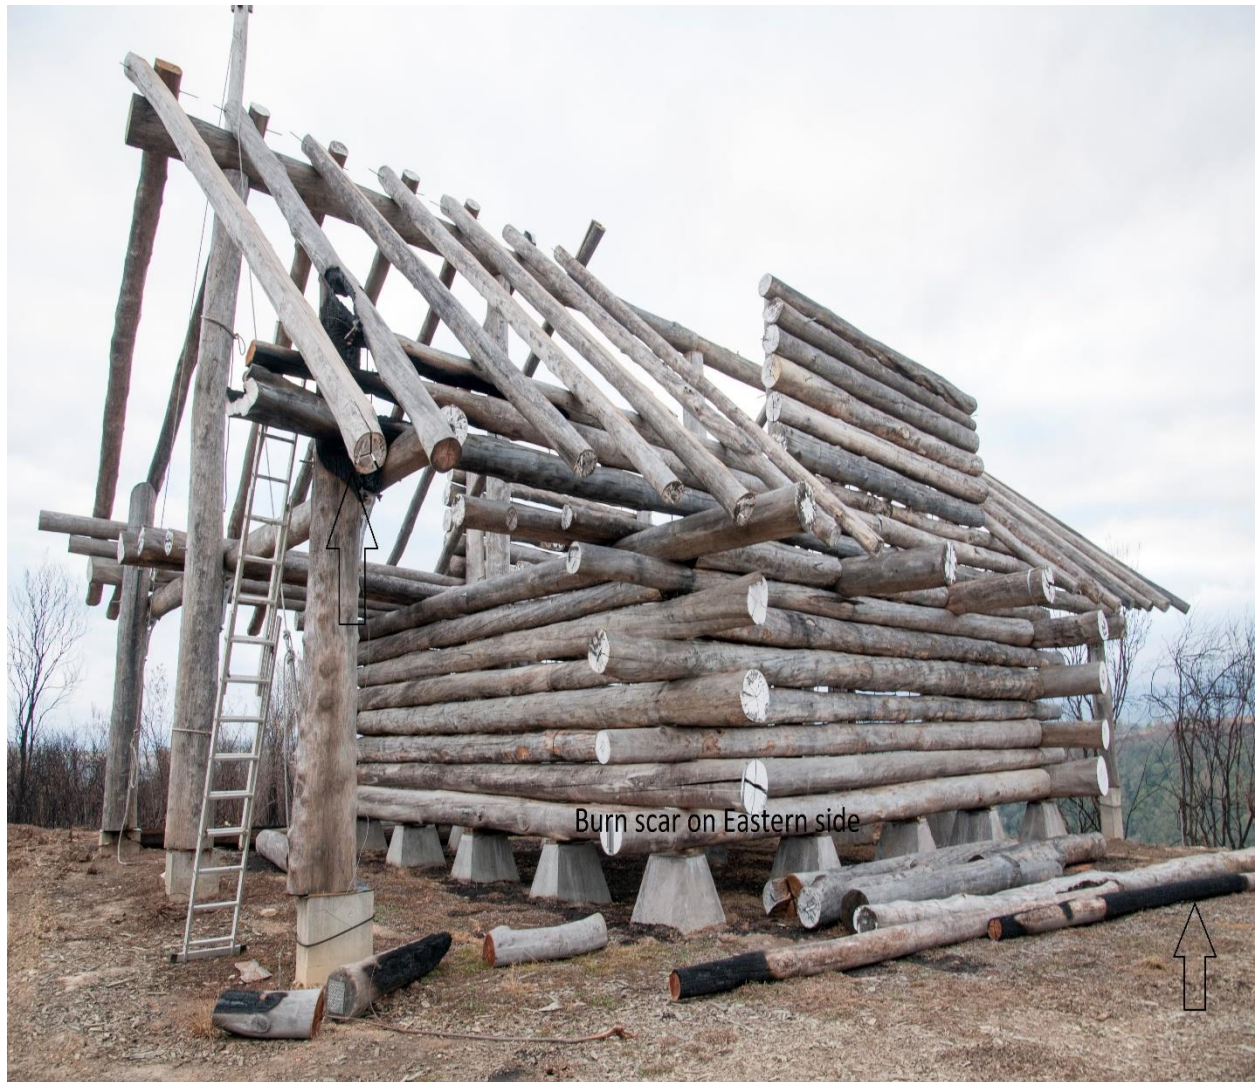
Figure 37: "Noah's Ark" showing the burn scar on the Easterly side.

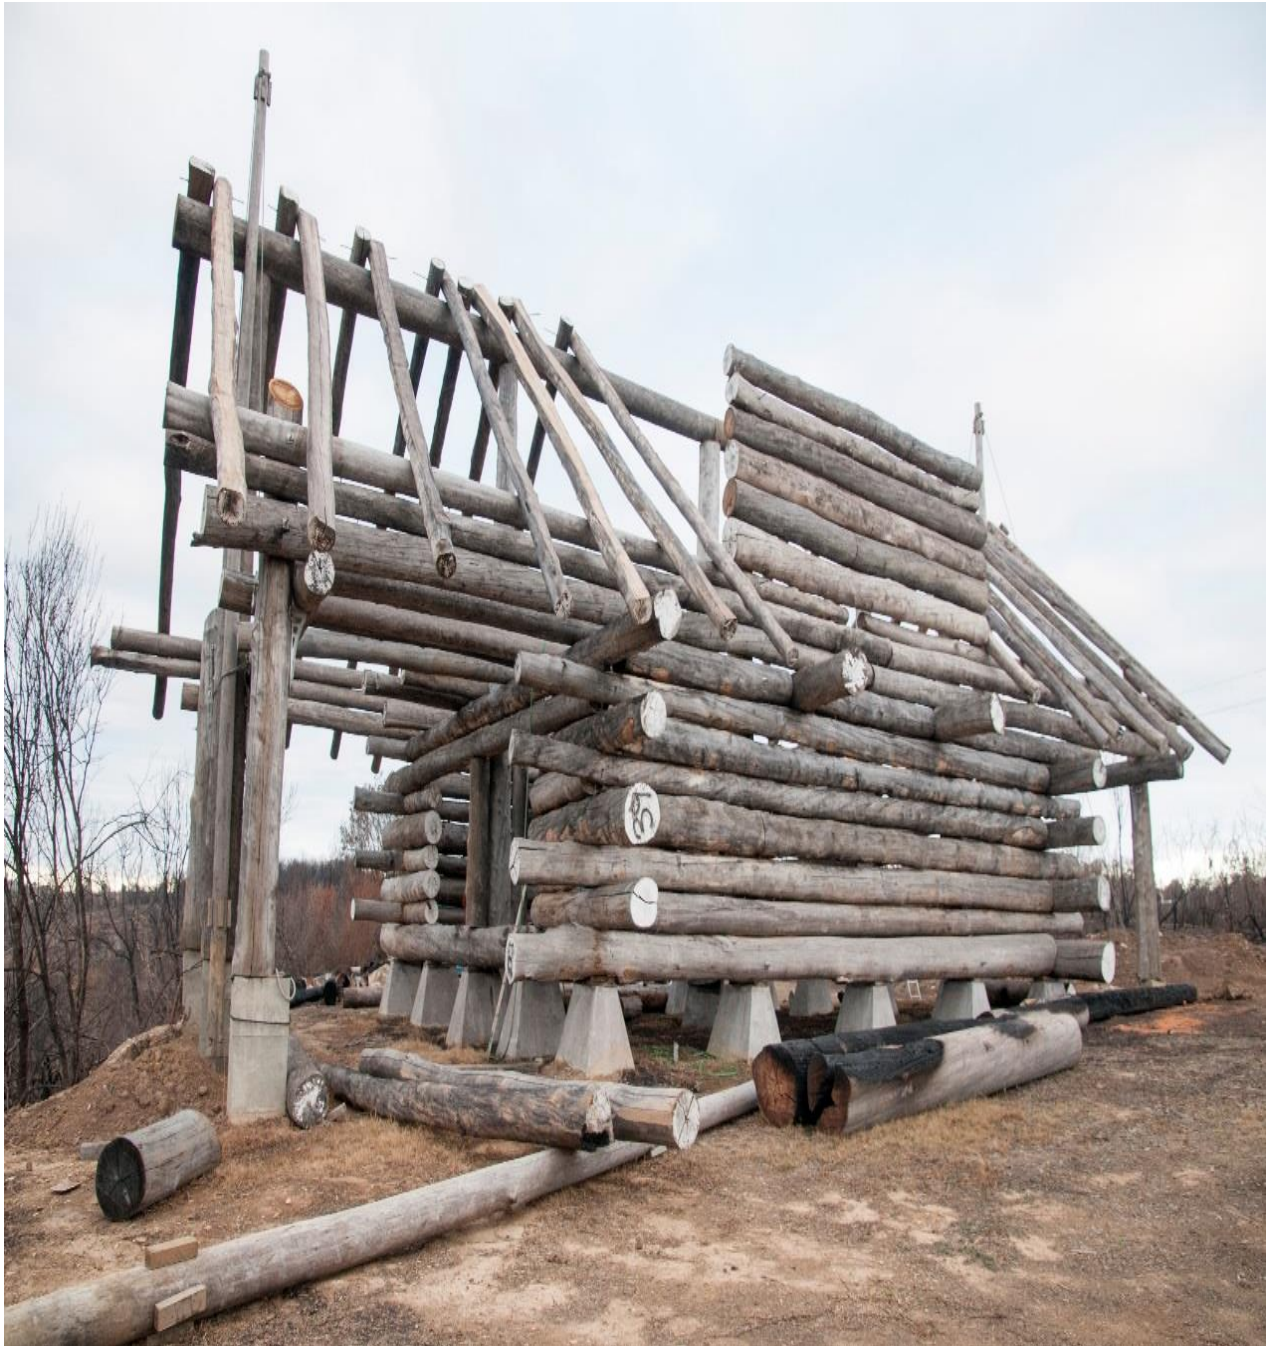
Figure 38: West side of "Noah's Ark", Shows no burn scar.

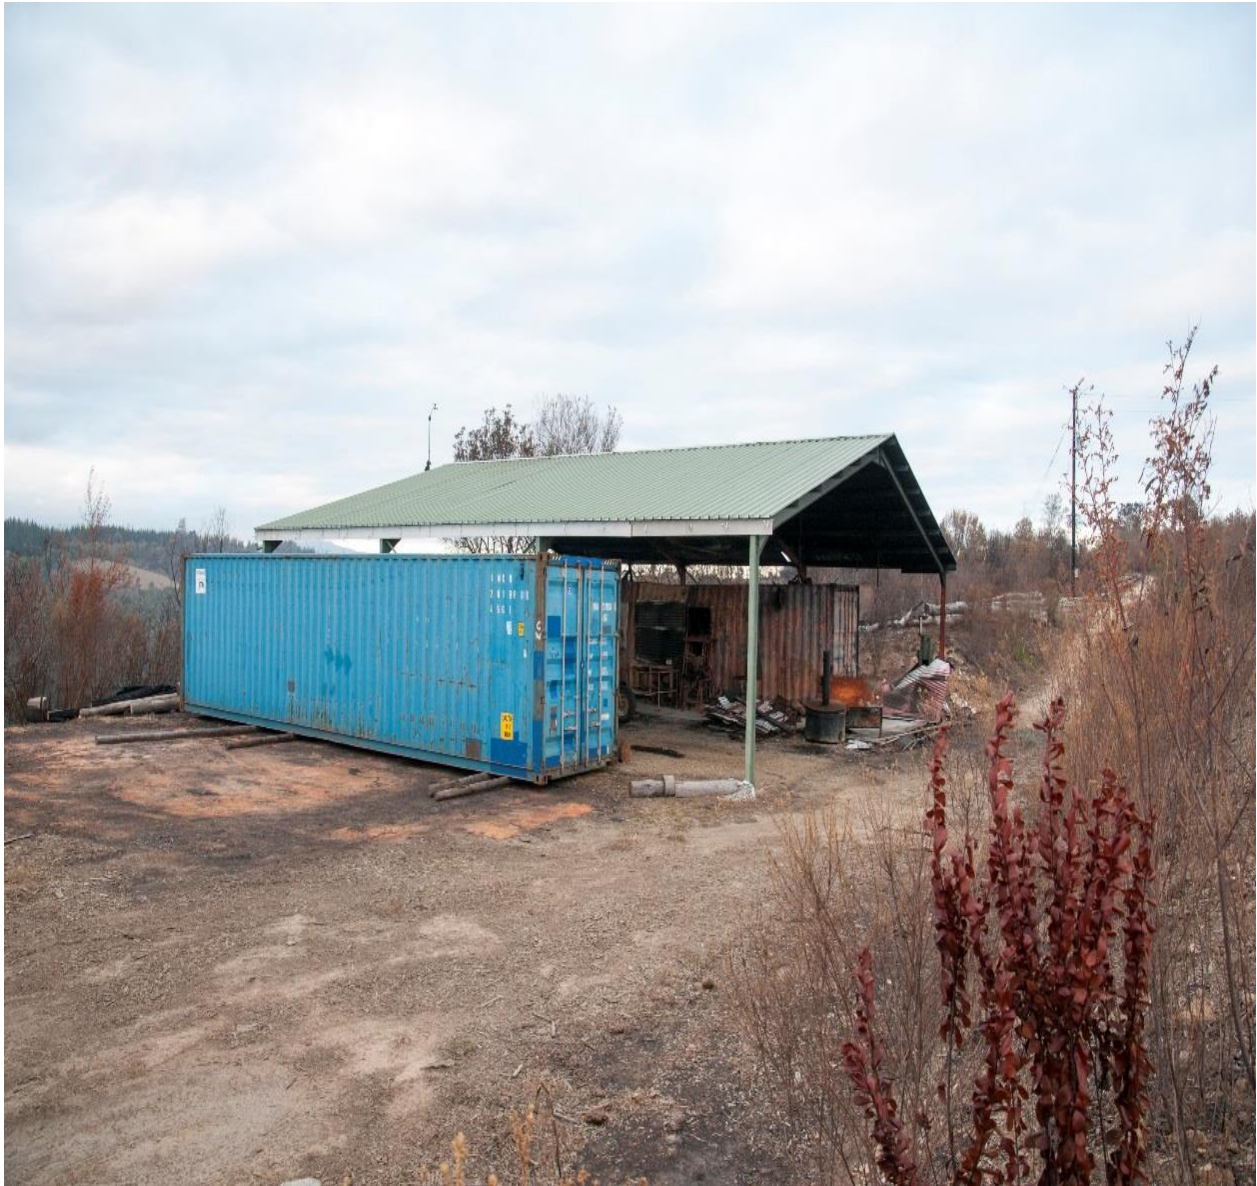
Figure 39: A shed to the East of "Noah's Ark". No burn pattern is visible on Western side of the shed. The container in the photograph moved here after the fire of 07 June 2017. Note that no fire or heat damage on nearest metal column and roof.

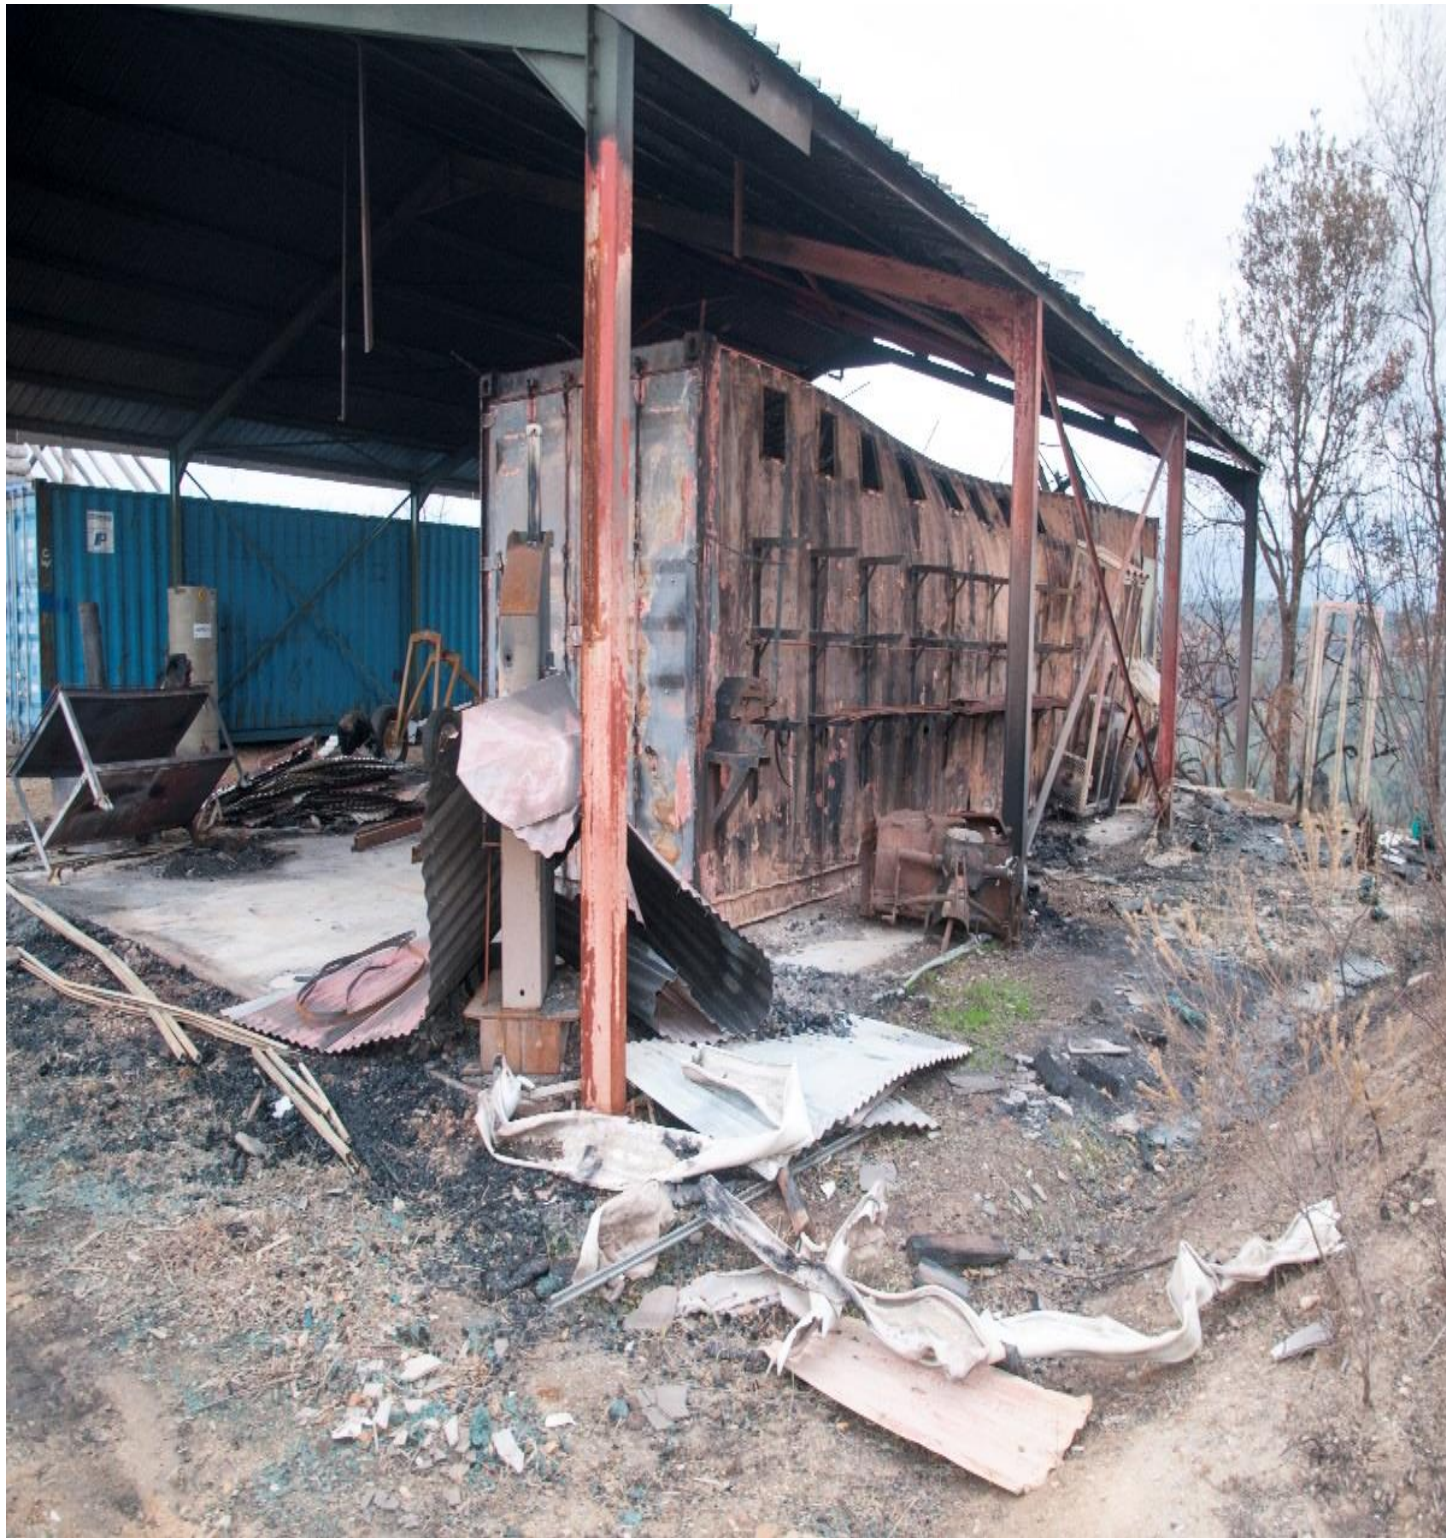
Figure 40: East side of the shed. Note the heat and fire damage on the steel columns and to container.

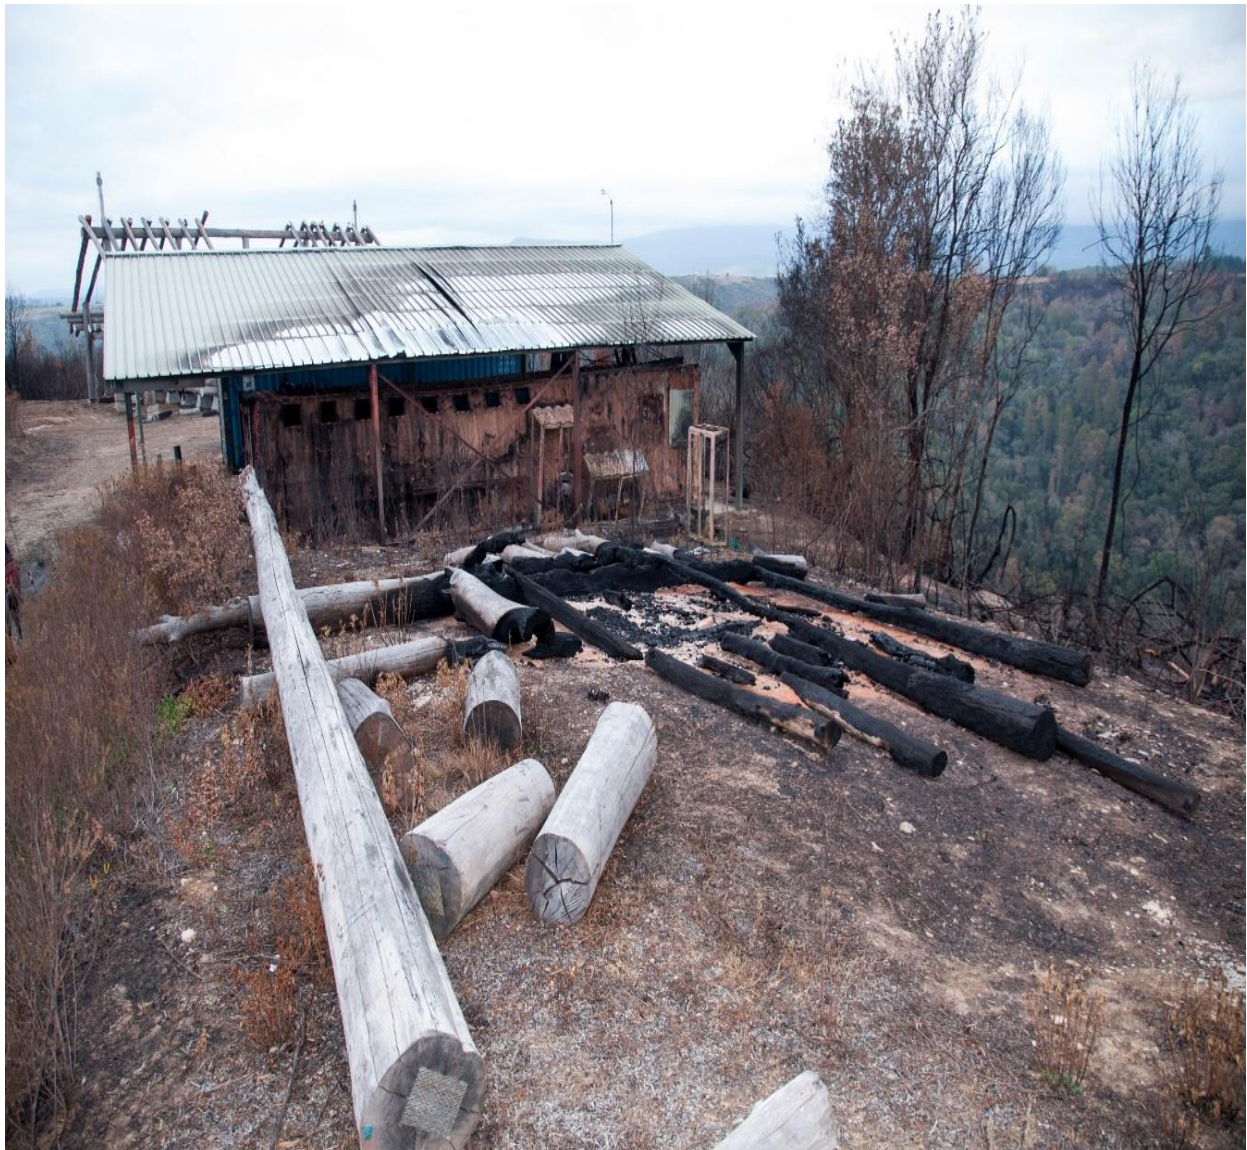
Figure 41: The Eastern side of shed. Note the heat damage to roof. "Noah's Ark" is visible in the background

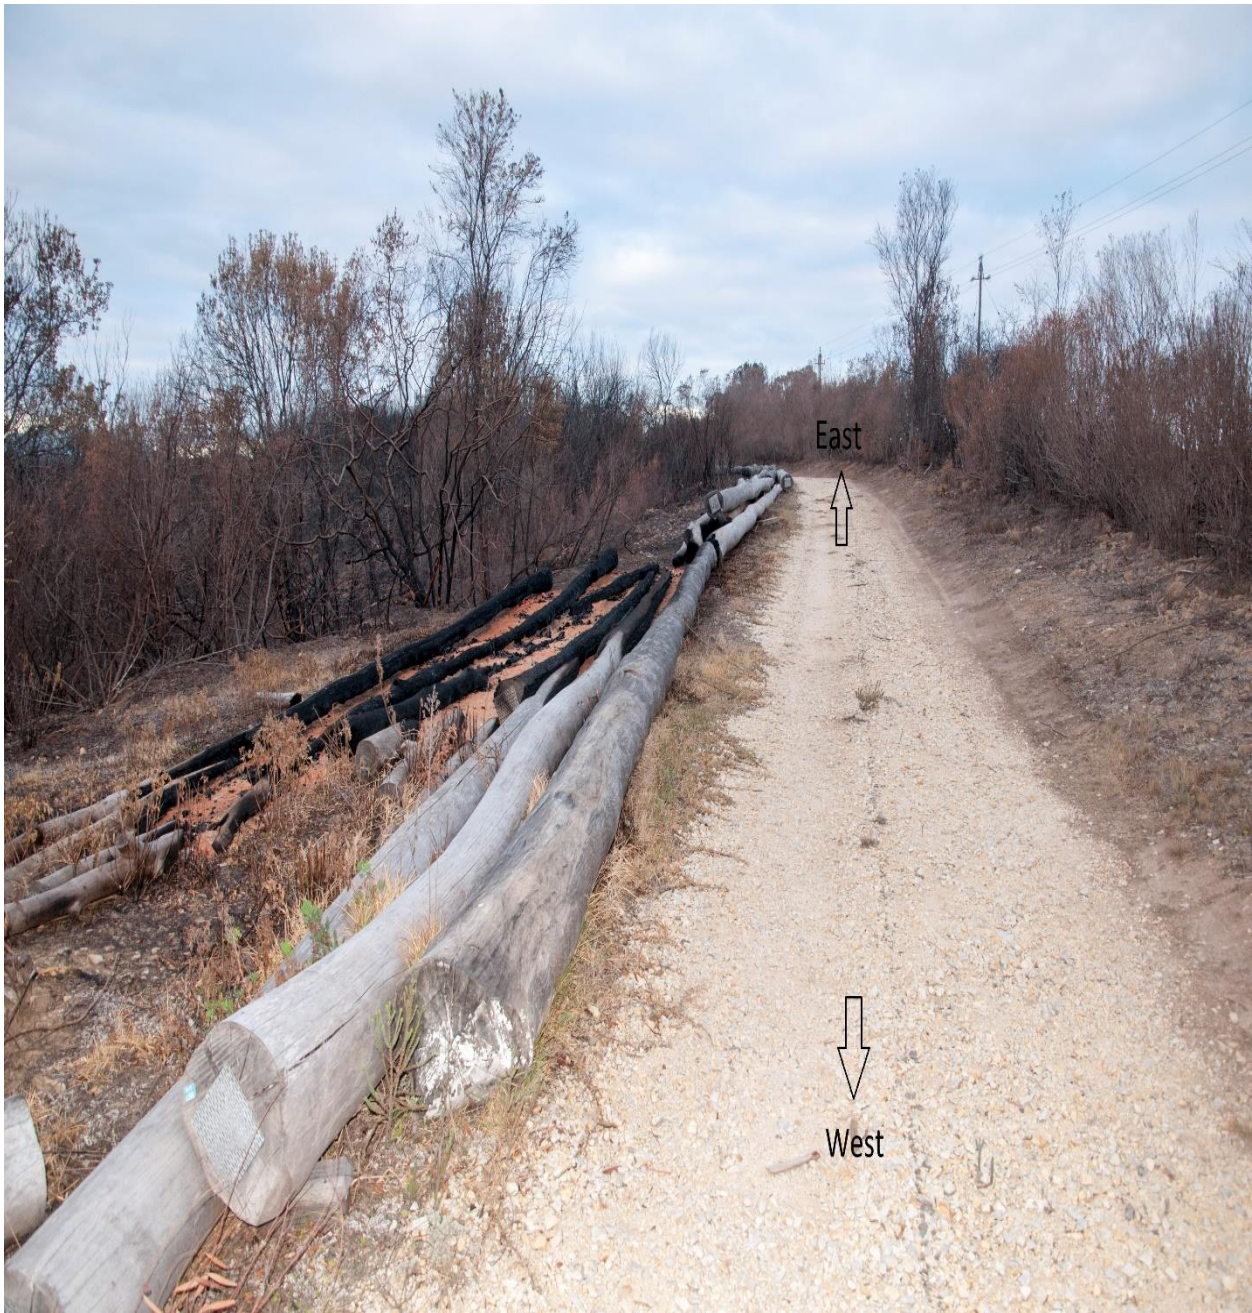
Figure 42: Logs to the west of the shed. Note the burn pattern from a westerly side

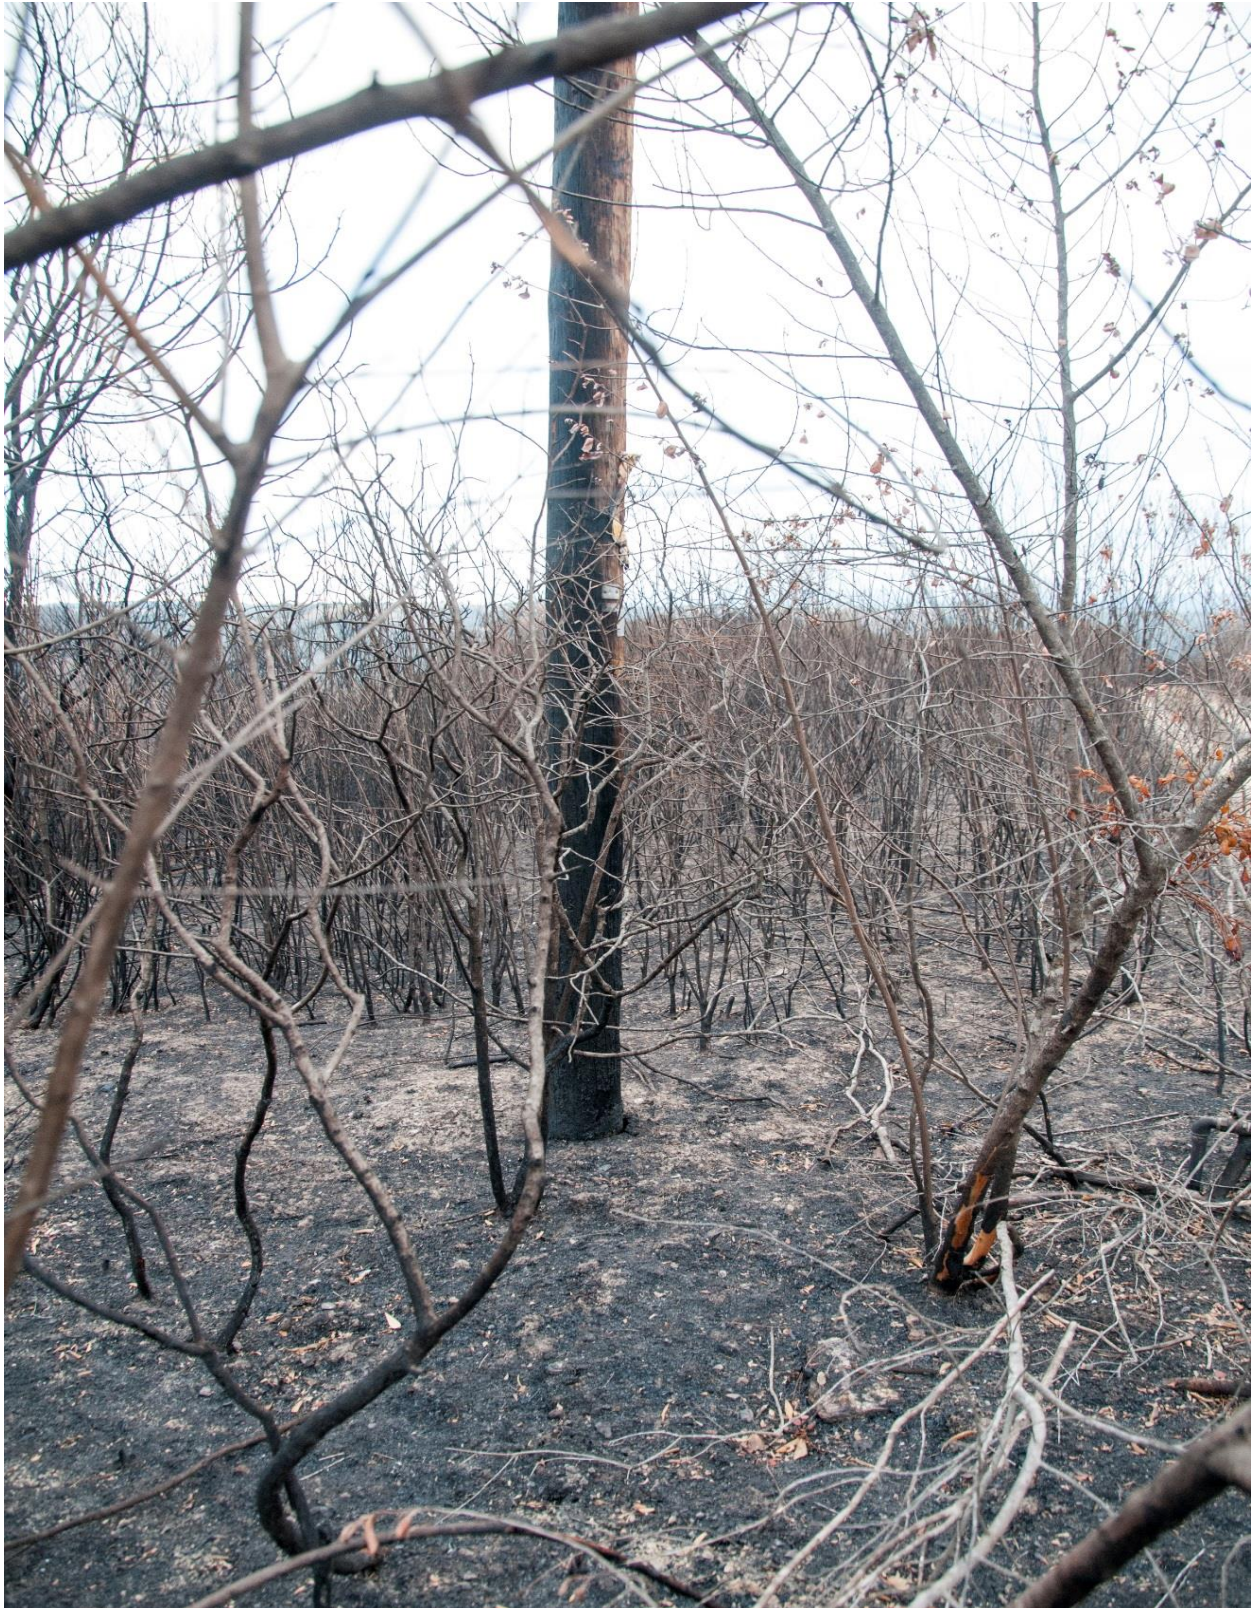
Figure 43: An electricity pole. Note the fire damage on the Eastern side

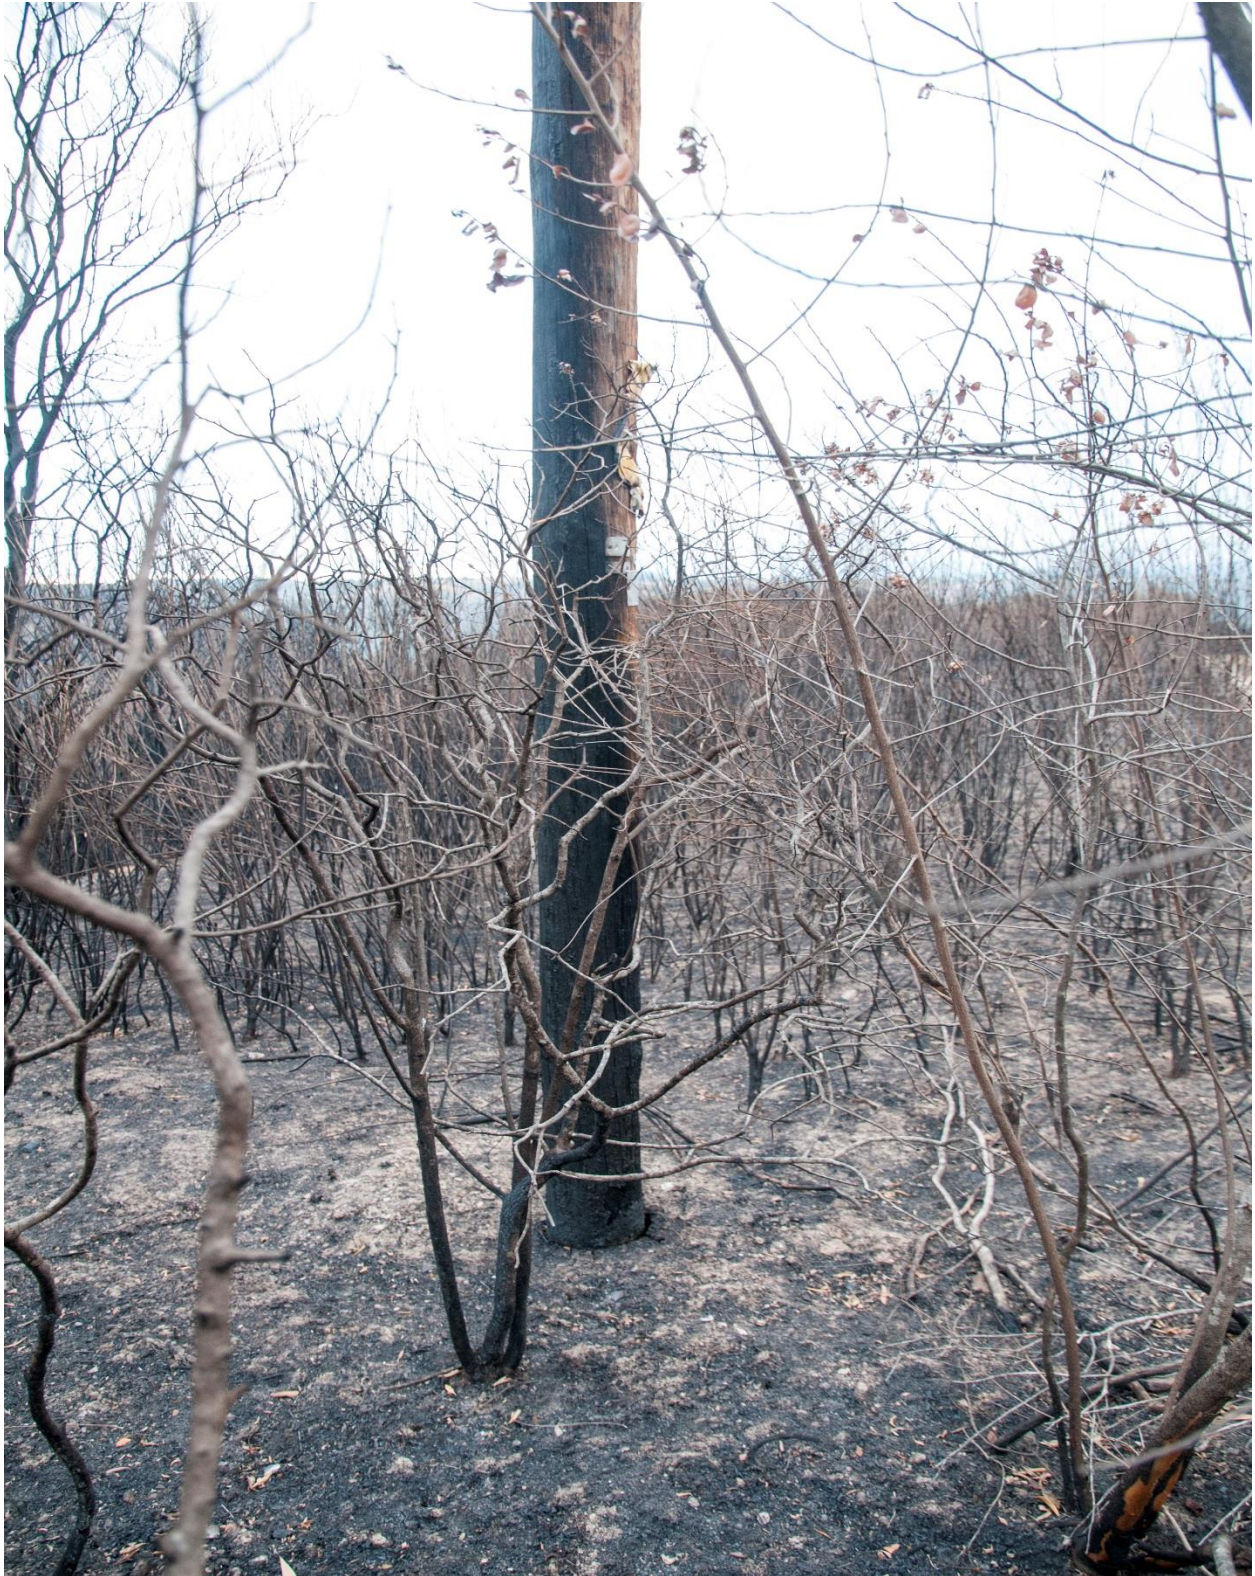
Figure 44: An electricity pole. Note the fire damage on the Eastern side
