Report of the Chief Fire Officer:

Knysna Fire and Rescue Service on the Fire origin and possible cause in the Elandskraal area:

Knysna on 07 June 2017

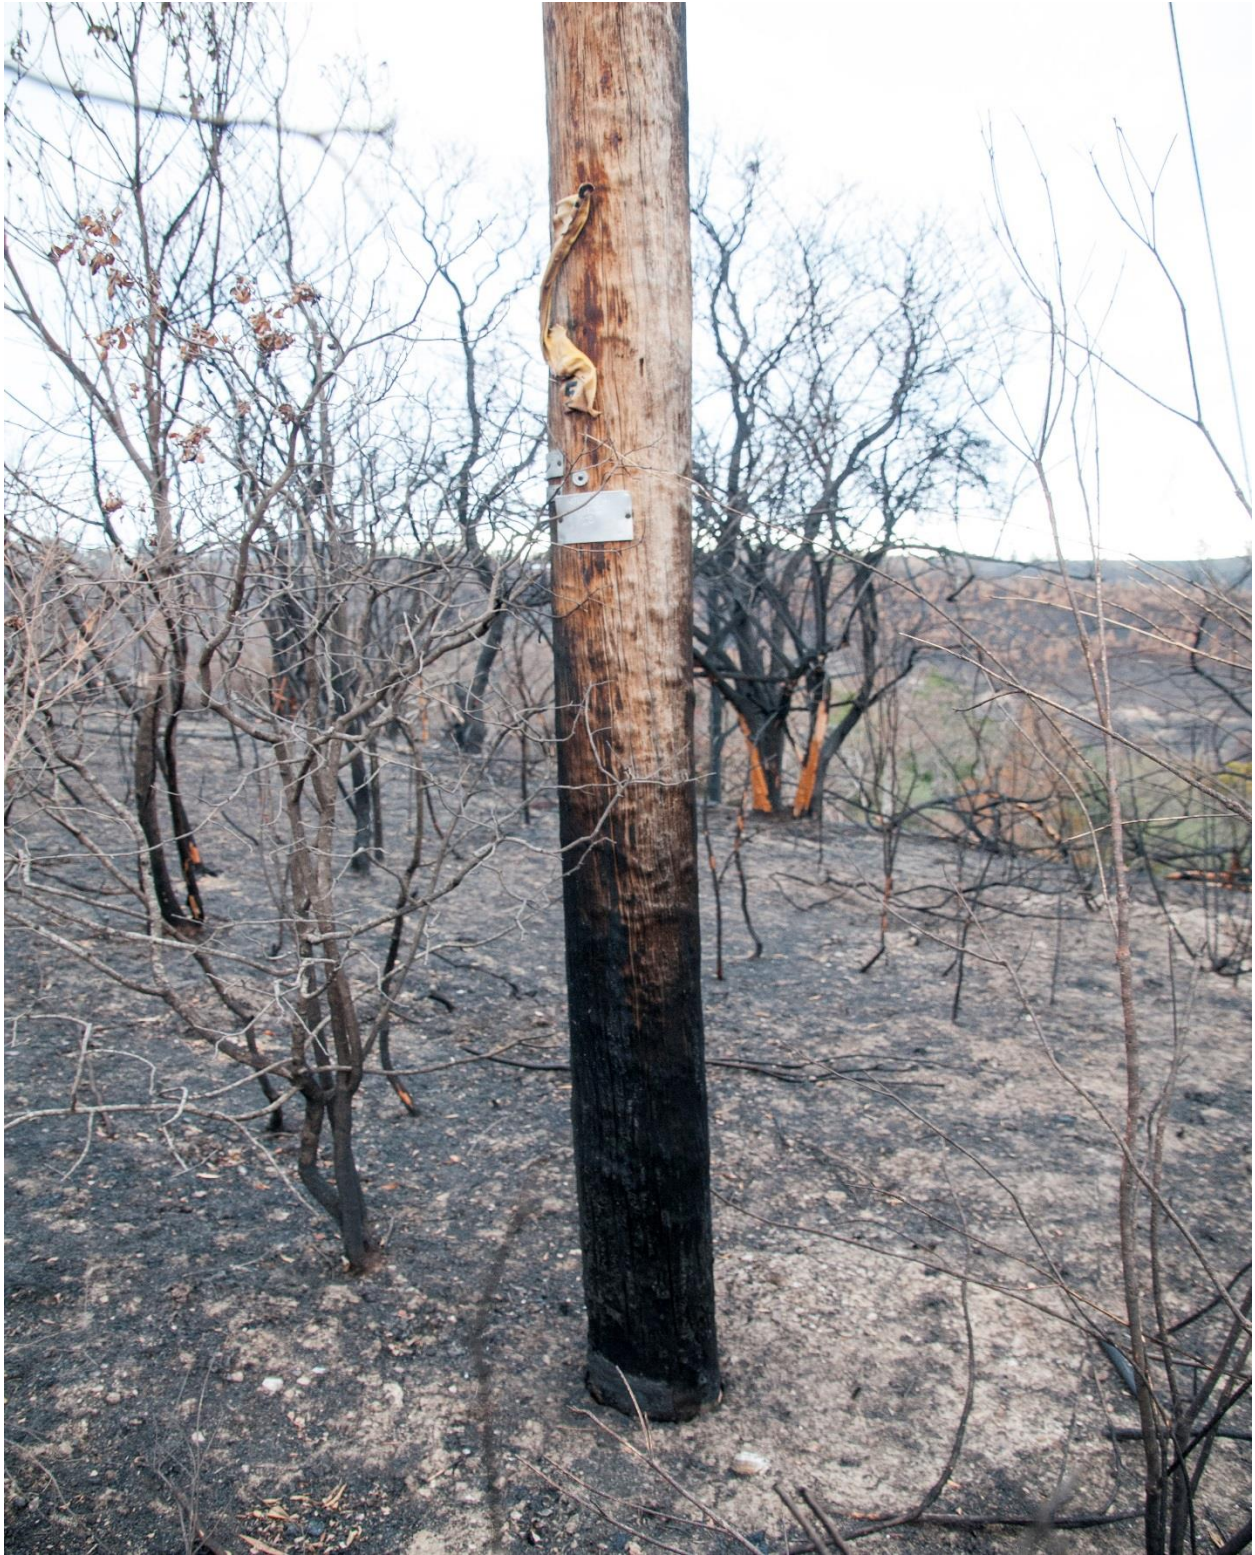
Figure 45: An electricity pole showing fire damage on the Eastern side

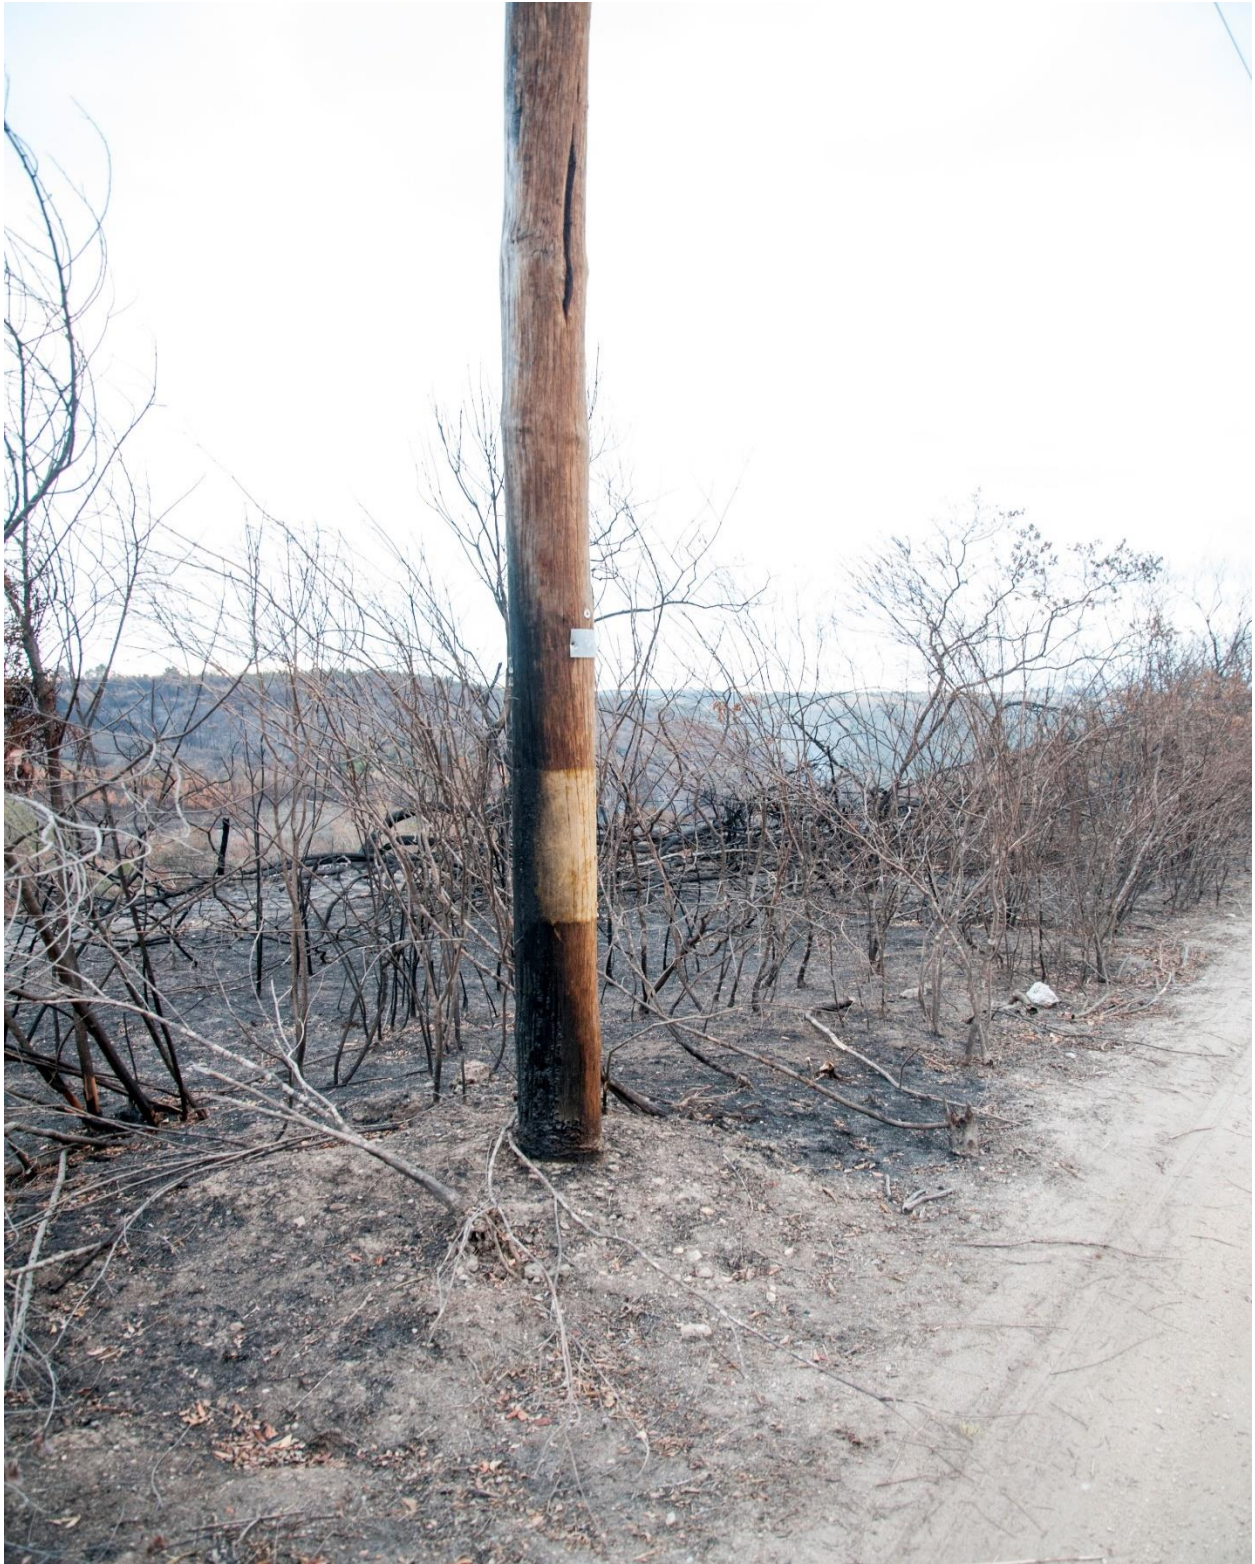
Figure 46: Electricity pole showing severe fire damage on the Eastern side in comparison to opposite Western side

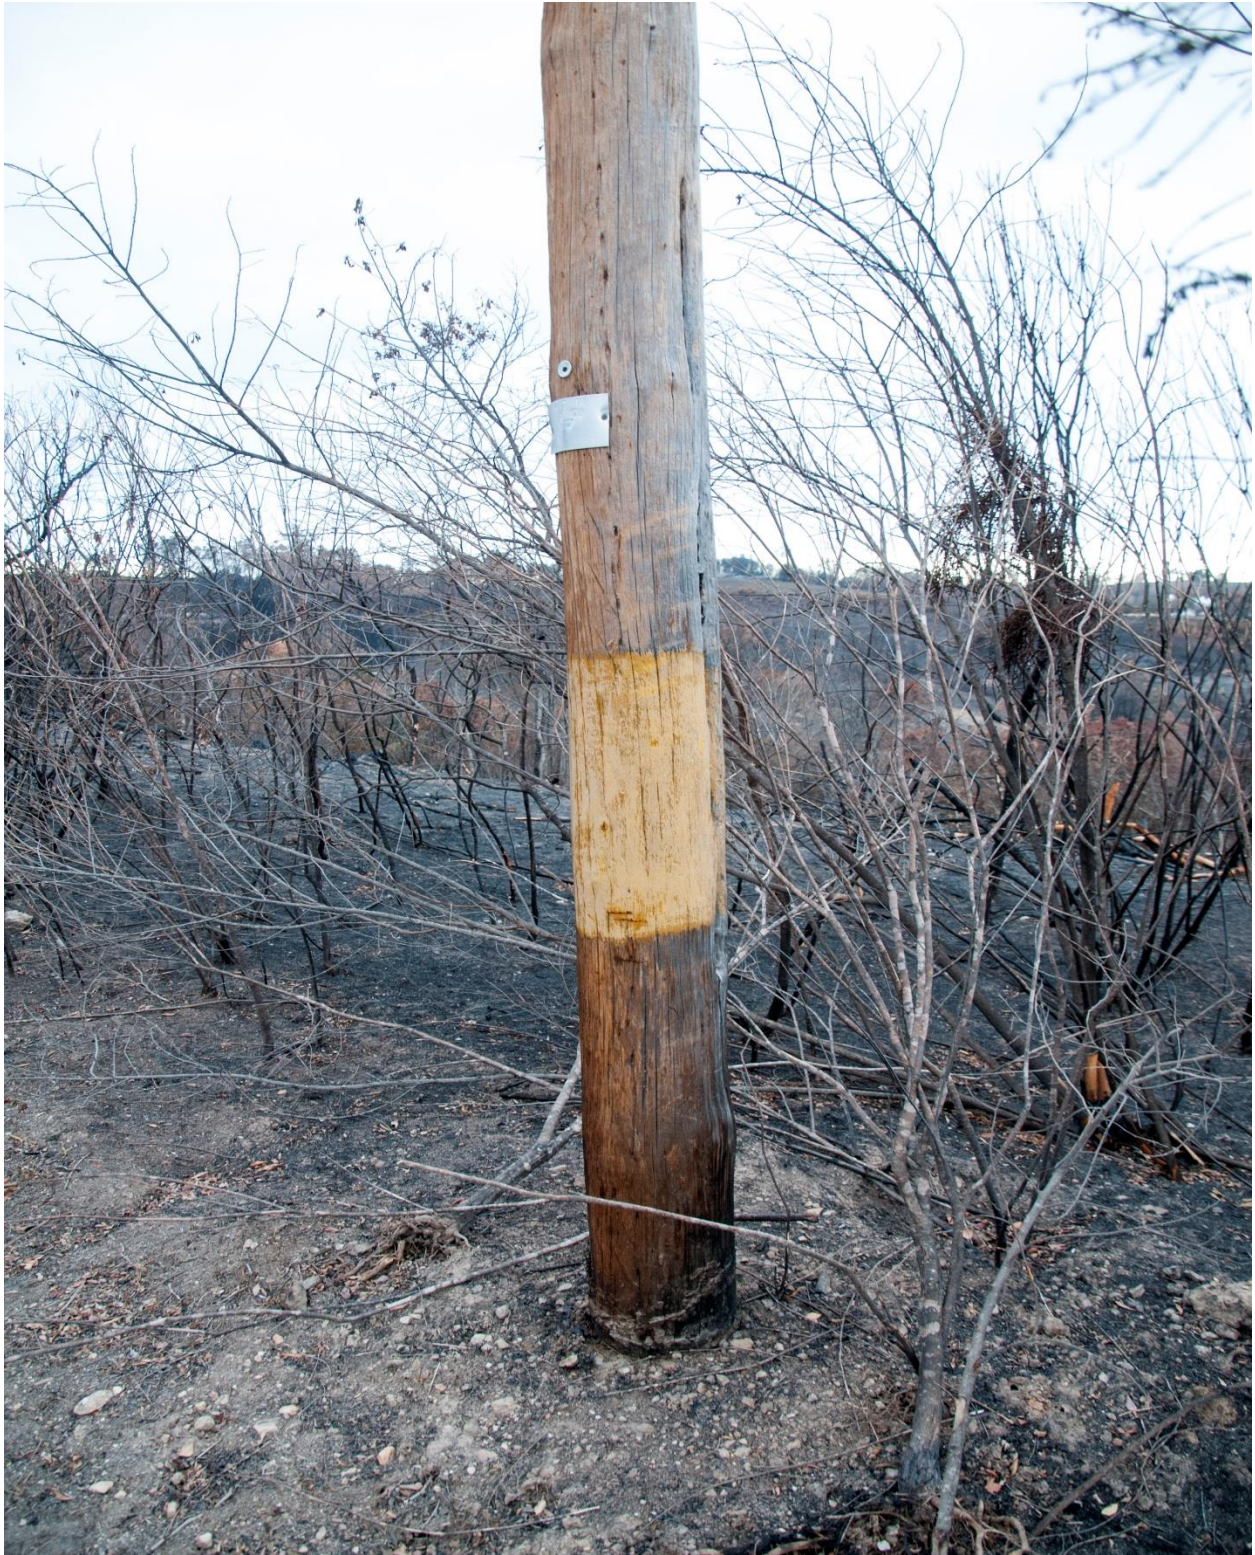
Figure 472: The Western side of pole in Figure 46 showing less severe fire damage

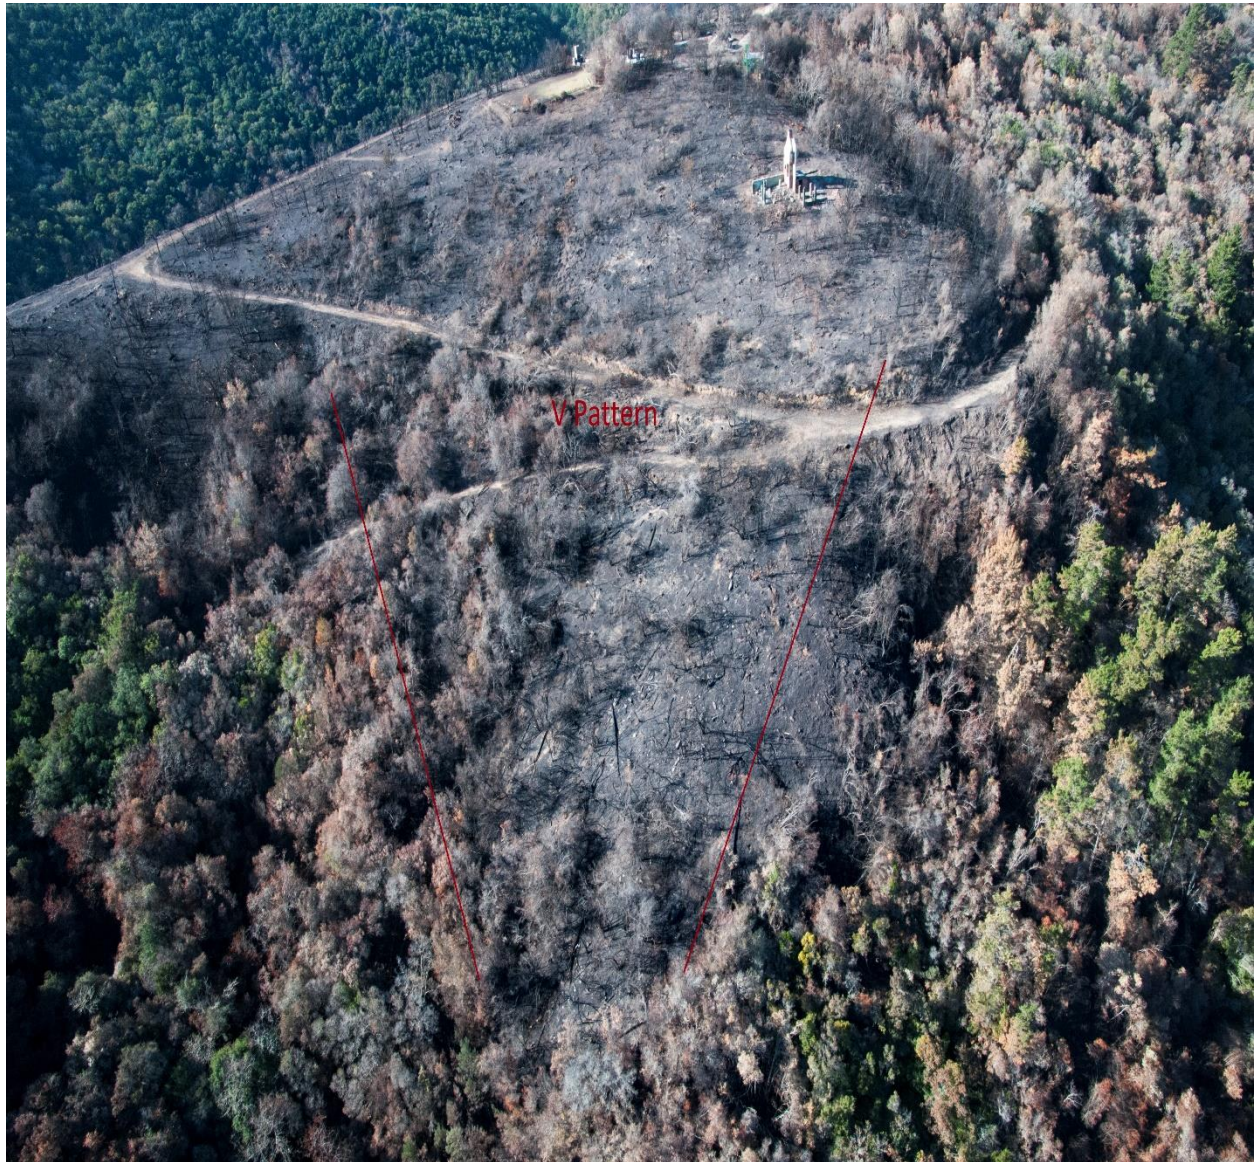
*Figure 48: "V" pattern of the fire spread. Note the building in the path of the fire spread.
Note the access roads/paths*

3.3 Figure 48 shows a clear "V" Pattern with the fire spread from the lowest section of the "V" and outwards. Notice must be taken of the degree of damage to fuels. Aerial

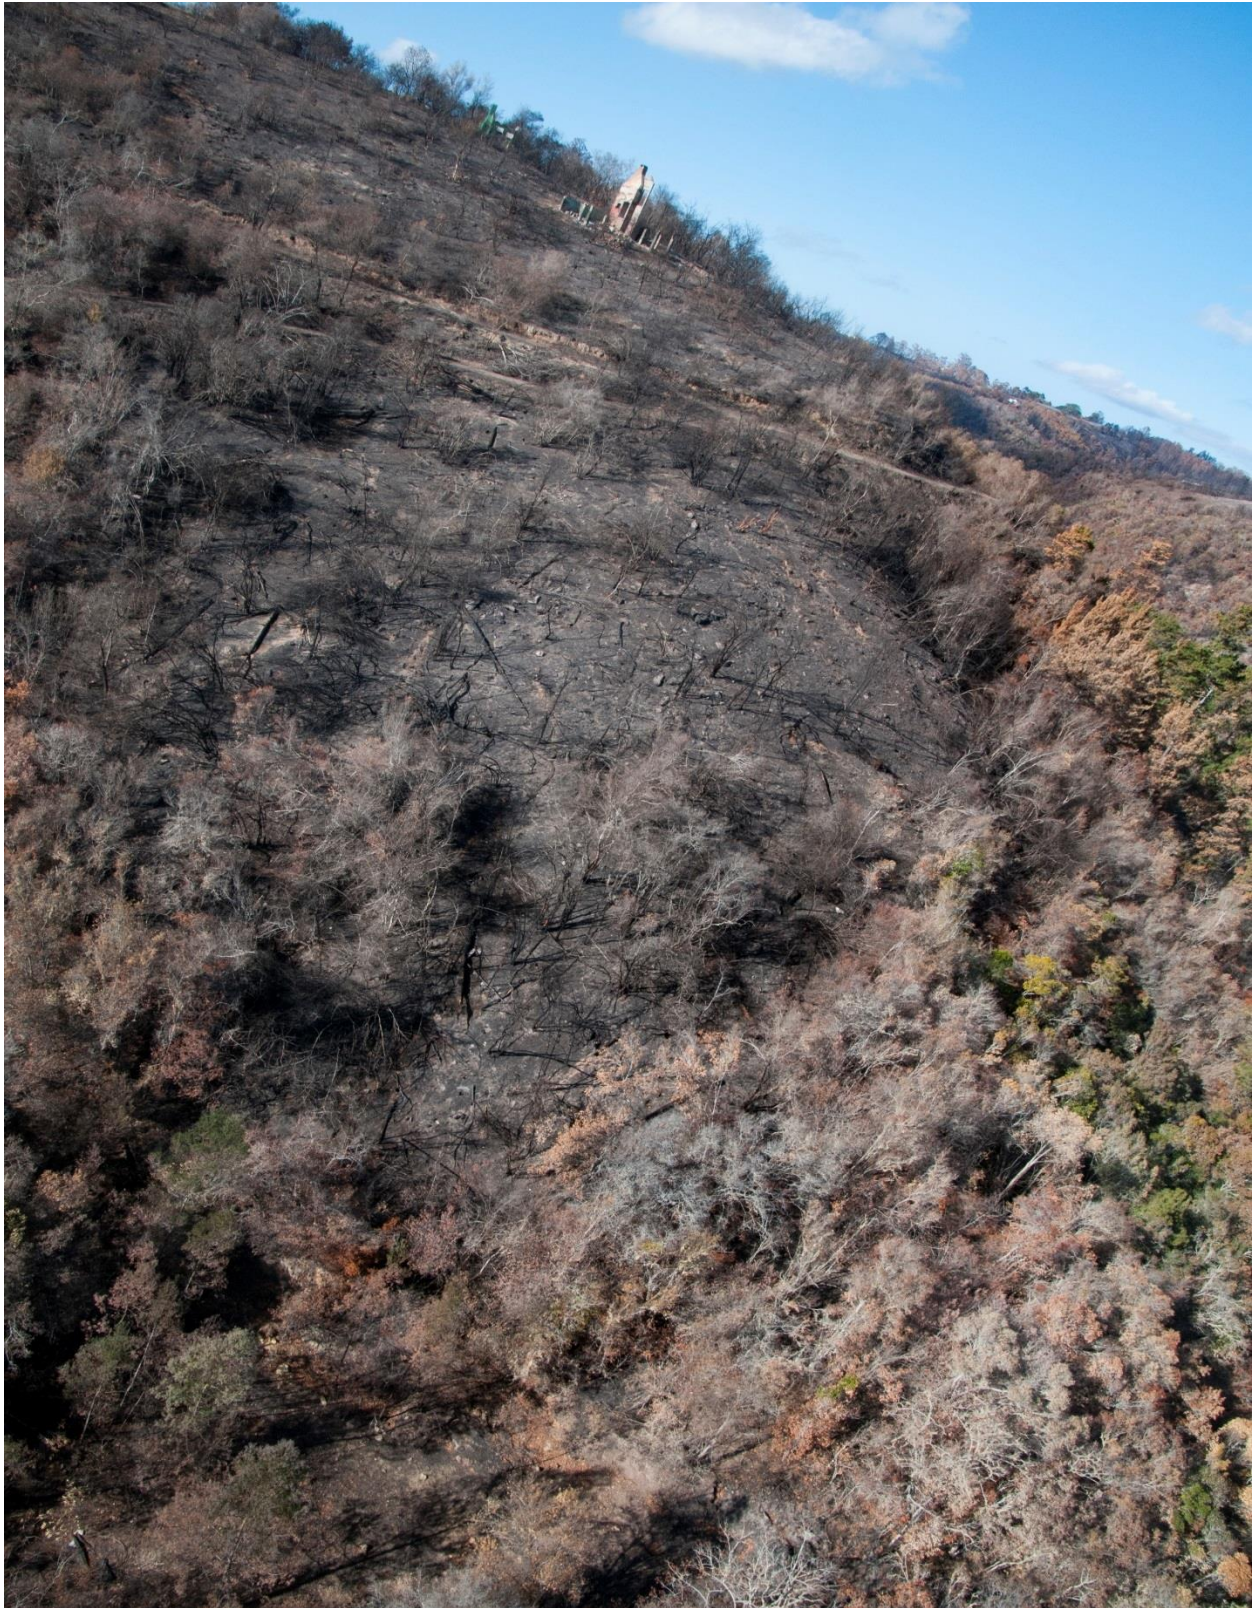
Figure 49: Low Angle photograph of the "V" pattern showing the house and clearing in left hand corner

3.5 Figure 49 shows the “V” Pattern and the progression of the fire towards the first building in its path. This building sits right in the “V” Pattern path and bears the full front of the fire spread. This shows the direction of most of the heat that severely damaged this building. Most heat is from the downslope along the “V” Pattern. At this stage, the fire is consuming heavier fuels, fanned by a West-North-Westerly wind that blew between 01:32 and 01:54 at approximately 40km/h. The wind changed from the North-West between 01:54 and 02:17 at speeds between 40 and 50 Km/h.

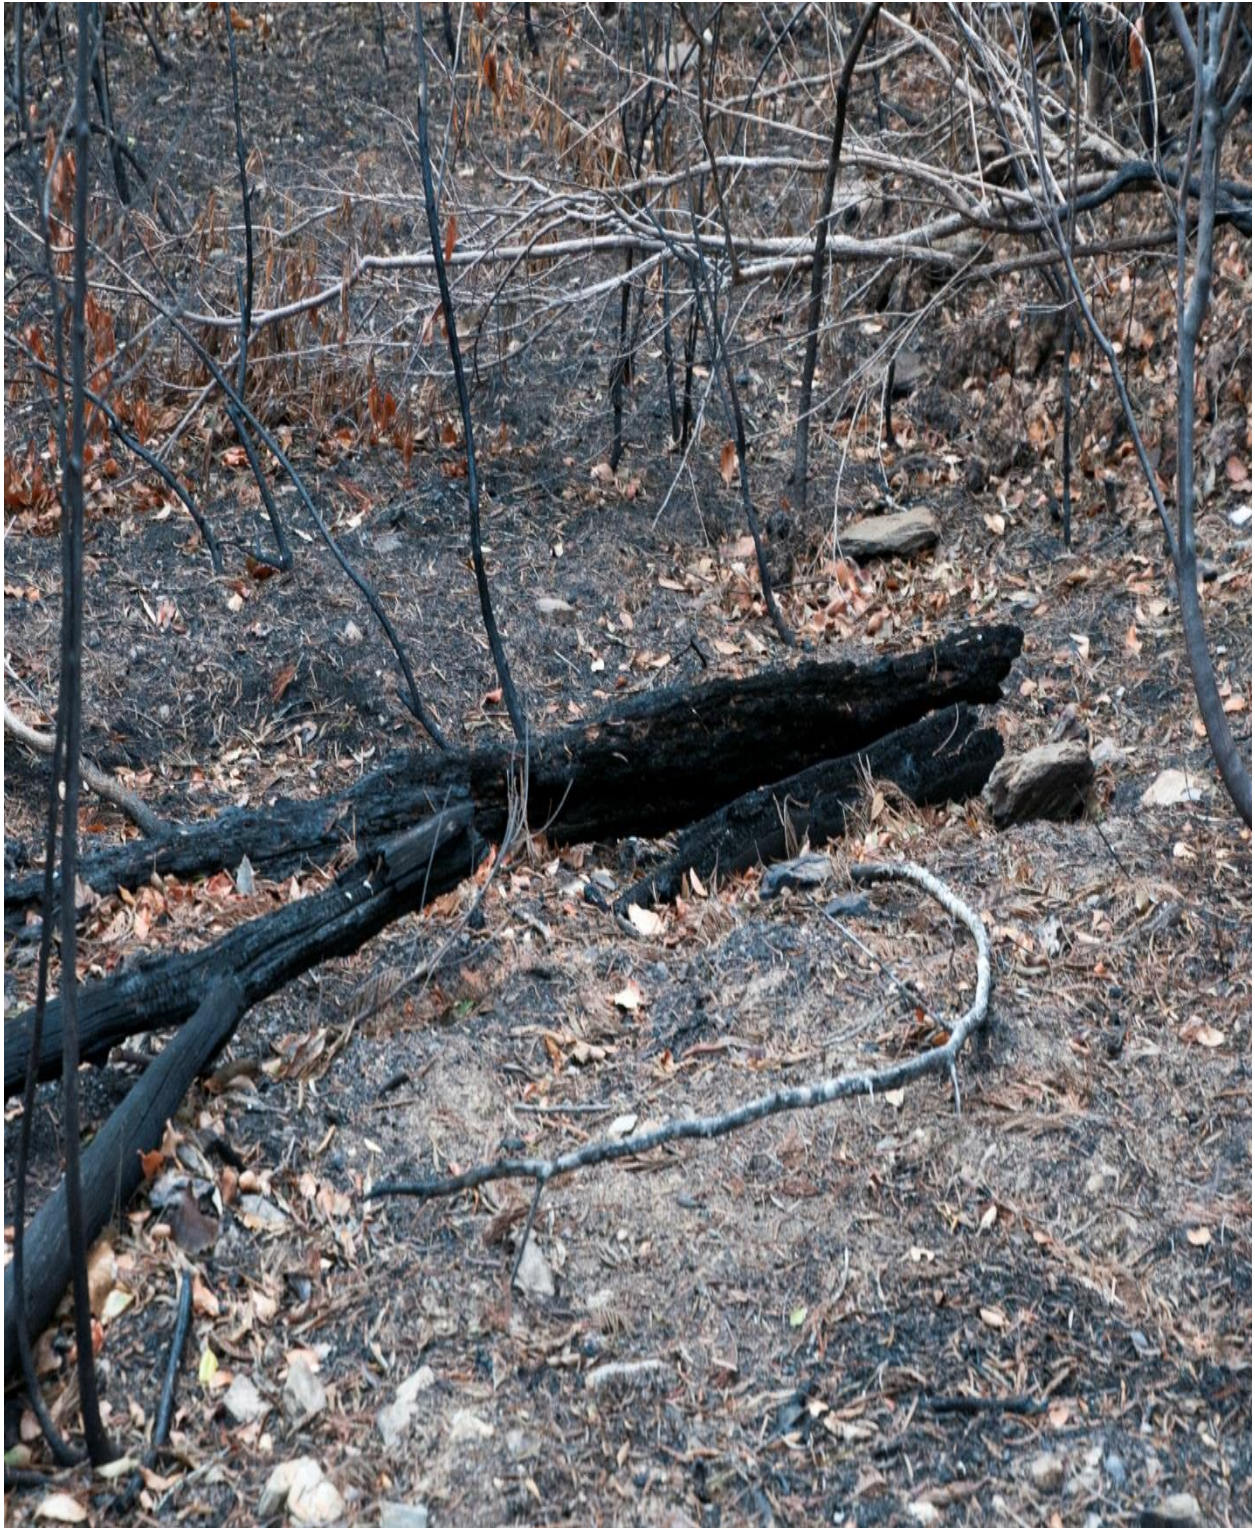
Figure 61: Burnt material found in the clearing. Note the young trees in the area slightly damaged by the fire, compared to the damage to the heavy fuel (stumps)

- 3.14 Scorching in the clearing showing the soot of light fuels (Figure 51, 60 and 61)
- 3.15 The above indicates that a fire spread from the clearing, at the lowest part of the “V”, uphill to consume heavier fuels. Scorching on the remaining tree trunks shows a fire burning uphill in the “V” Pattern. (Figures 67, 68, 69 and 70)

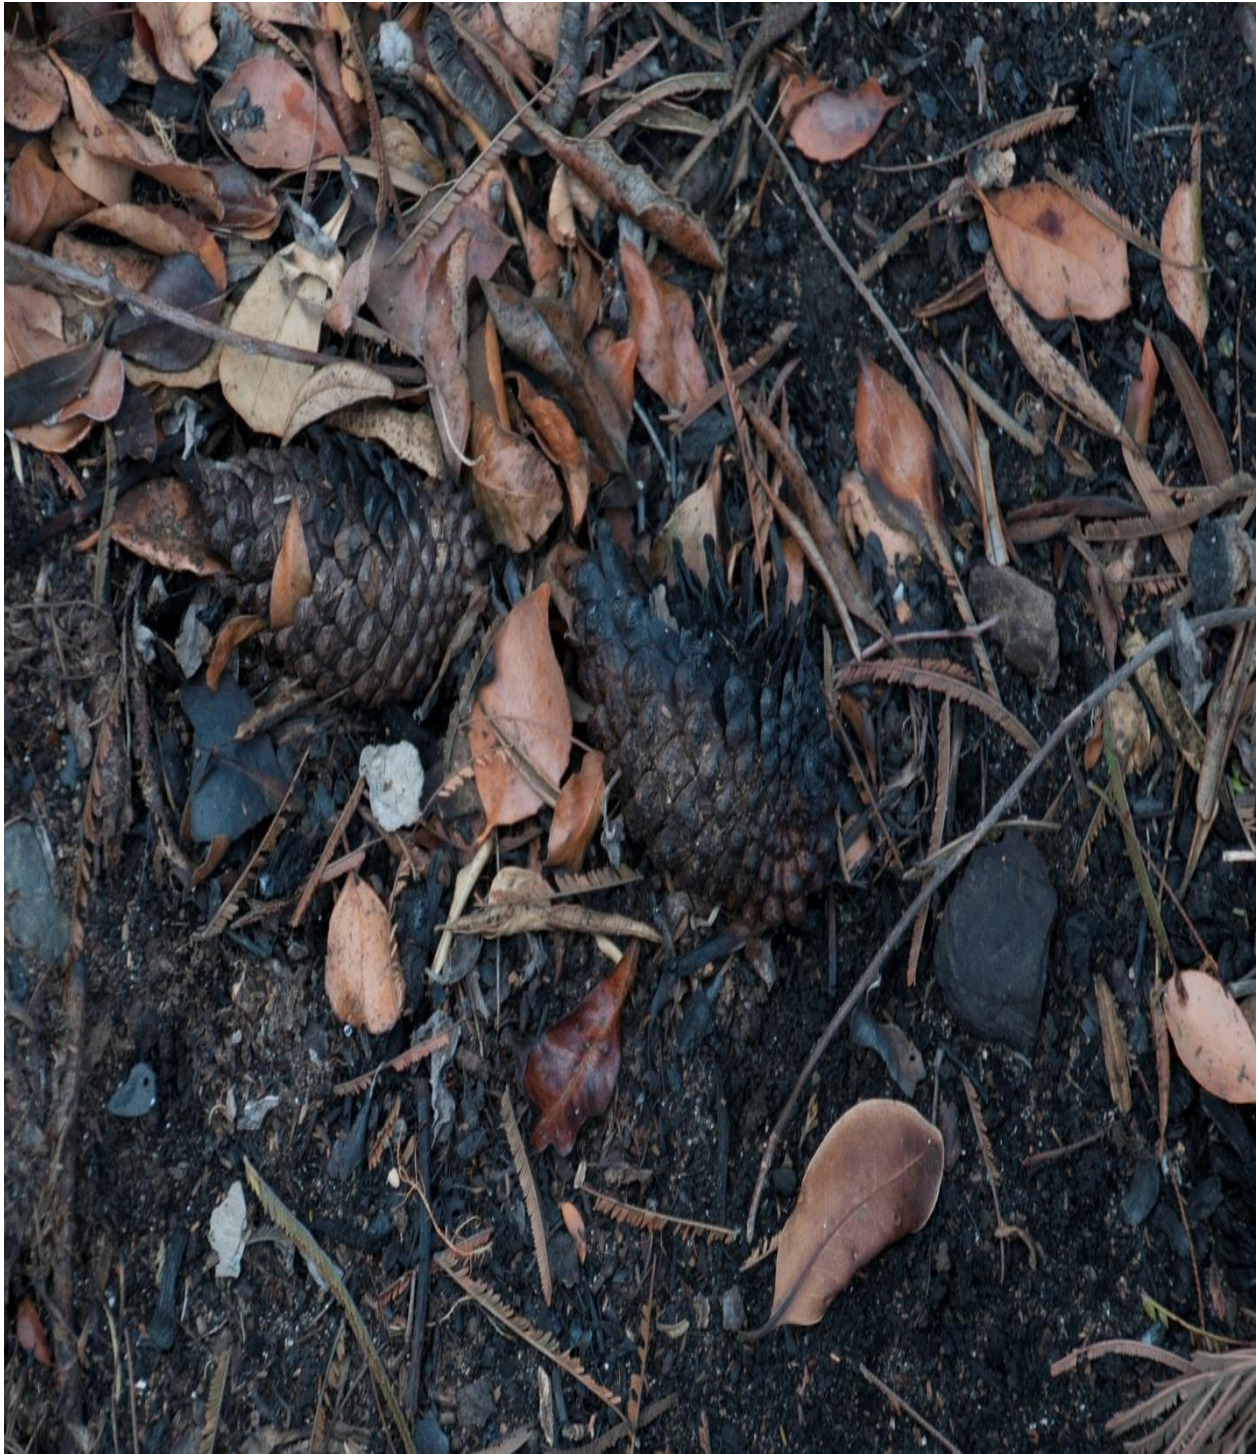
Figure 63: Partially burnt pinecones in the clearing. Note - there are no pine trees in the nearby vicinity.

- 3.12 No Pine trees grow in this area, yet pinecones were found in the clearing (Figures 63, 64, 65 and 66)
- 3.13 Recently burnt pinecone stacked with combustible heavy fuels were located in the clearing (Figure 66)

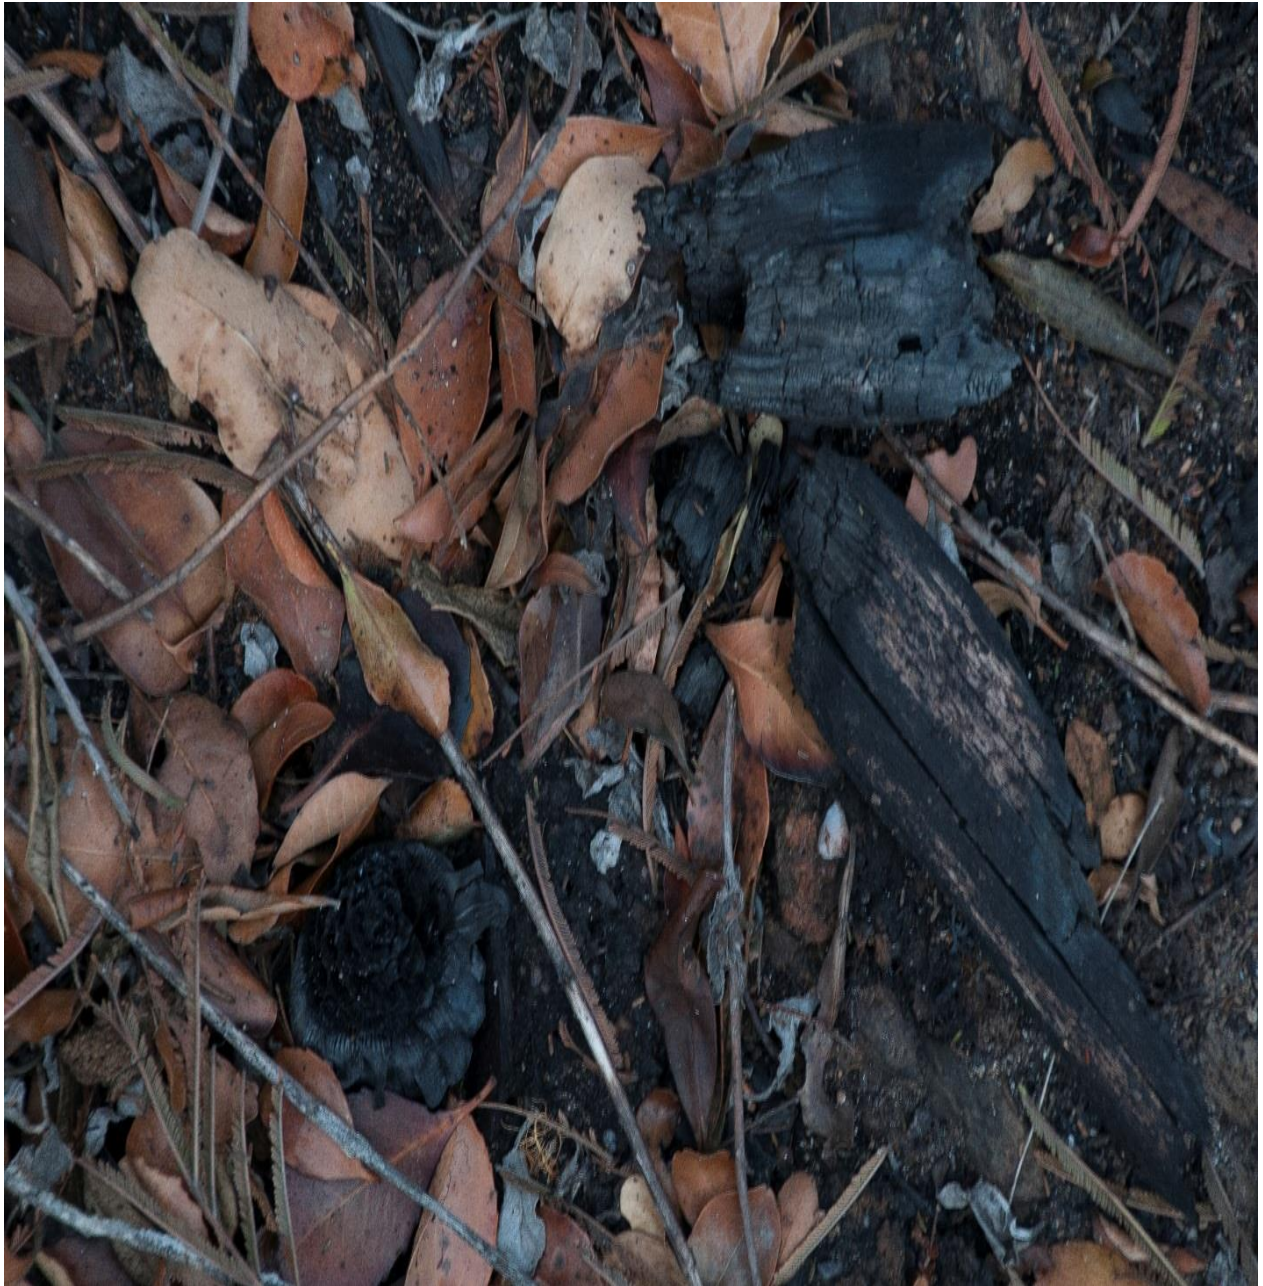
Figure 66: Combustible material found stacked in the clearing. Note the pinecone position. This burnt material shows that it had burnt recently.

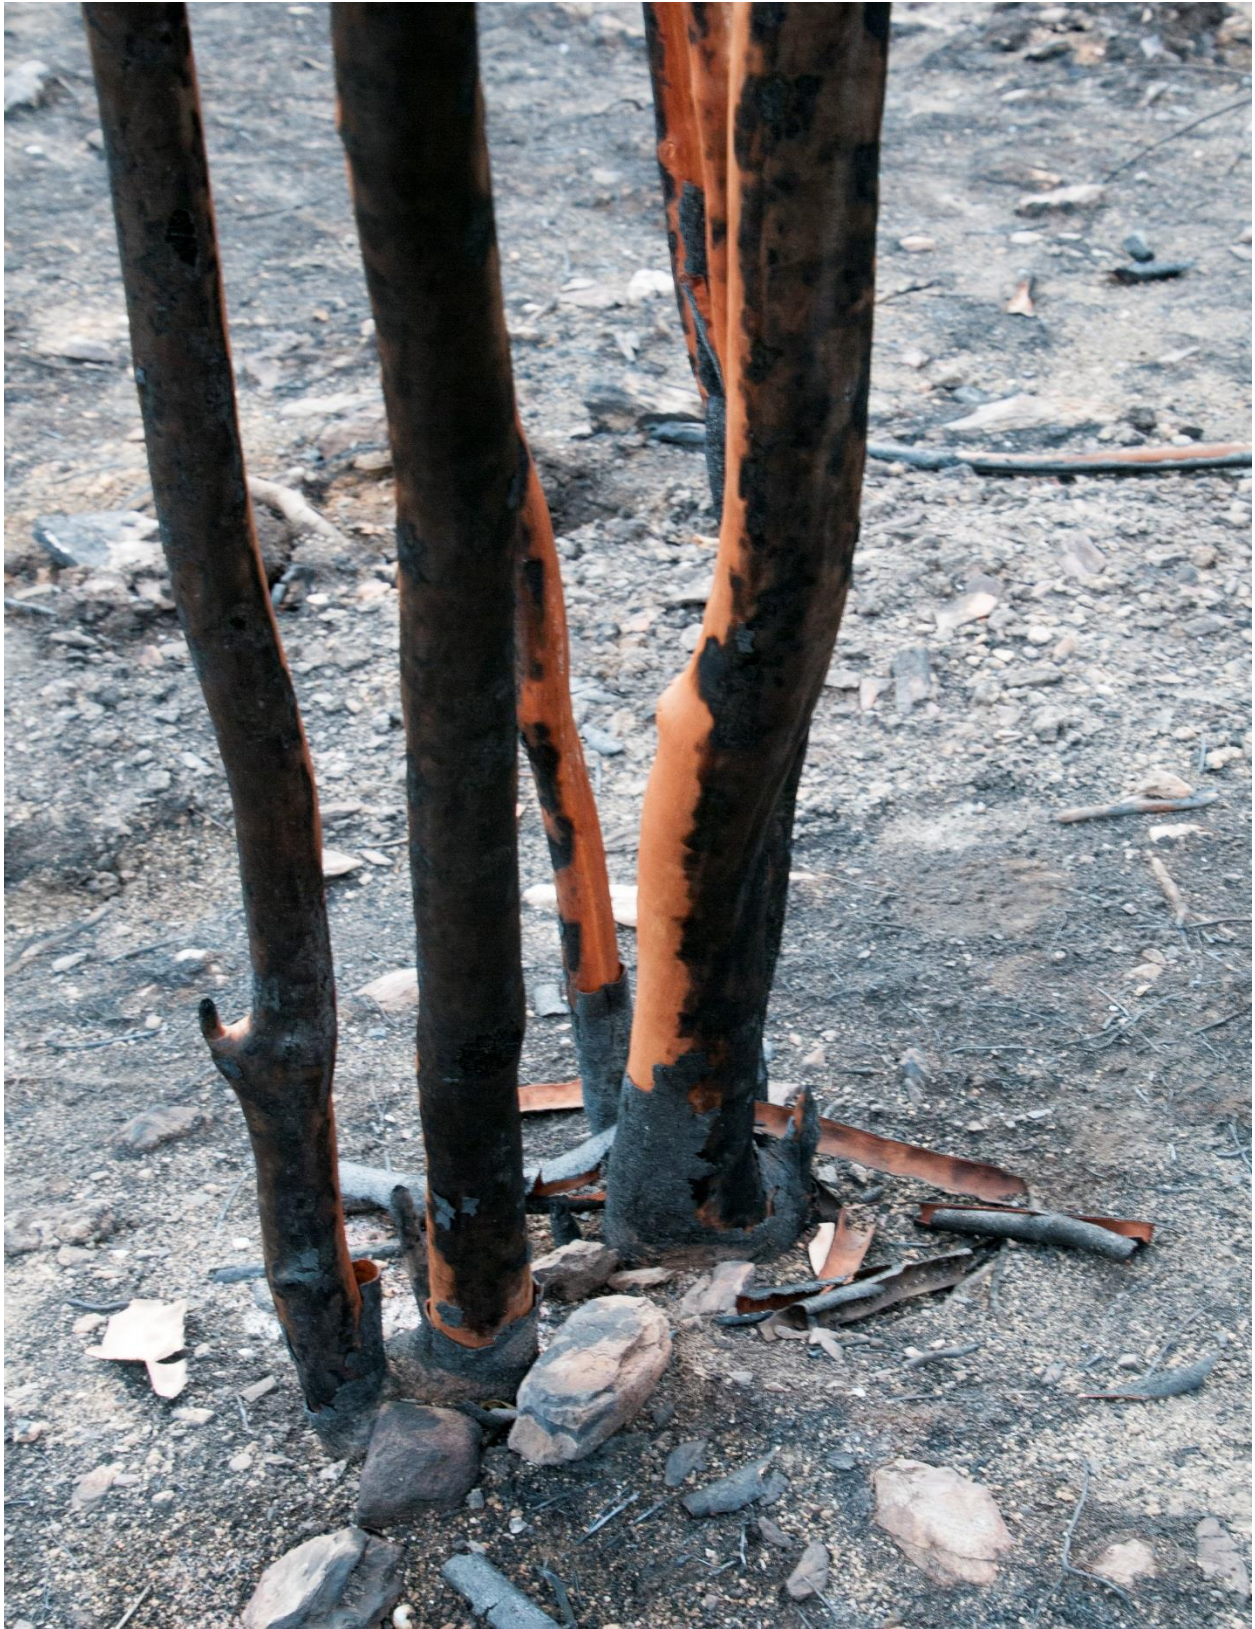
Figure 67: Fire damage to the tree trunk is more severe from downslope side.

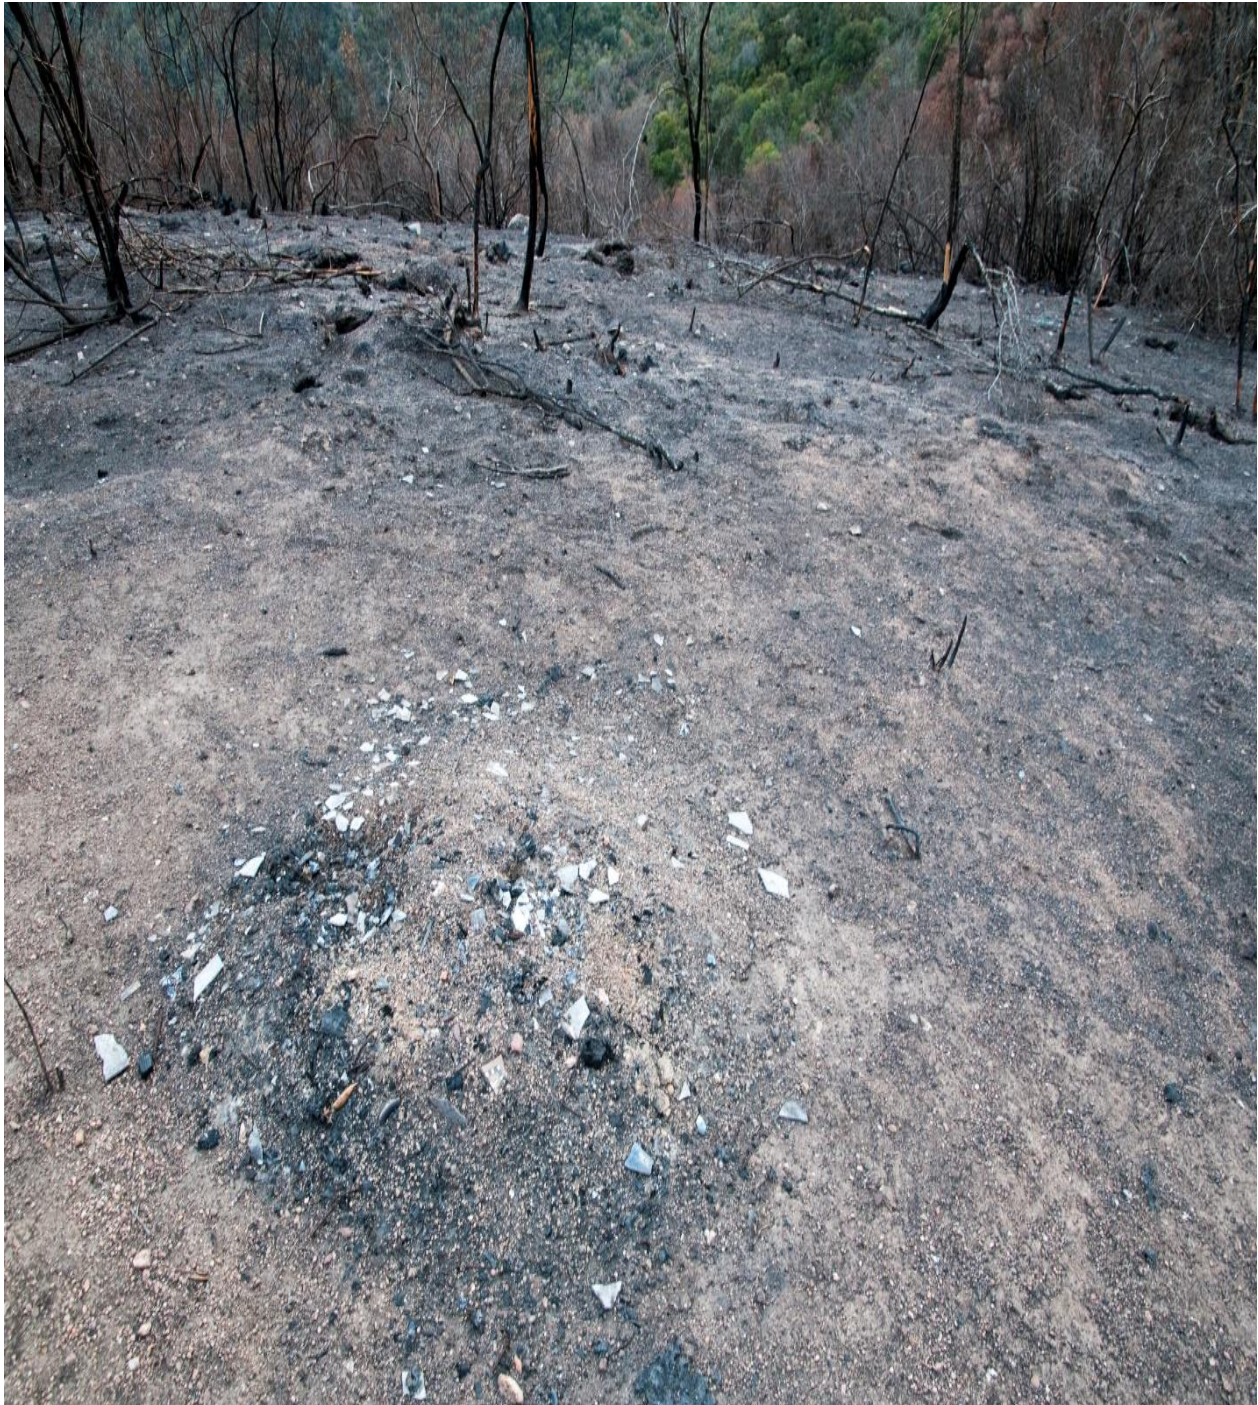
Figure 71: Fire remains and broken pottery. Nails were also present in the ash, indicating planks were used as fuel. Electronic photograph shows nails when enlarged.

- 3.16 Evidence of three previous fires containing broken pottery, ash and nails (possibly from planks) were found in the area (Figures 71, 72, 73 and 74)

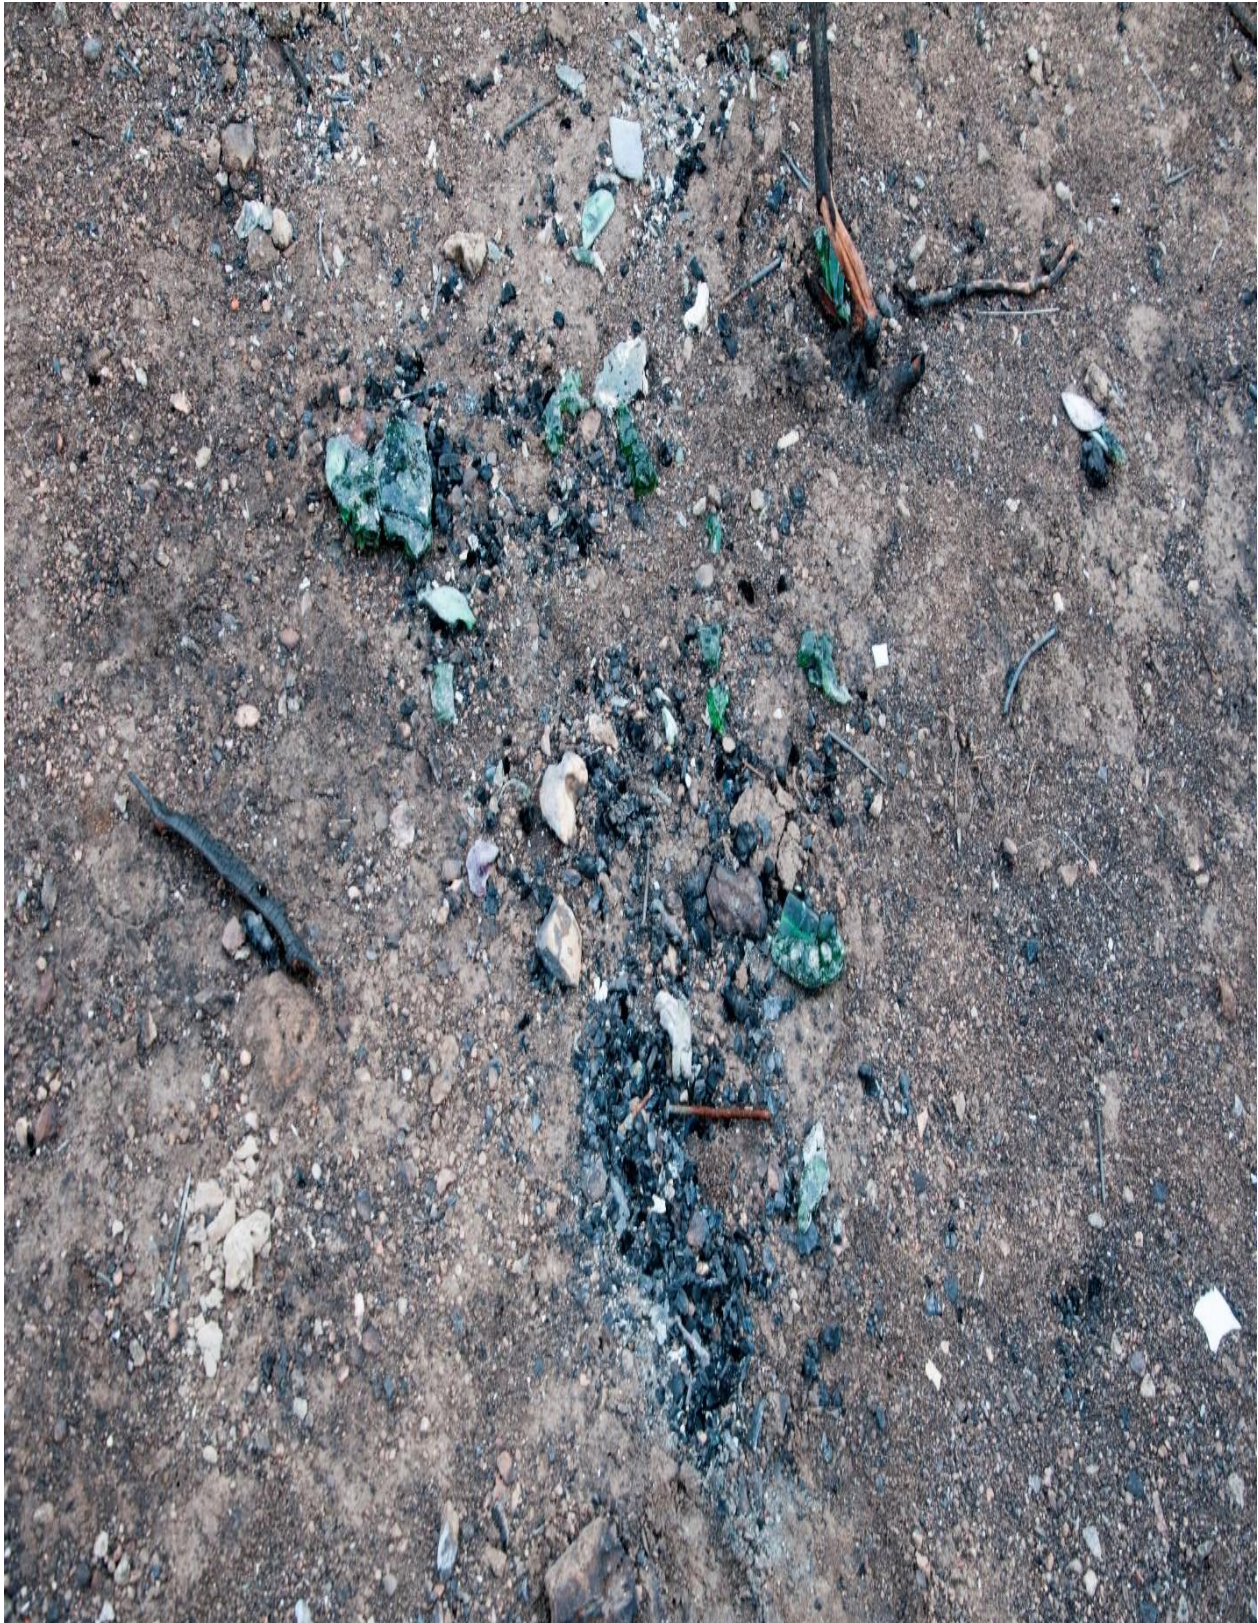
Figure 74: Remains of the fire in the “V” section. Note the nails which indicate that planks were used as fuel

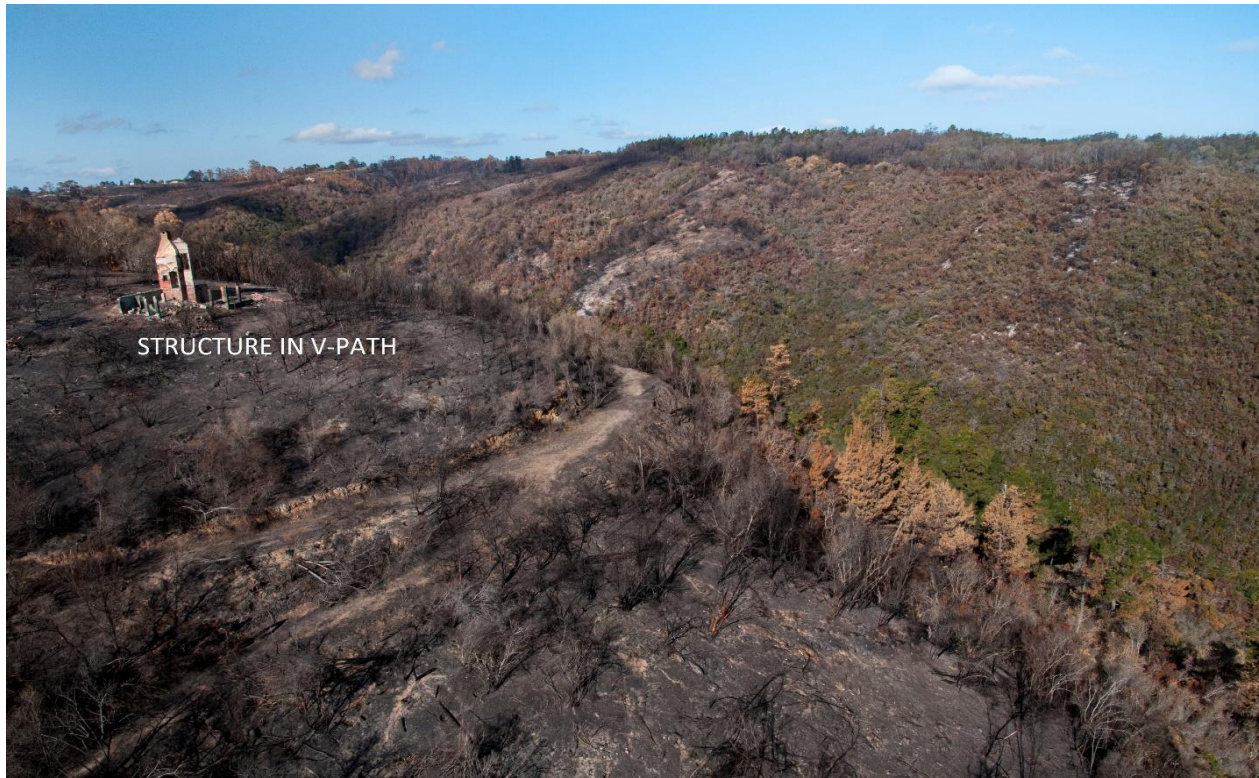
Figure 75: Structure found in the “V” path.

- 3.17 Remains of a building in the direct “V” path of fire spread shows extensive damage on the exposed side (Figures 75 and 76).
- 3.18 Wind data, as supplied in an Elandskraal resident’s report is interpreted and compared with spread of fire. (Figures 88, 89 and 90)
