Report of the Chief Fire Officer:

Knysna Fire and Rescue Service on the Fire origin and possible cause in the Elandskraal area:

Knysna on 07 June 2017

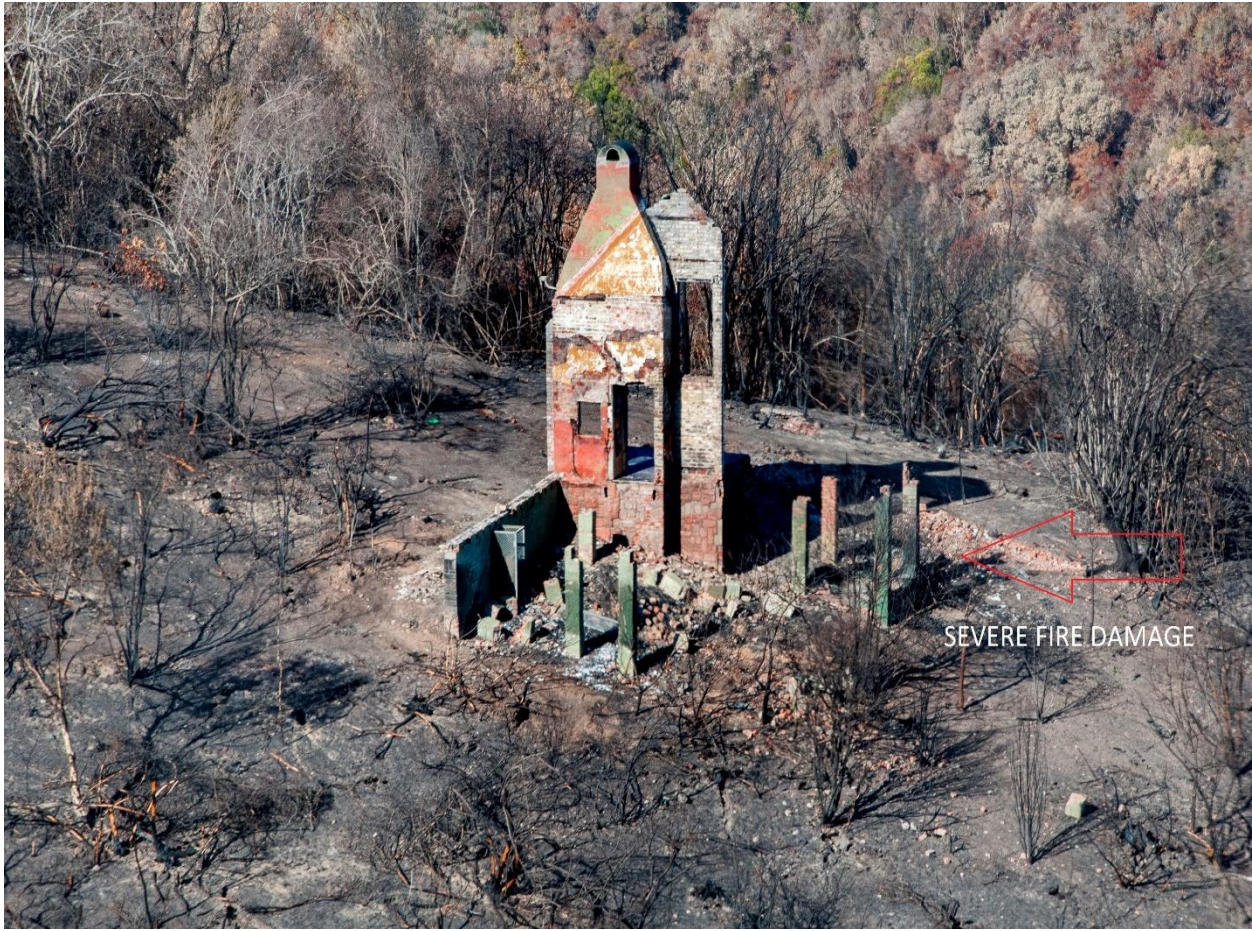
Figure 76: Severe damage from the exposed side with Wind from South-South-Westerly direction.

- 3.17 Remains of a building in the direct “V” path of fire spread shows extensive damage on the exposed side (Figures 75 and 76).
- 3.18 Wind data, as supplied in an Elandskraal resident’s report is interpreted and compared with spread of fire. (Figures 88, 89 and 90)
