Report of the Chief Fire Officer:

Knysna Fire and Rescue Service on the Fire origin and possible cause in the Elandskraal area:

Knysna on 07 June 2017

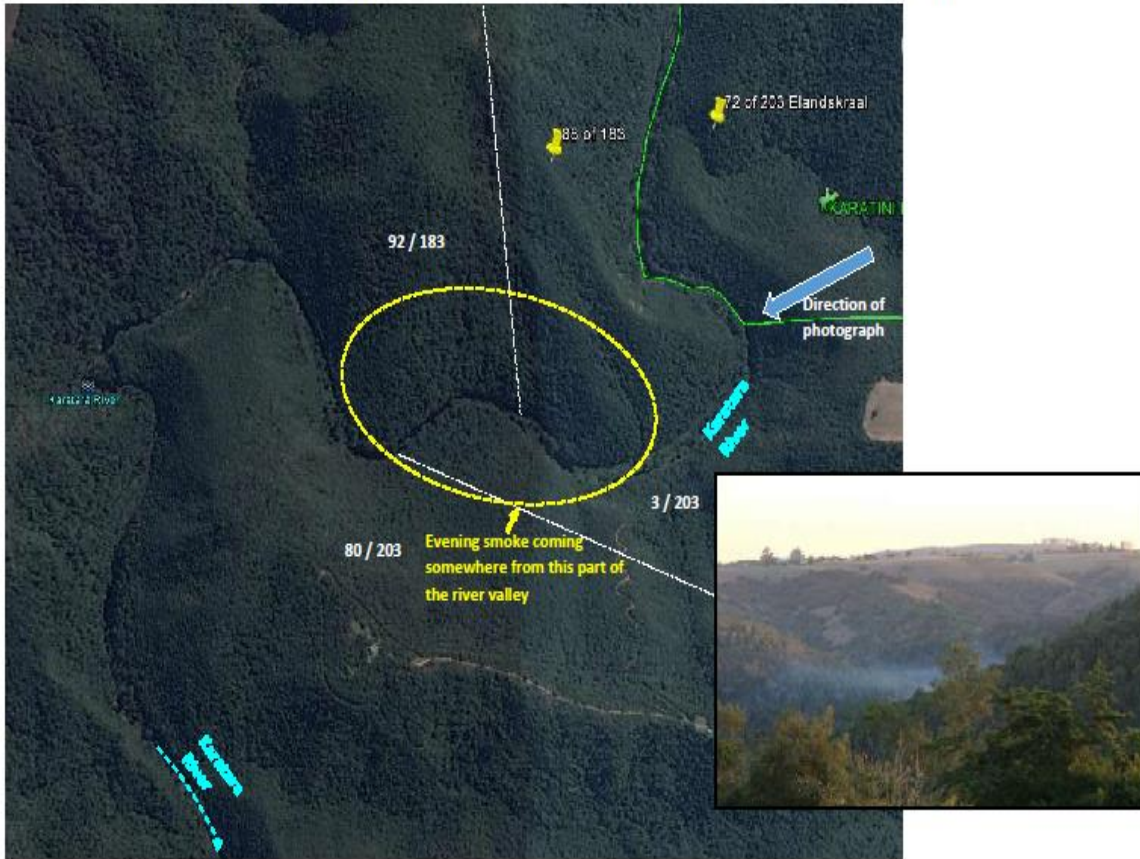
Figure 3: Google Earth photograph showing the location of smoke as at 10 May 2017. Note the position of the origin of the fire as indicated in Figures 5 and 11.

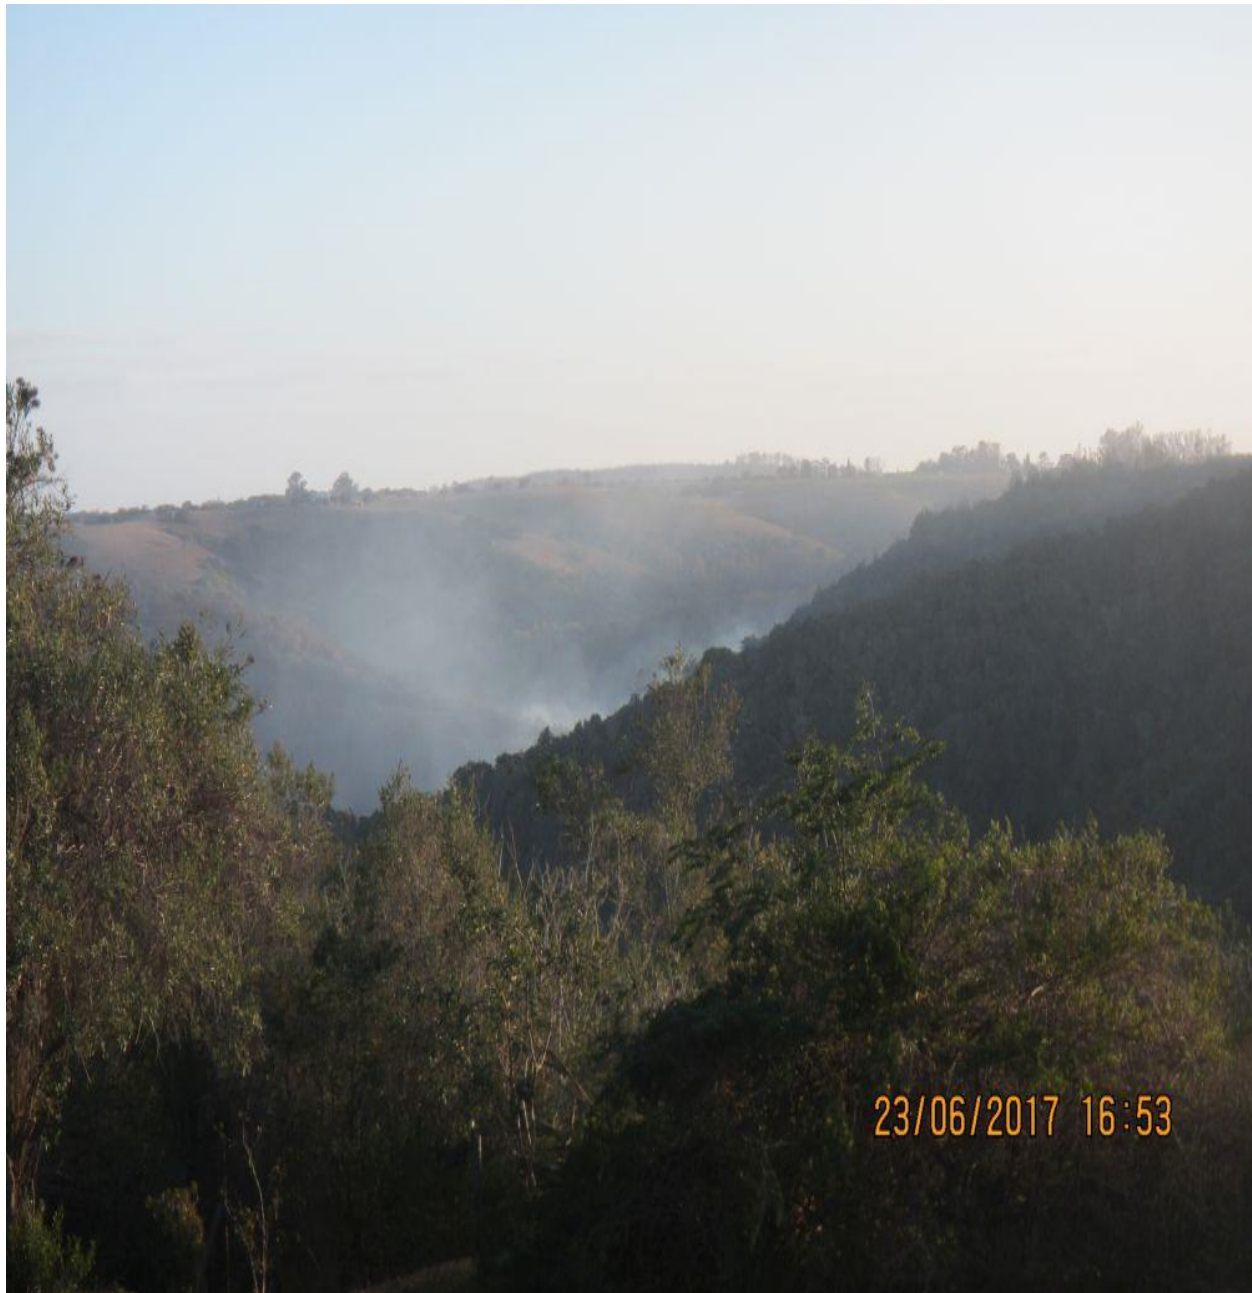
Figure 4: Photograph taken on 23 June 2017 after the fire of 07 June 2017. Note smoke coming from unburnt area and the background houses as in figures 1 and 2.

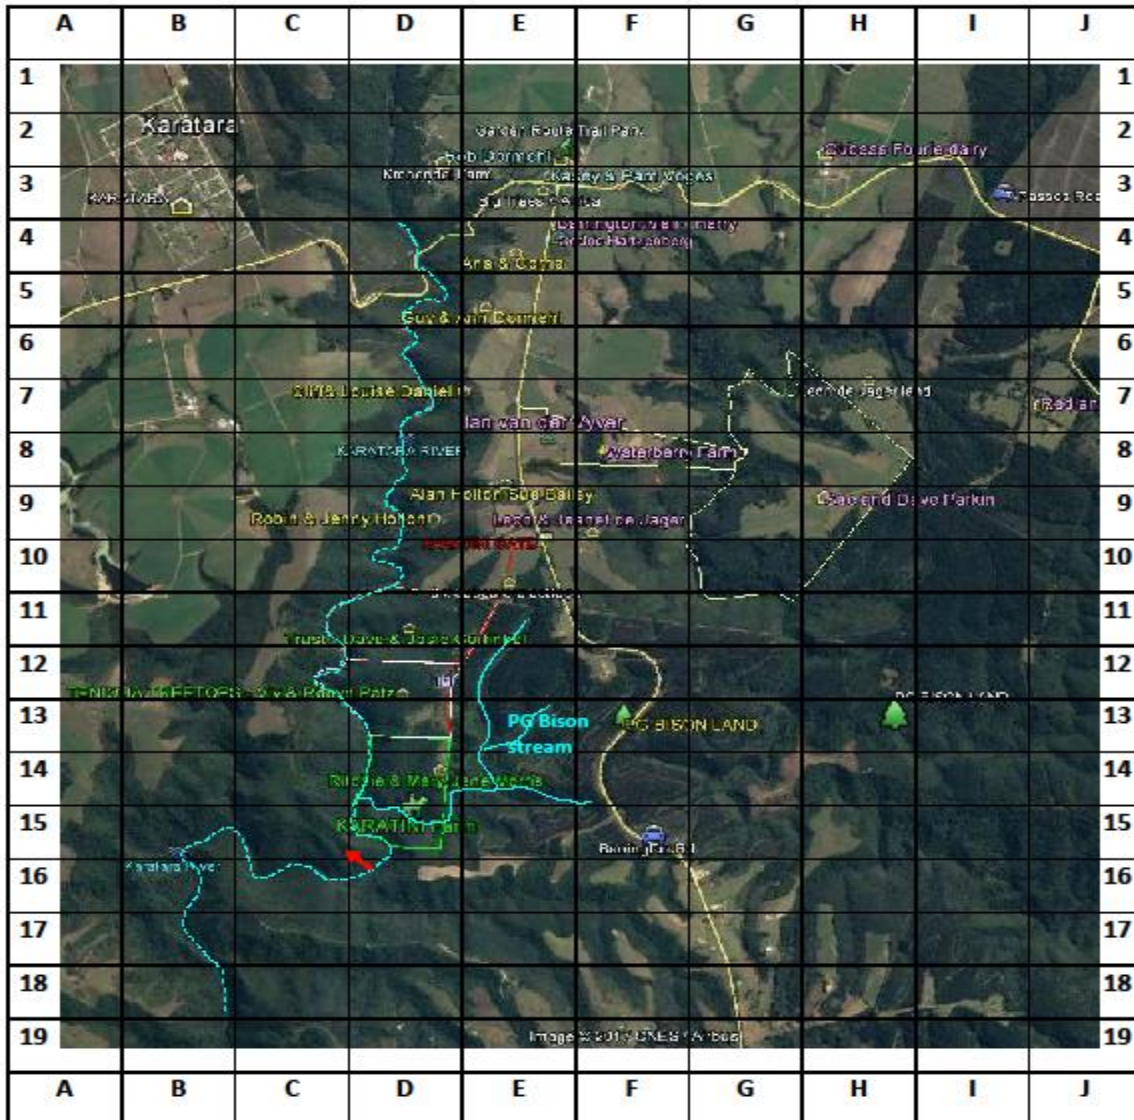
Figure 5 Grid map showing the location of smoke in figure 4 indicated as emitting from Grid C 15.

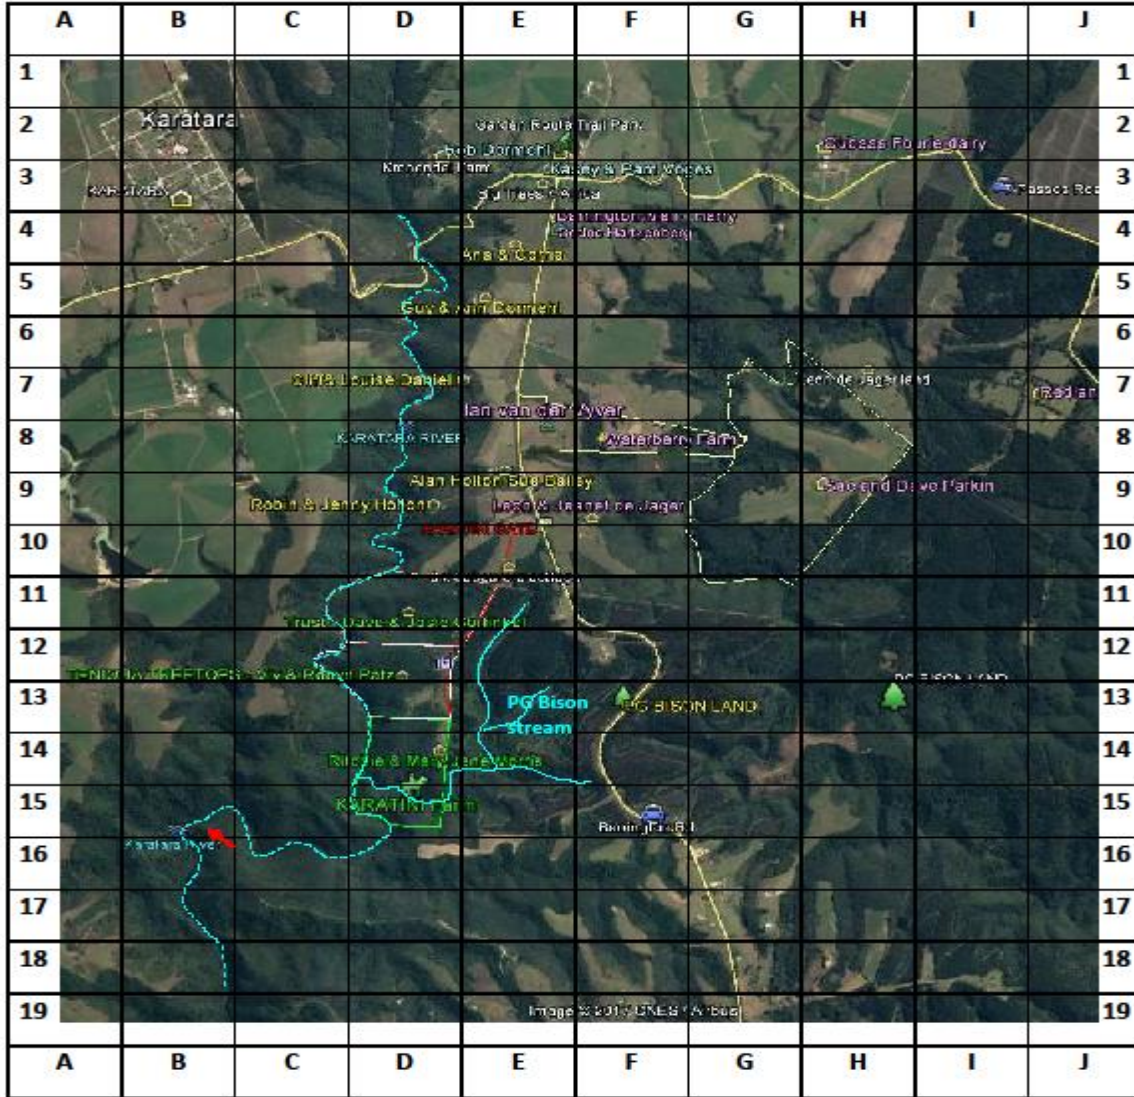
Figure 10: Note the red arrow moved from the location in Figure 3. Compare this arrow with red circles in Figure 11 and with smoke in Figures 6 - 9.

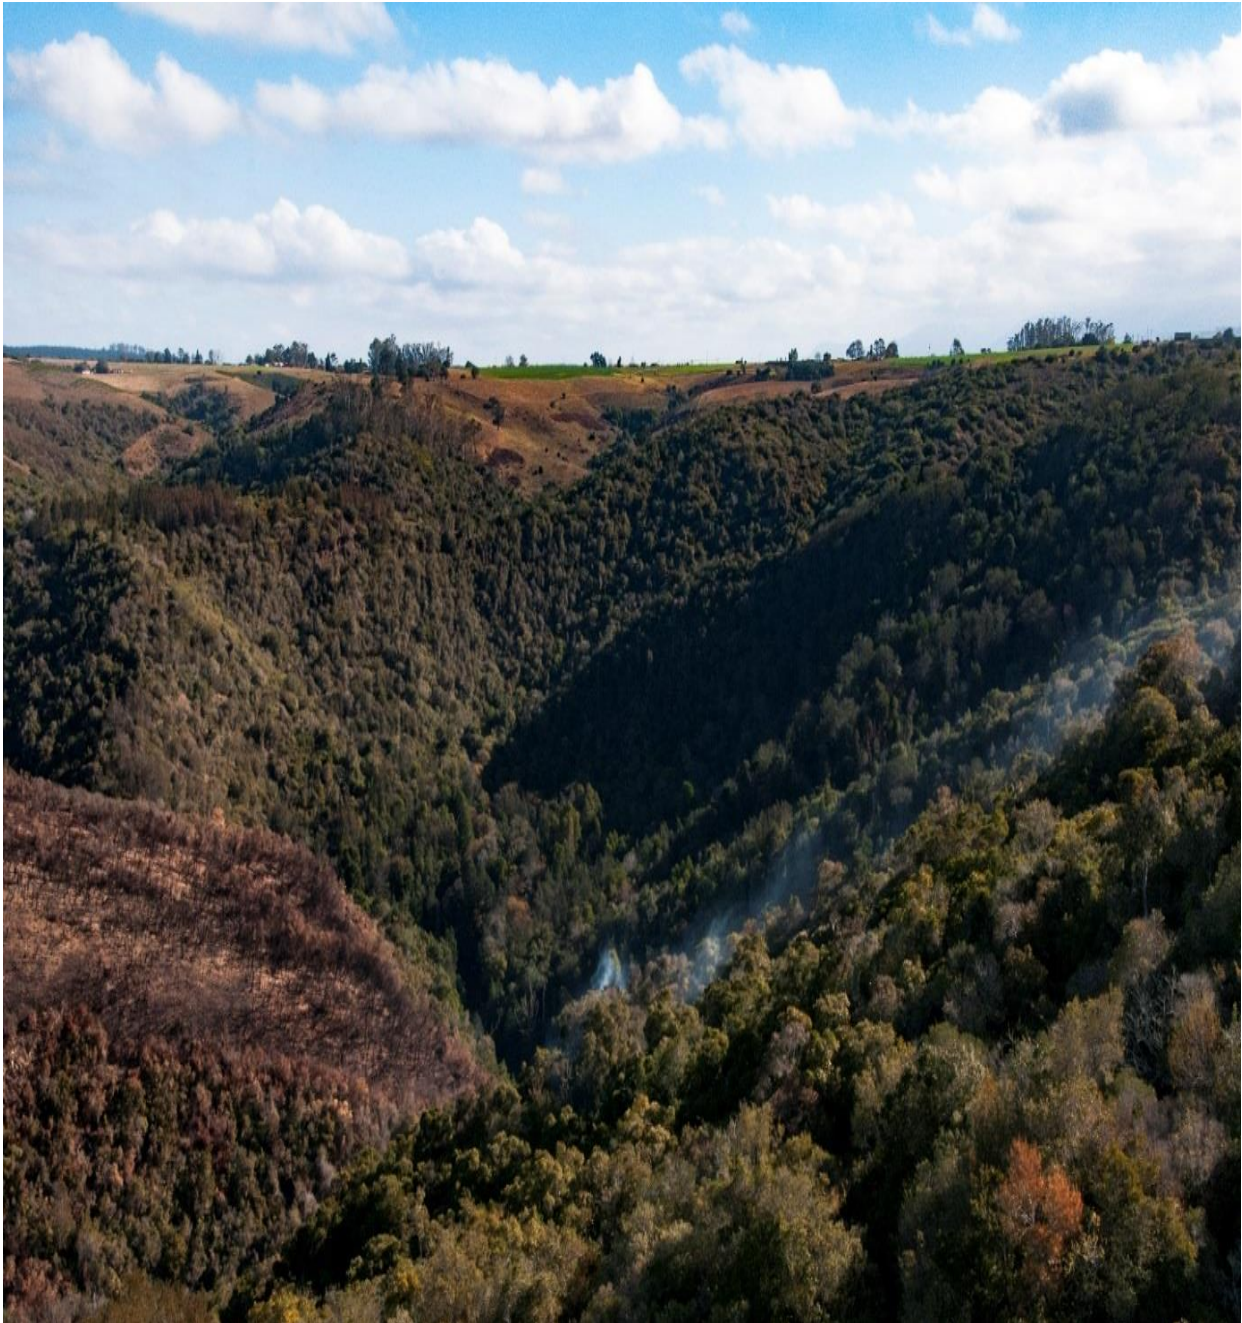
Figure 12: Smoke in the area as shown in figures 1, 2, 3, 4, 5, 6, 7, 8, 9 and 10. This photograph, taken on 14 July 2017, still shows the smouldering section in an unburnt area.

1. Fire origin and cause as shown in Figures 1, 2, 3, 12, 13, 14 and 18. This area is referred to as Area 2
2. This proposes that the fire originated in the area where a smoulder was still visible at 14 July 2017 and which is smouldering in an unburned section of the forest.
3. It further proposes that the fire was started by lightning before 08 May 2017.
4. This smoulder was first reported via email on 10 May 2017.
5. This fire presented itself as a smouldering fire.

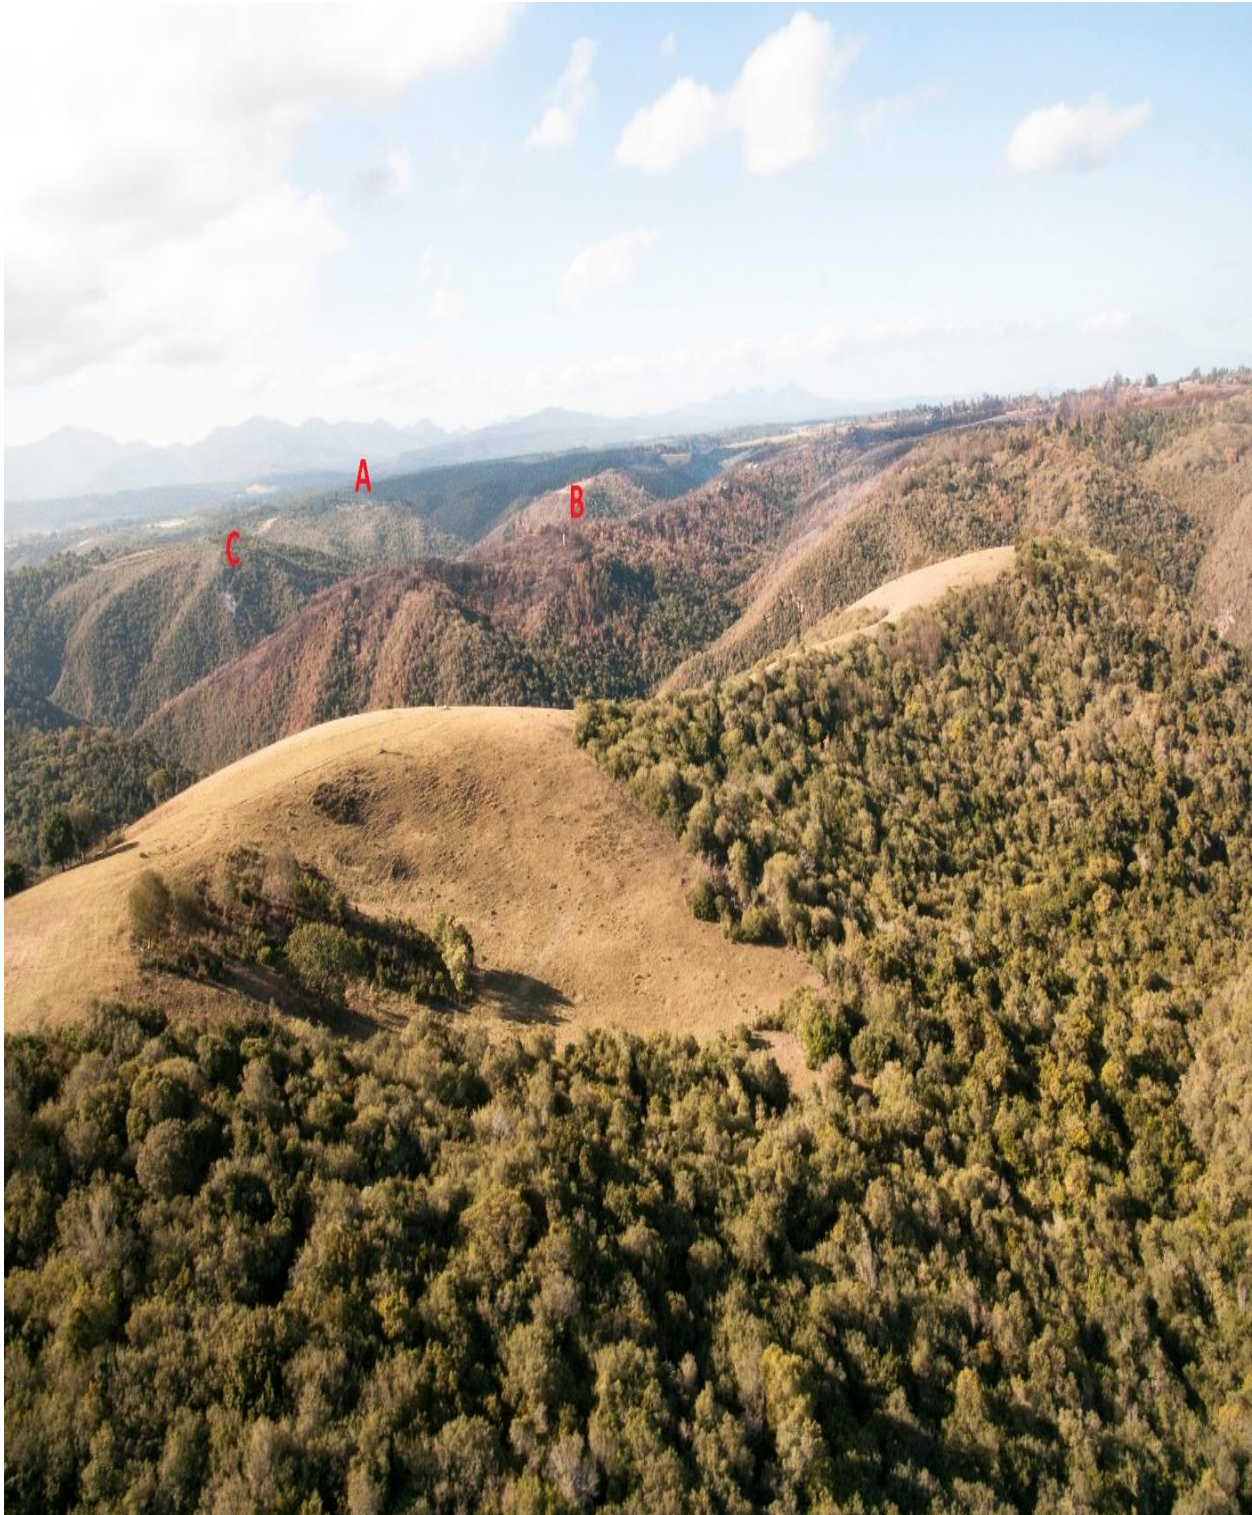
Figure 20: Photograph taken from the opposite position to Figures 1, 2 and 19. Notice plume of smoke “C” in unburnt area. Buildings “A” and the ploughed lands marked “B” are visible from this position.

2.2 Figure 20 shows the reverse direction. From this angle it can be seen that the smoulder at "C" in an unburnt area

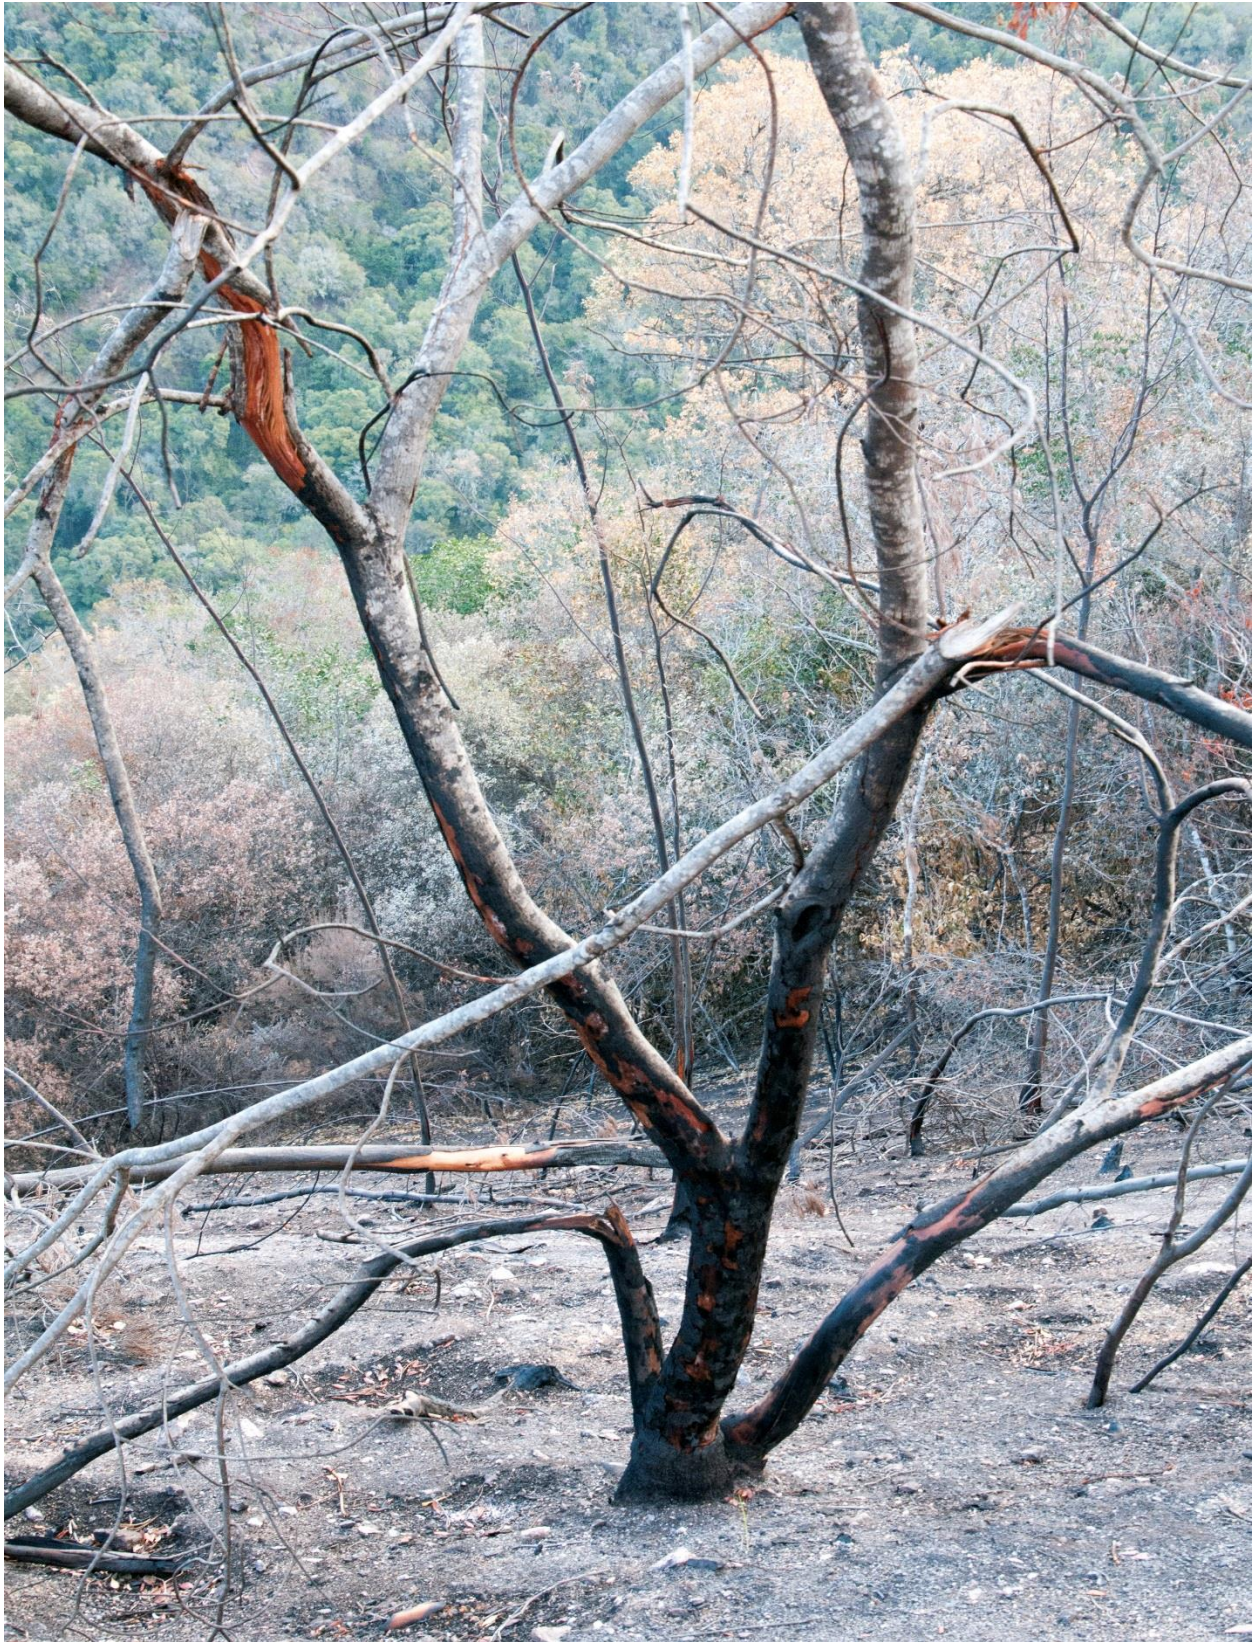
Figure 30: Close-up of Figure 29

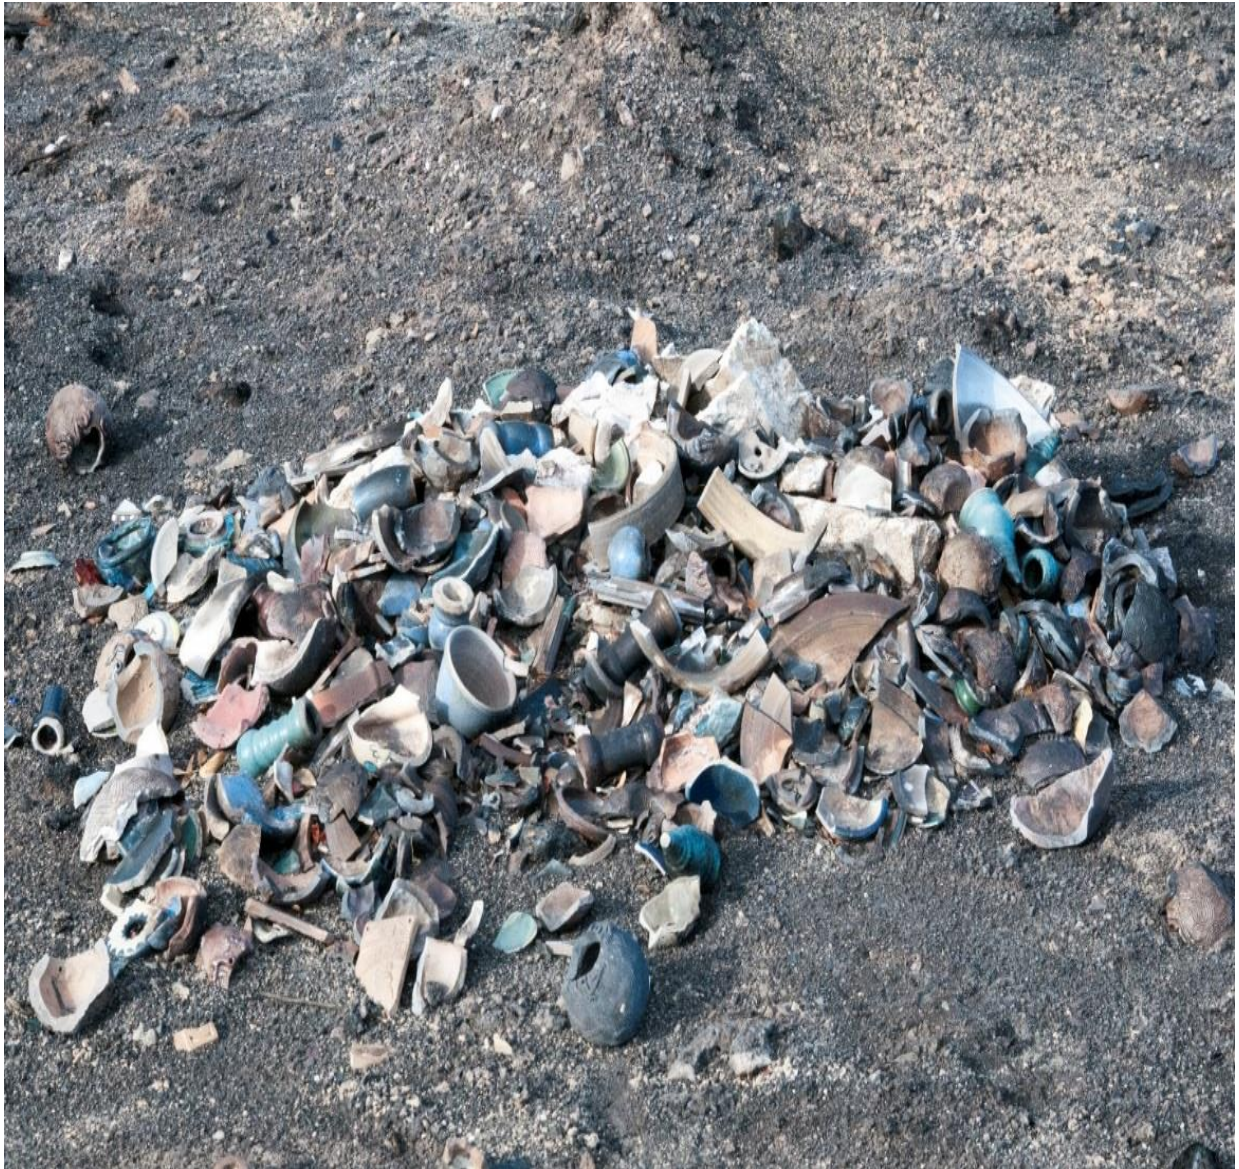
Figure 33: Close-up of a pile of pottery as seen in Figure 32

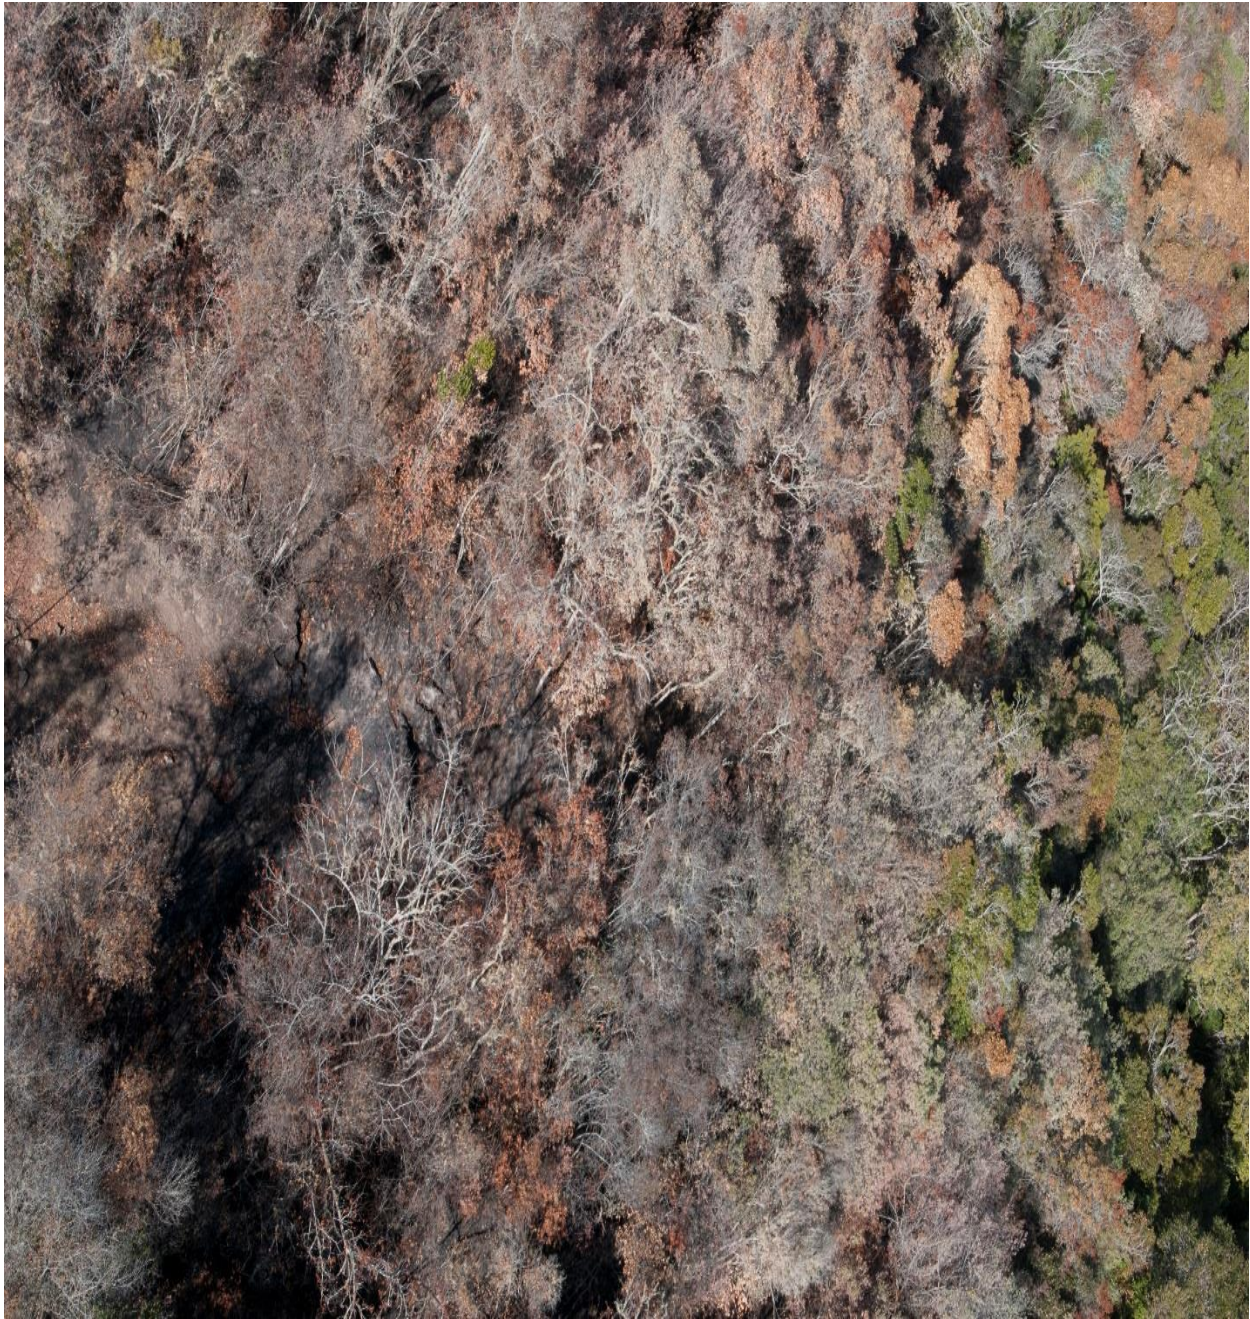
Figure 50: Clearing at lowest section of the “V” Pattern as indicated in Figure 49

2.6 A clearing identified at the lowest part of the "V" pattern. This clearing shows signs of soot on the ground. (Figures 49, 50 and 51)

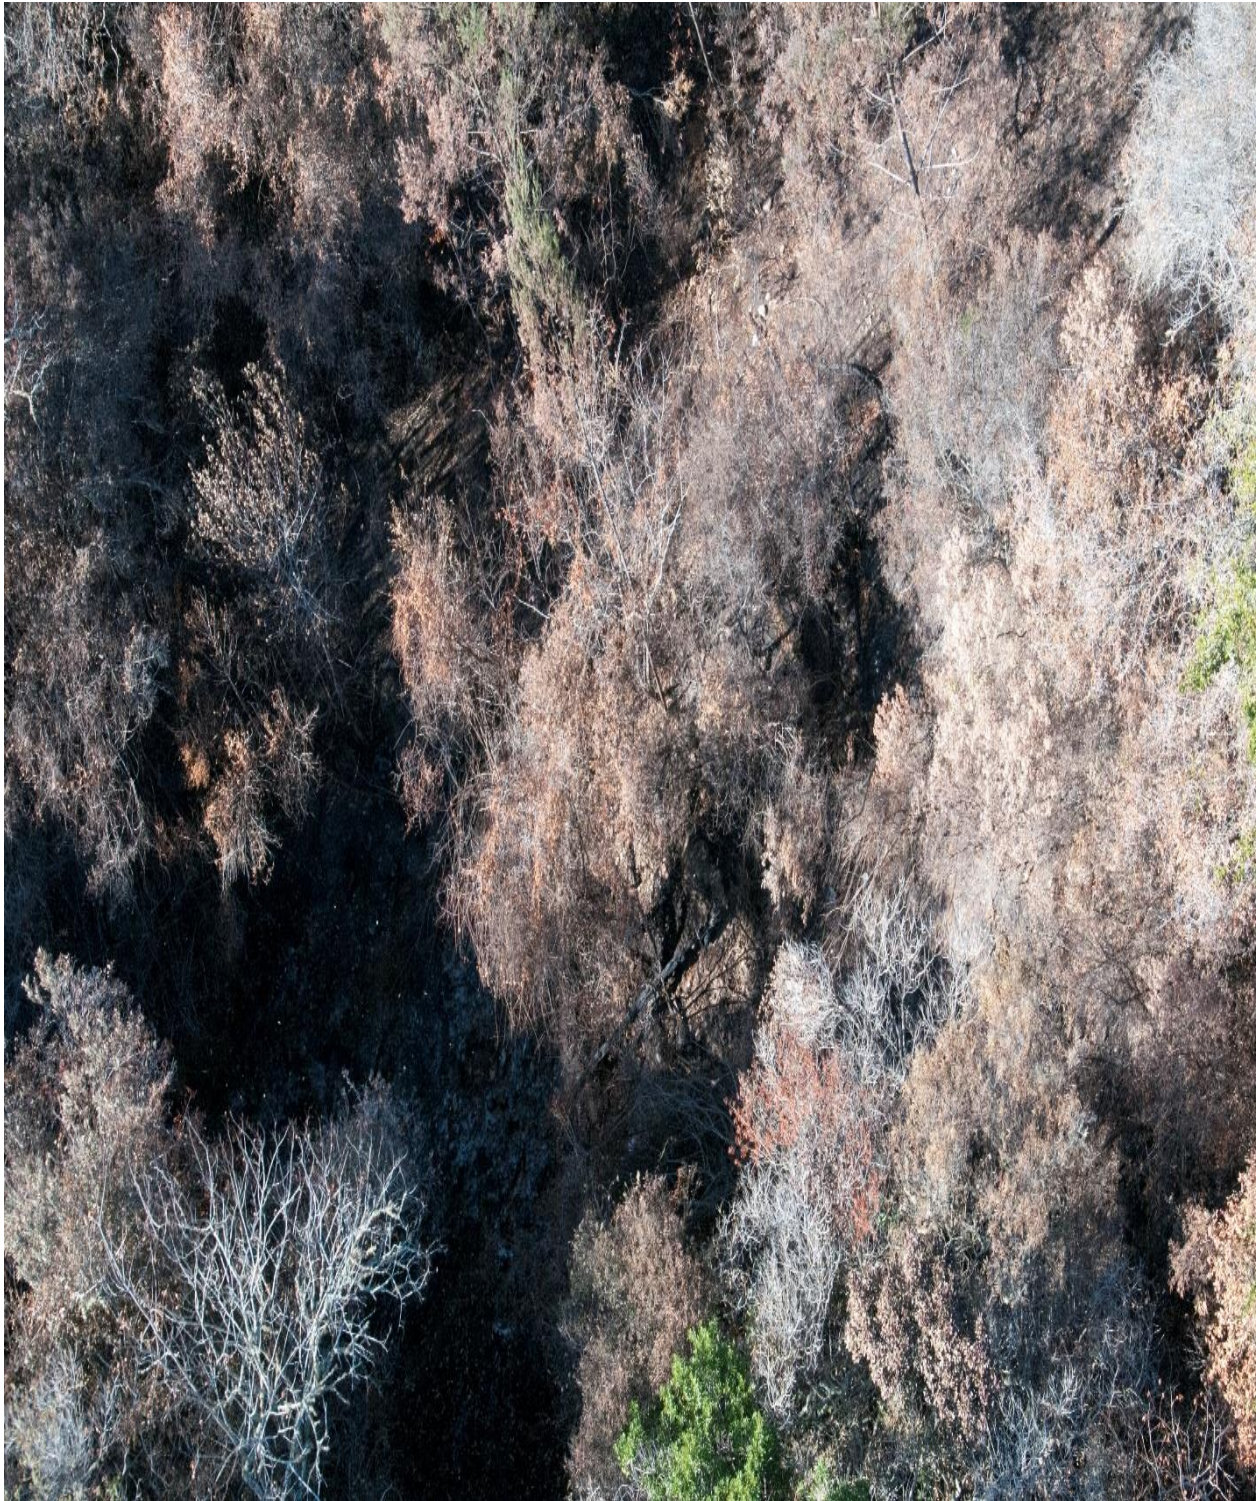
Figure 51: Close-up photograph of the clearing at lowest part of the “V” pattern

2.7 A burn scar consistent with a fire starting to consume light fuels and then picking up intensity and consuming heavier fuels was observed in the clearing (Figure 51)

3.4 In Figure 51 the burn scar in the clearing is visible and shows the fire burning on the ground, and from there intensifying.

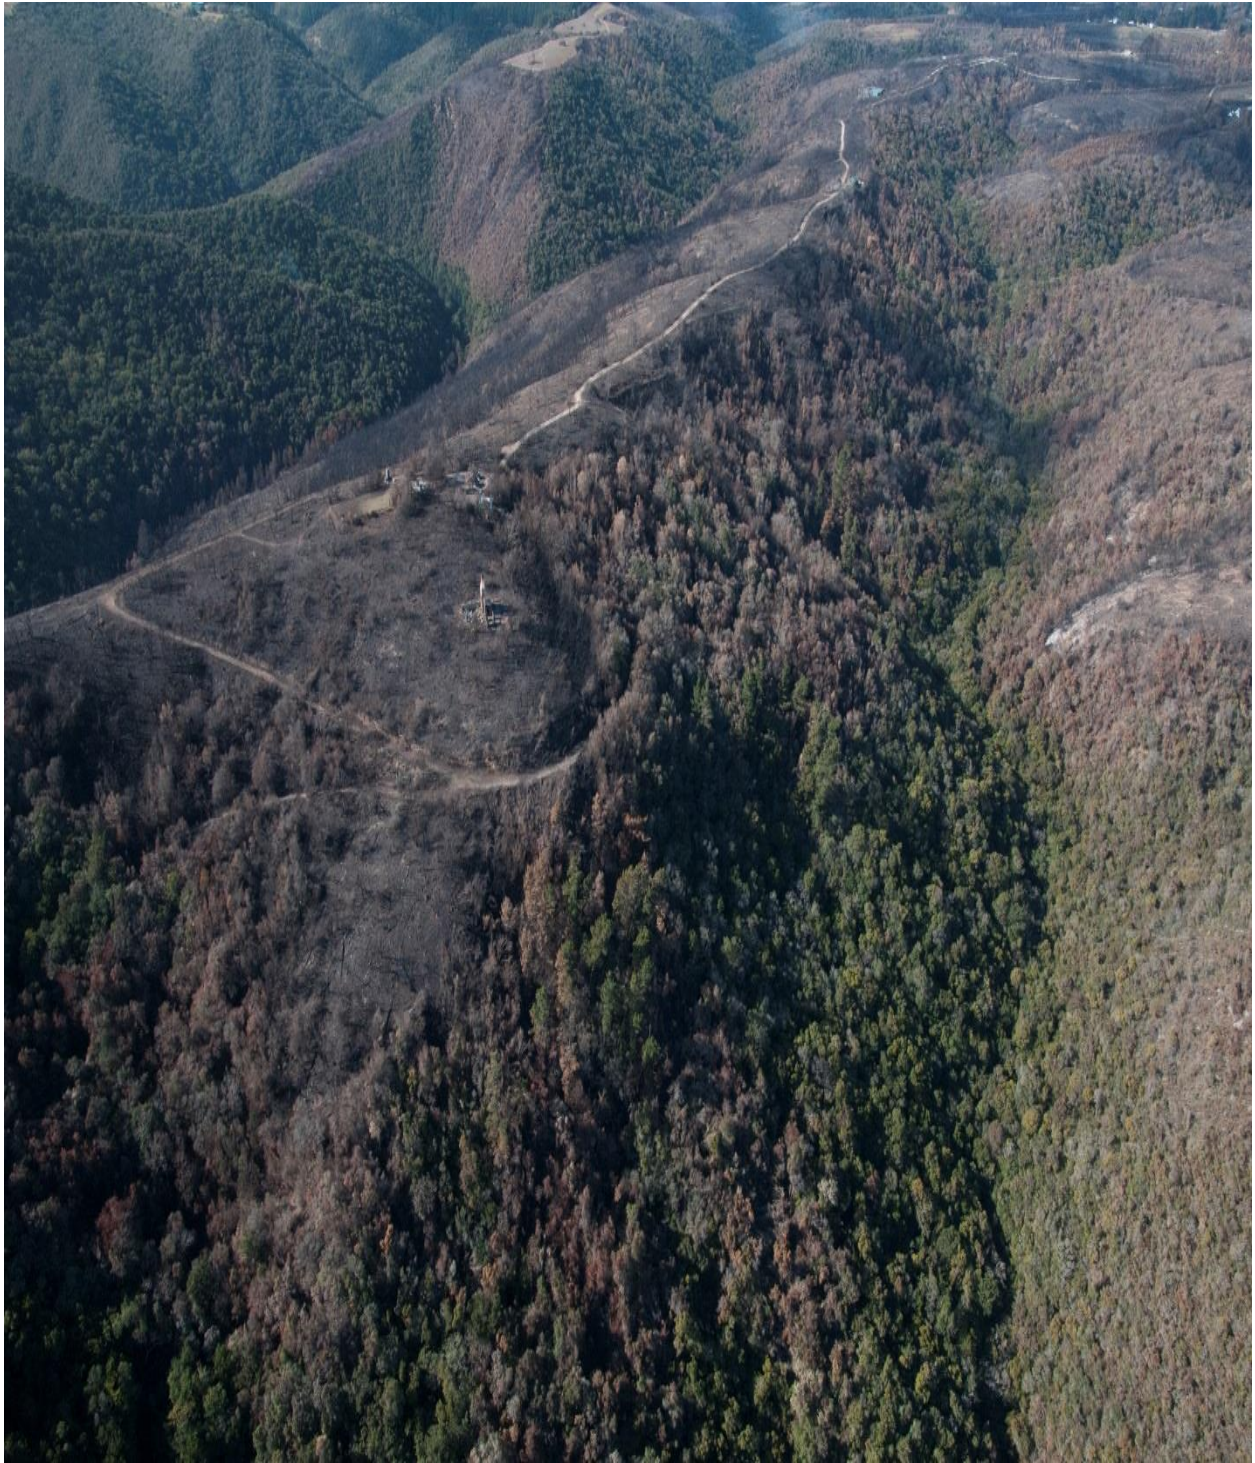
Figure 53: High altitude photographs of the fire origin and showing the two areas of the fire spread to the right.

3.2 Figure 53 is an area with a clear "V" Pattern that showed a clear possible origin of the Elandskraal Fire that occurred on 7 June 2017. The wind blew from a South-South-West direction between 01:09 and 01:32. This wind would have spread this fire up the slope in the "V" Pattern area.

3.7 Figure 53 shows the same area and can be put in relation to the supposed origin in the “V” Section.

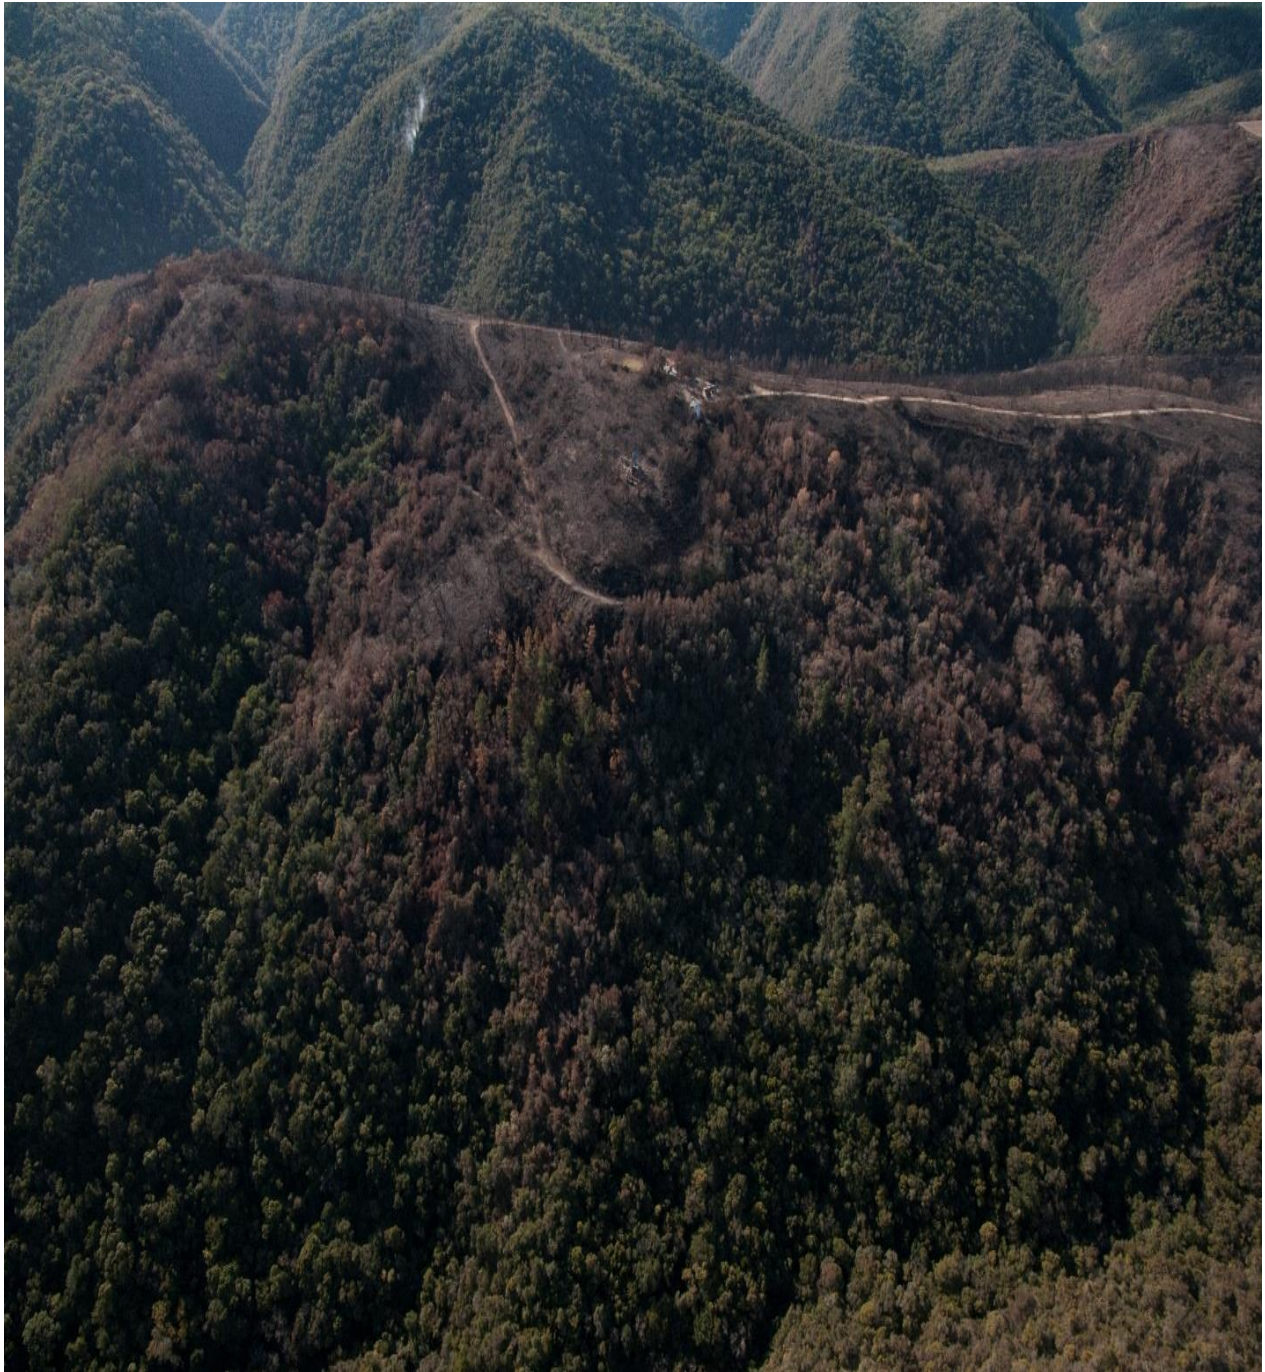
Figure 54: Different angle of the fire origin. Note the smoke plumb in the background. Compare the location of the smoulder with Figures 11 and 24.

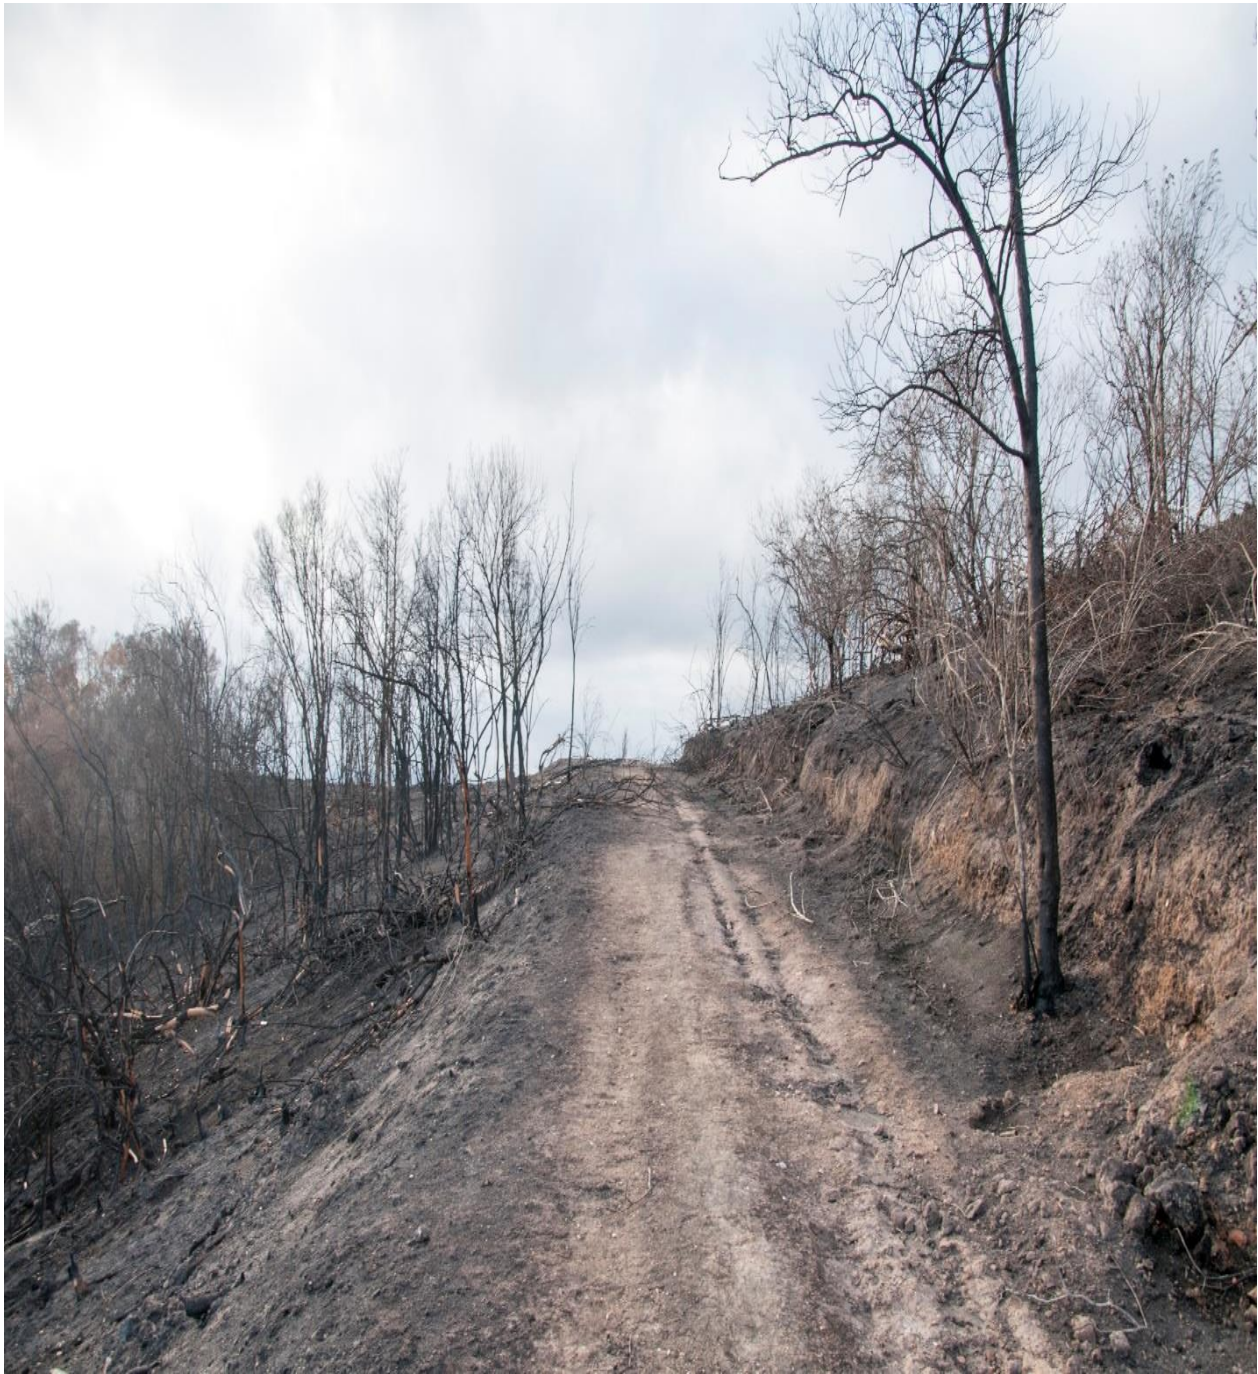
Figure 55: The access road to area showing the “V” Pattern.

2.5 Clear access routes to this "V" pattern area are visible (Figures 48, 53, 54, 55, and 57).

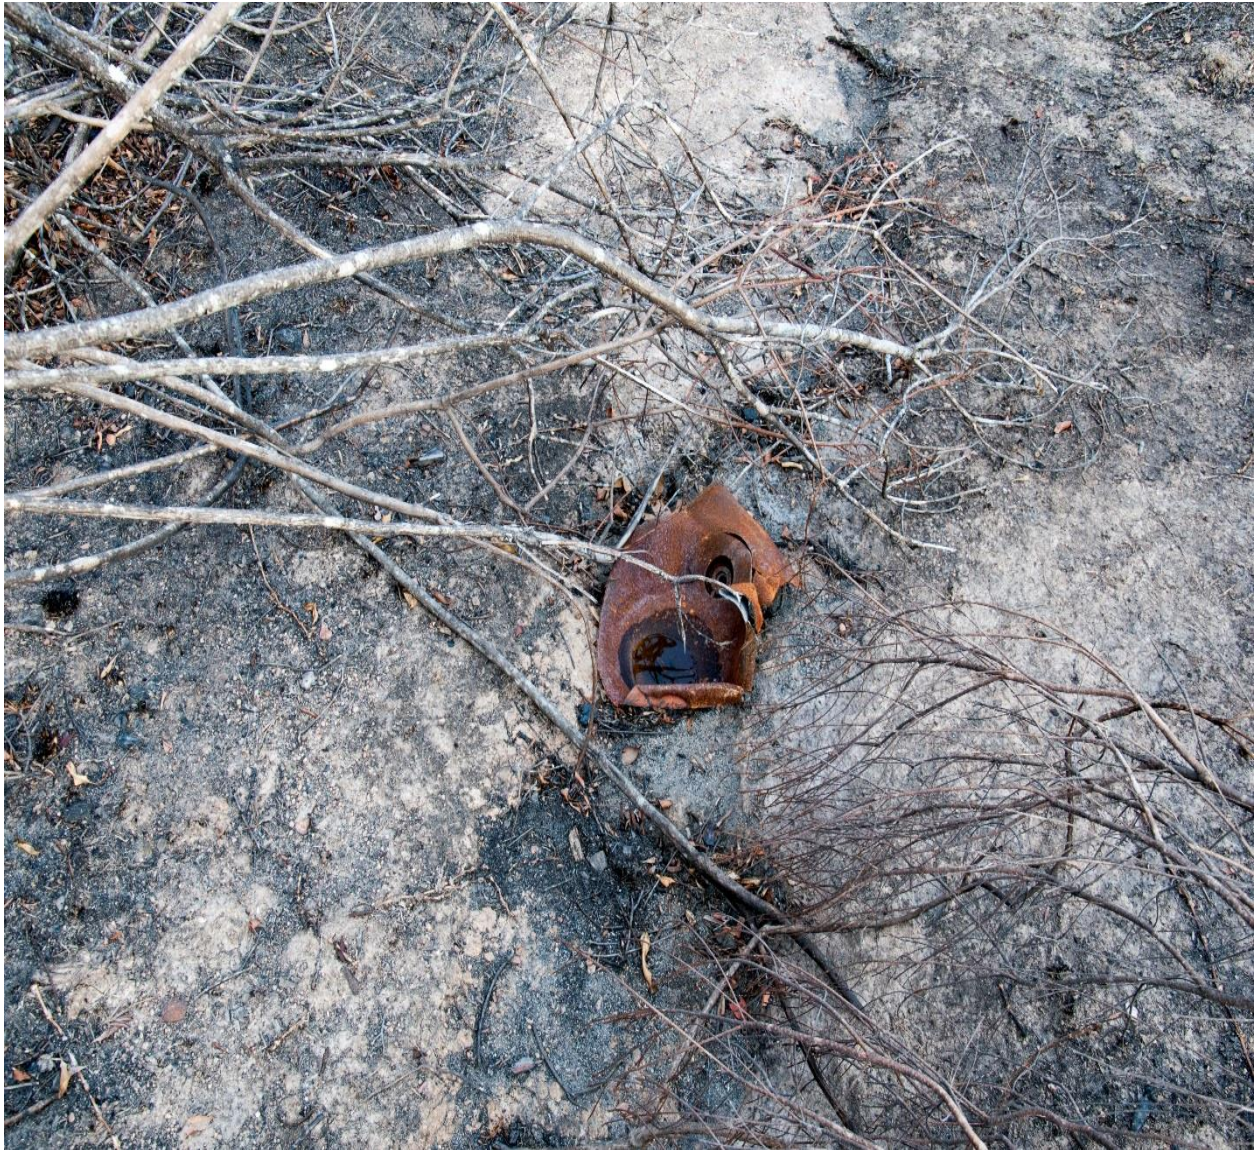
Figure 56: Remains of a LP Gas cylinder found in the access path
