Report of the Chief Fire Officer:

Knysna Fire and Rescue Service on the Fire origin and possible cause in the Elandskraal area:

Knysna on 07 June 2017

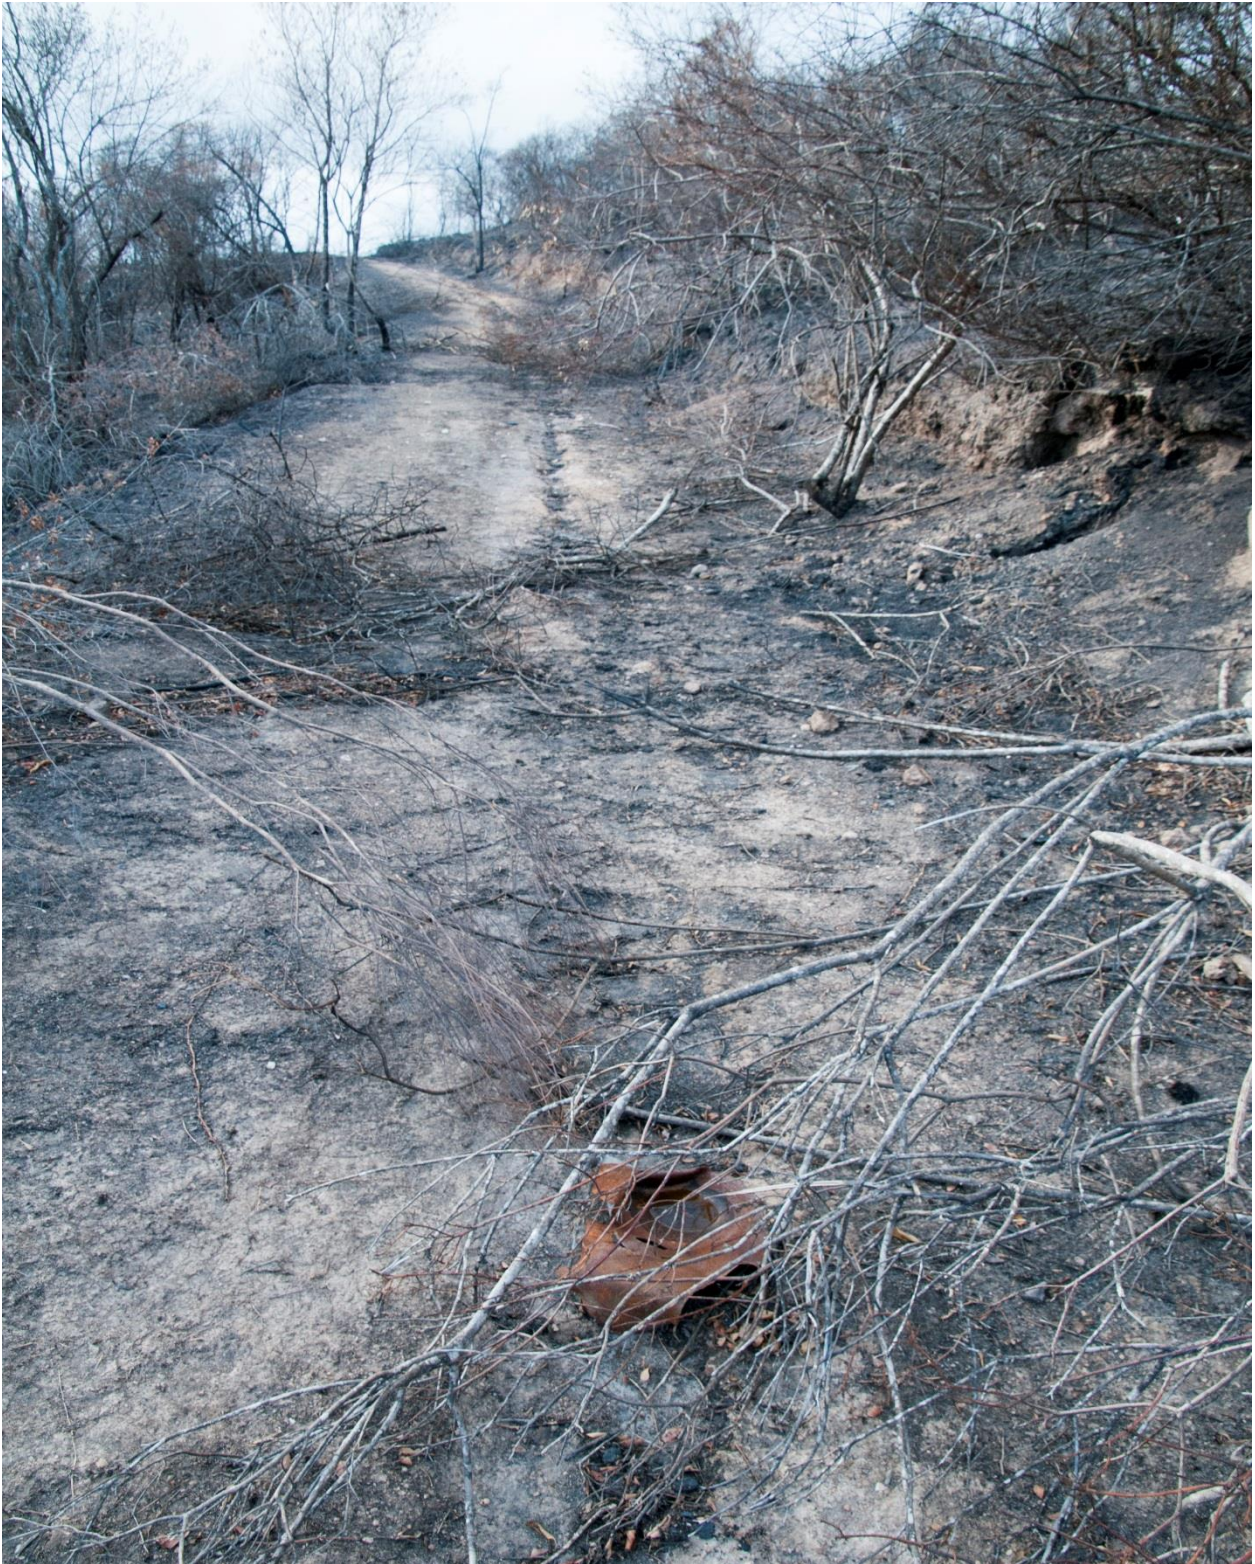
Figure 57: Remains of LP Gas cylinder in the access path

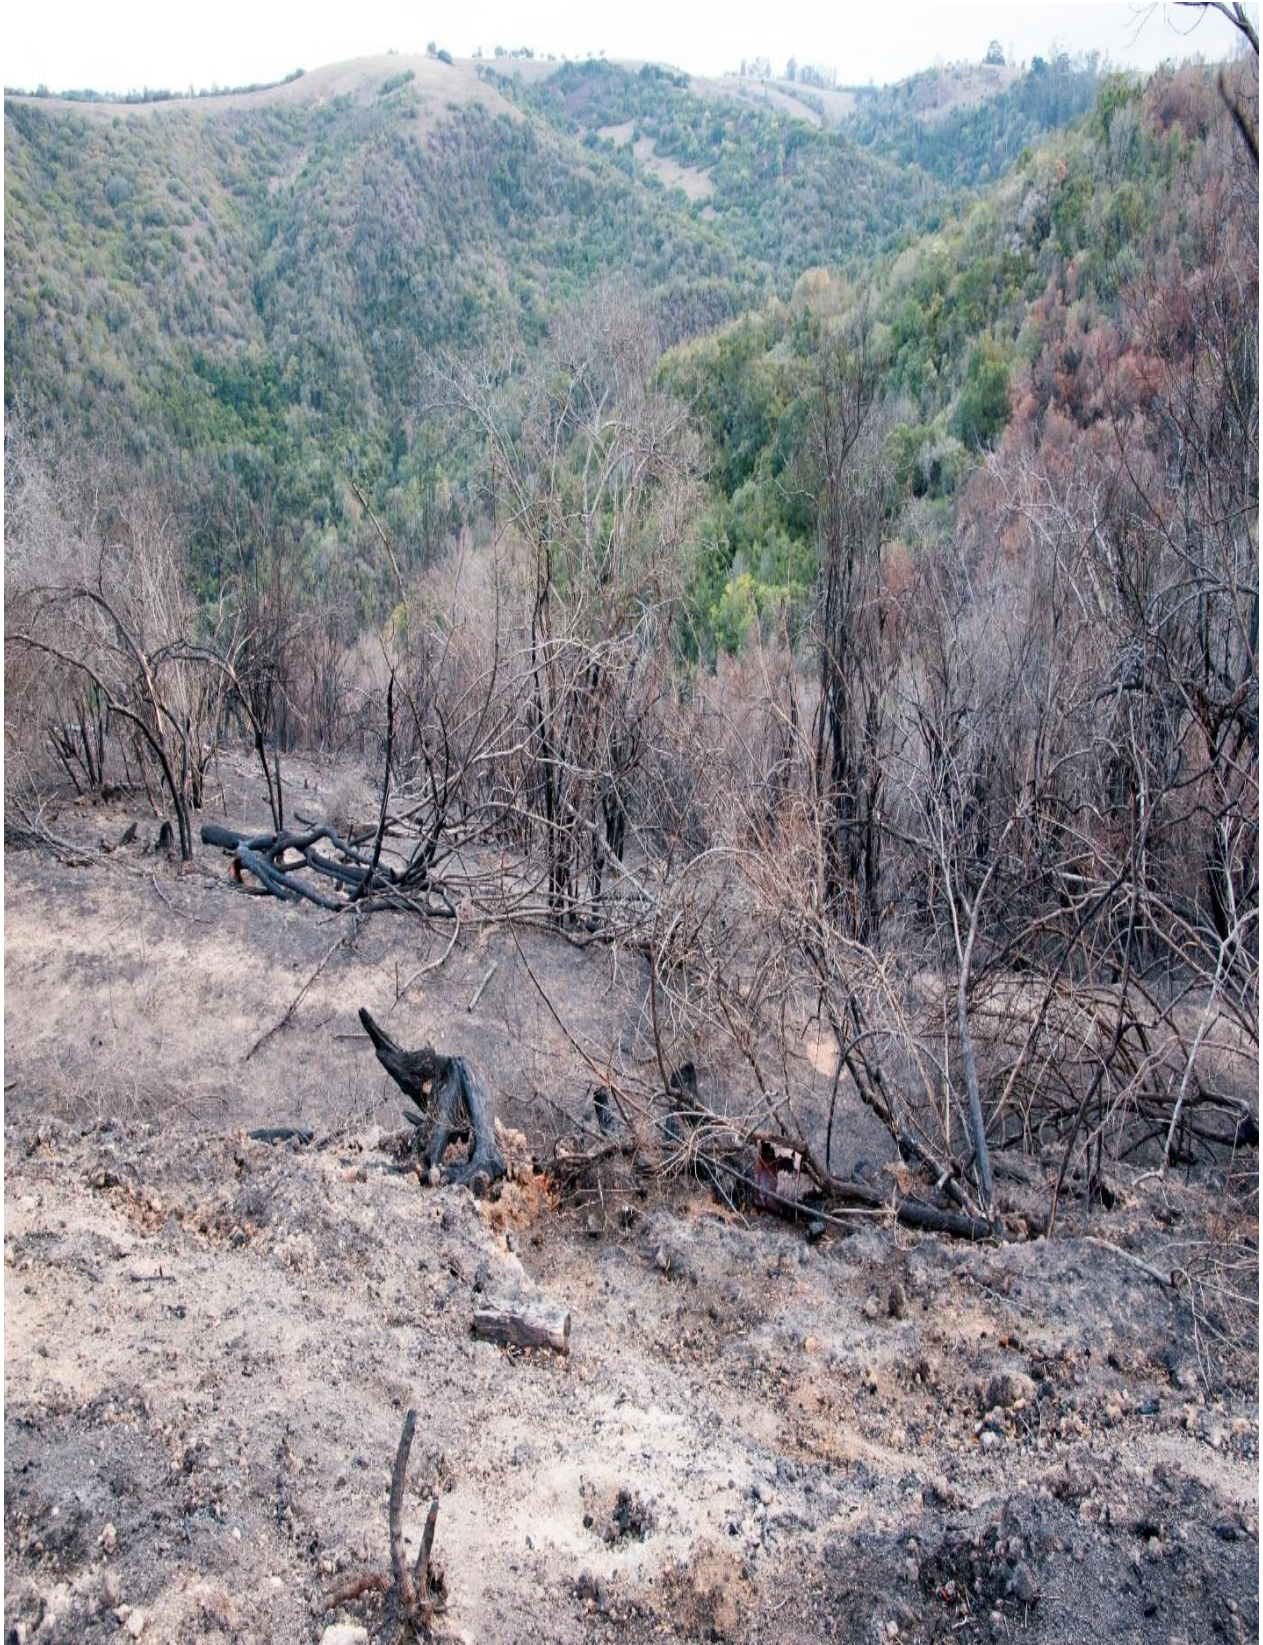
Figure 58: Presence of a metal drum found in the “V” Pattern area.

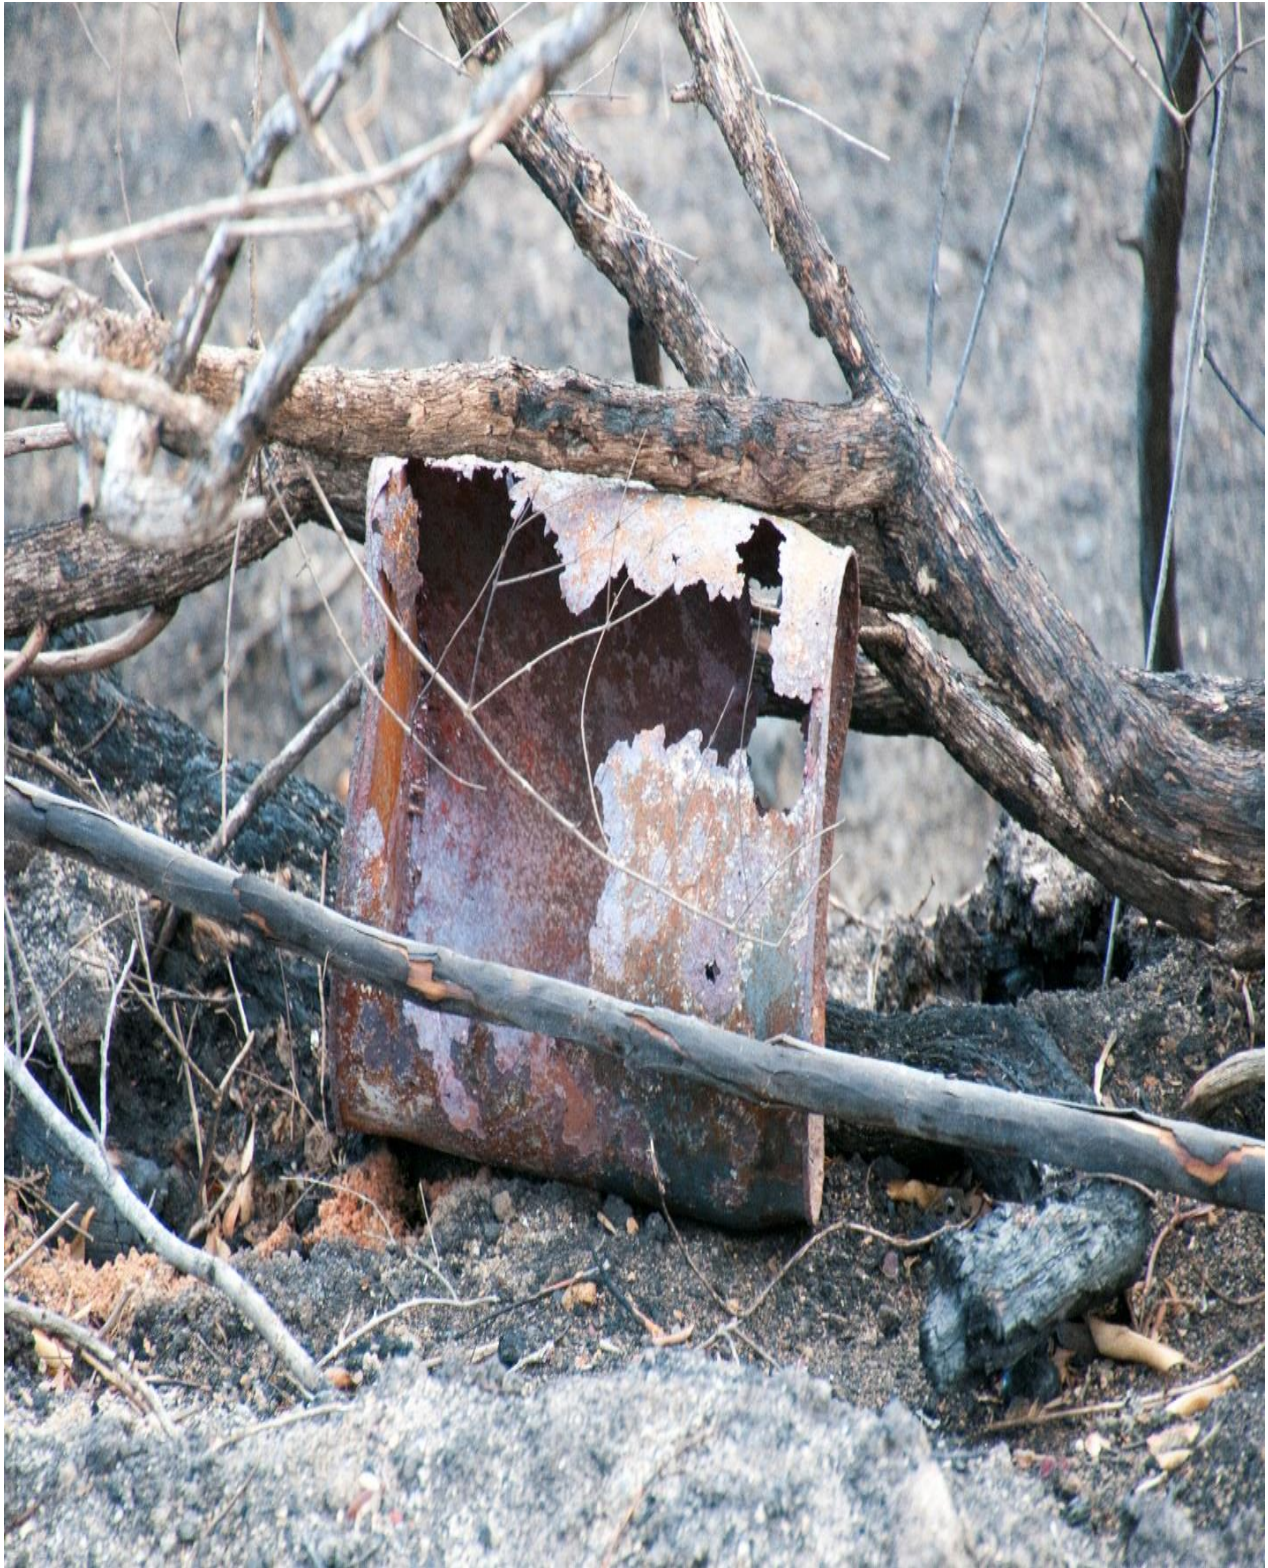
Figure 59: Close-up of the metal drum as shown in Figure 58.

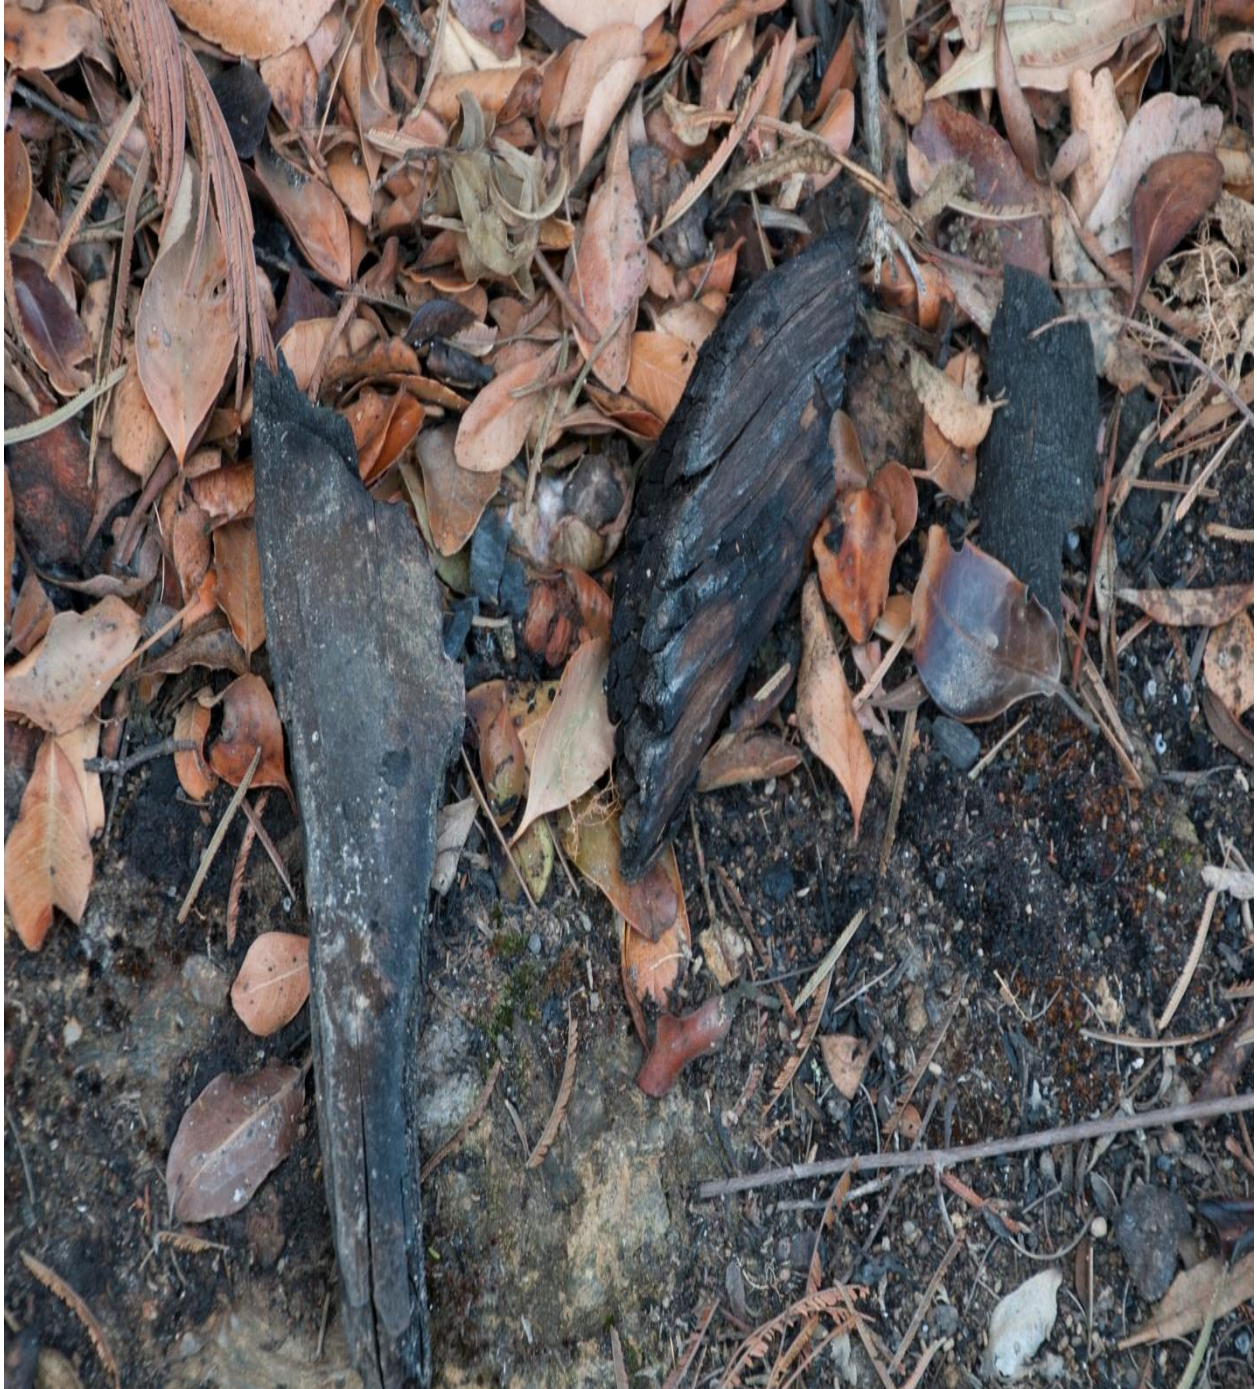
Figure 62: Partially burnt material in the clearing

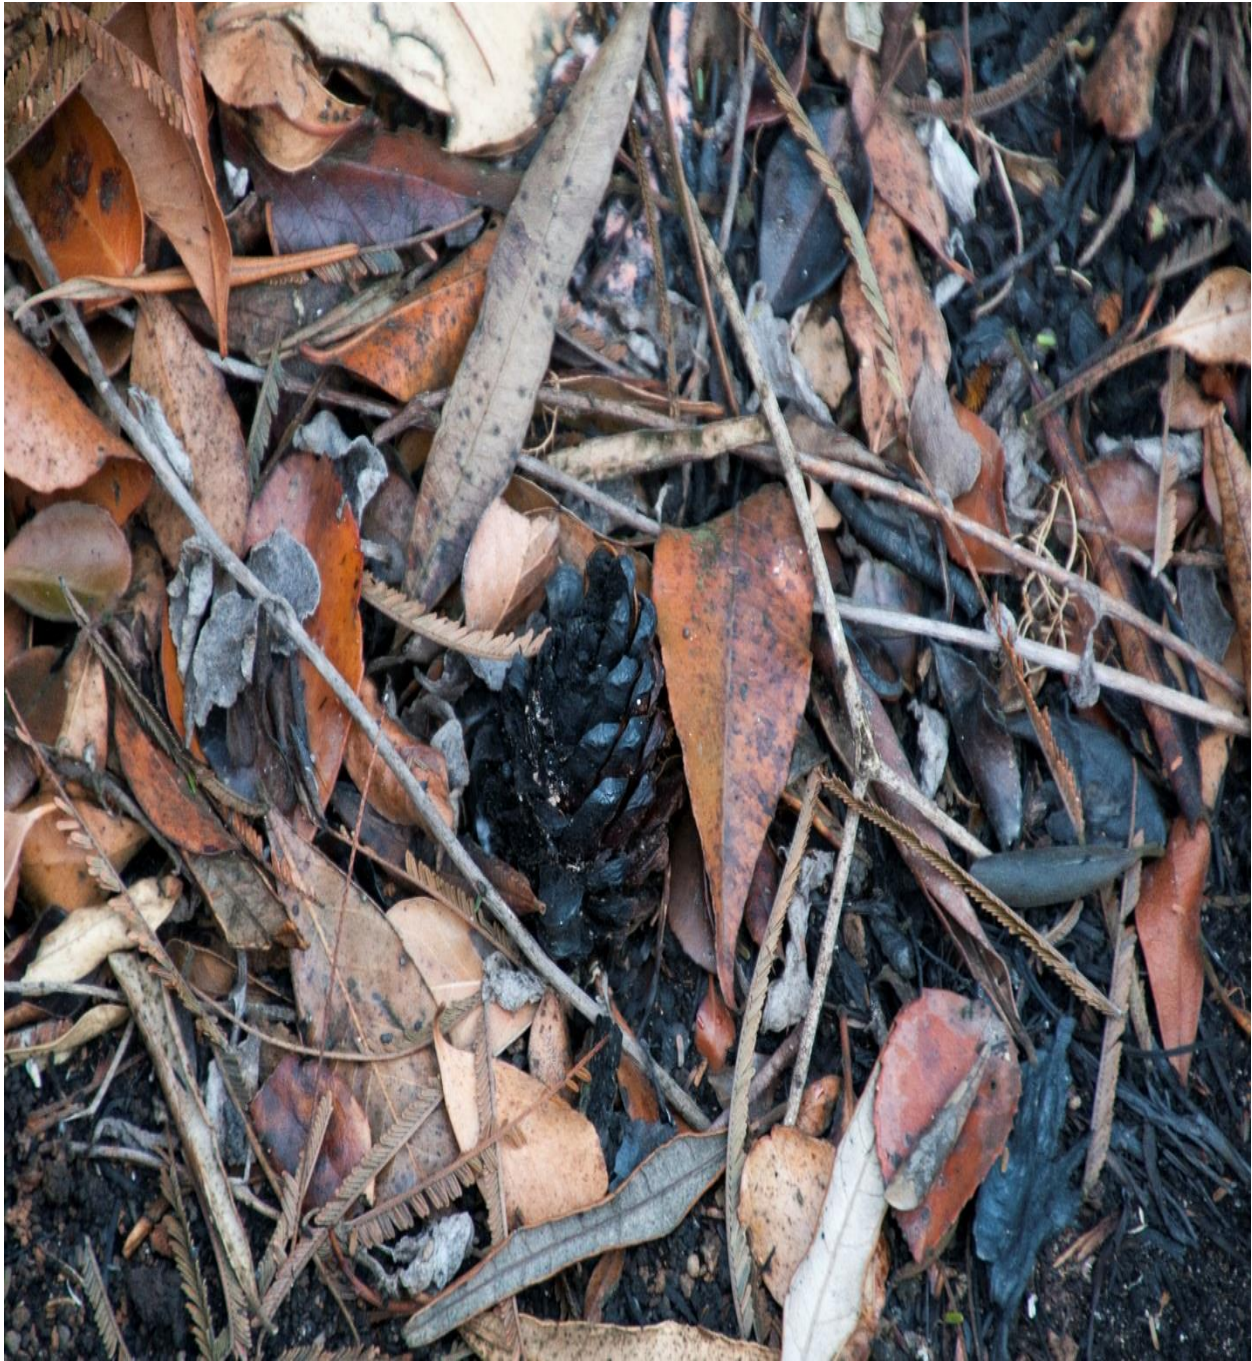
Figure 64: Partially burnt pinecone in clearing

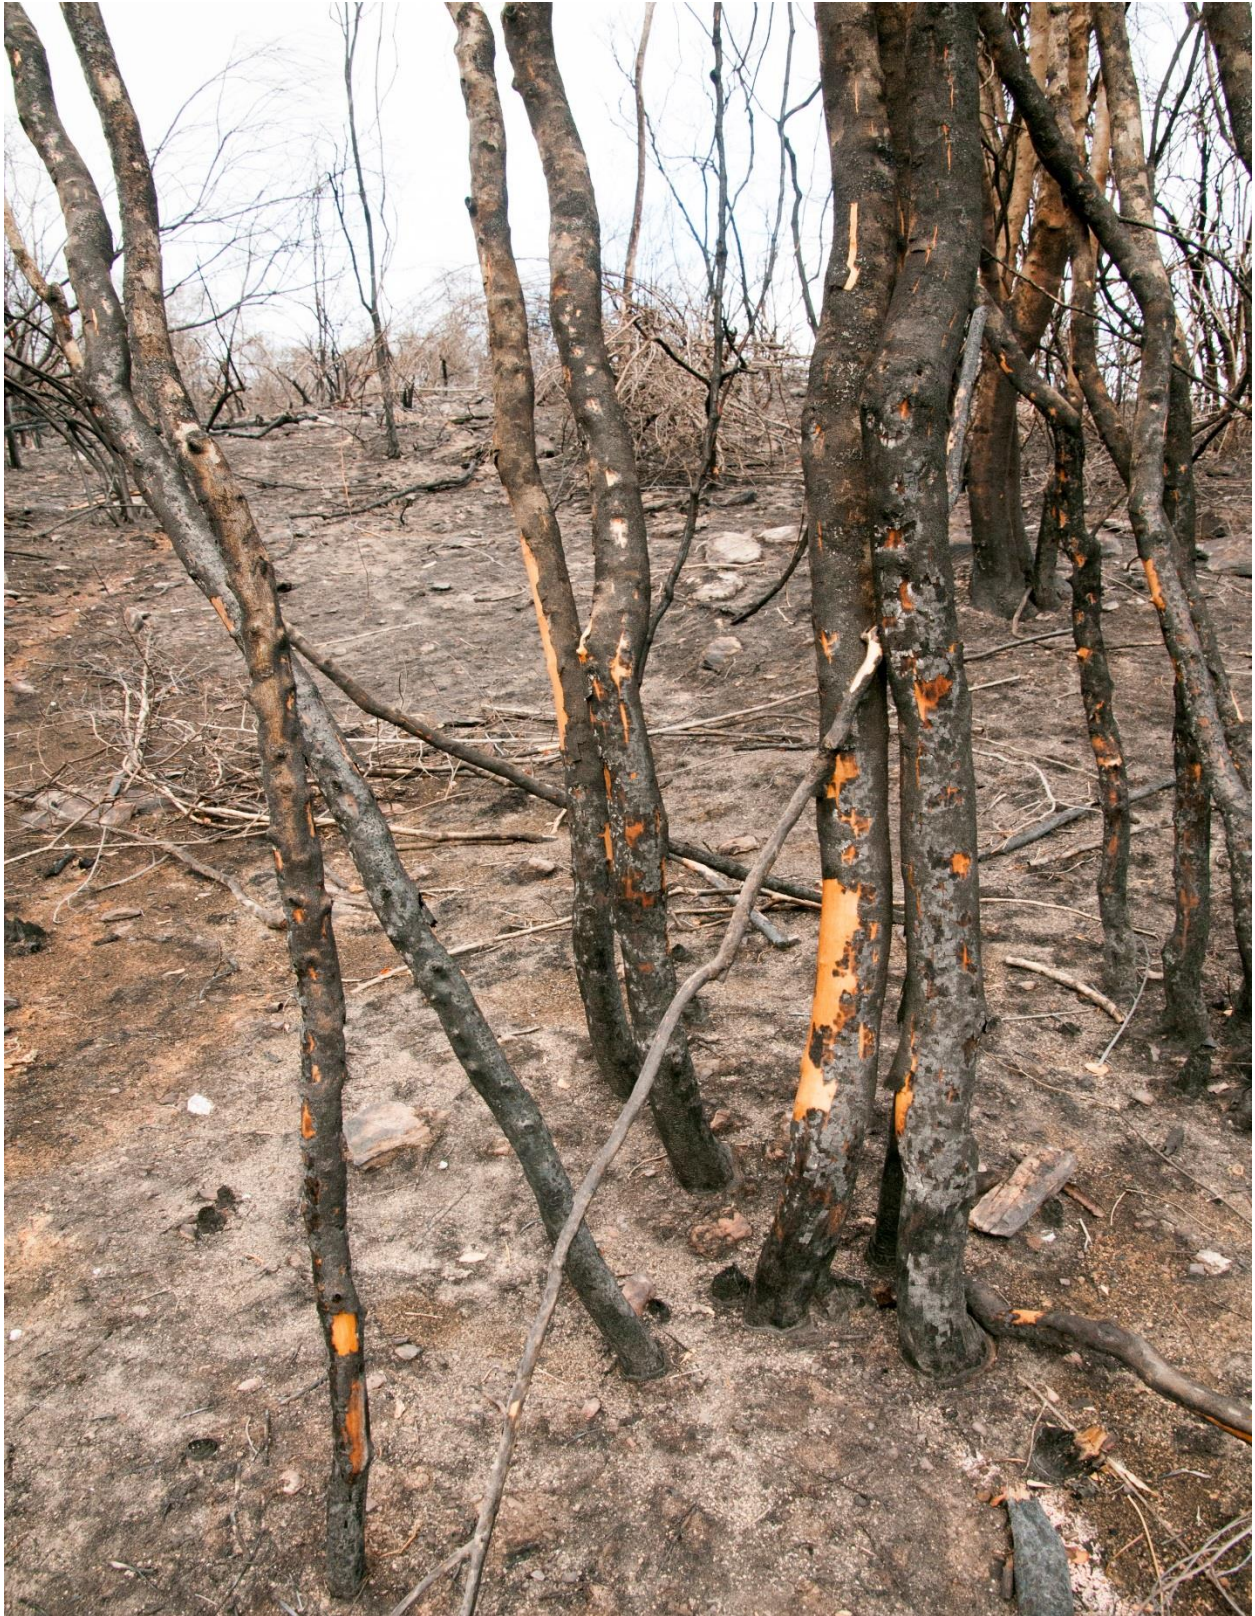
Figure 68: Fire damage visible from the uphill side.

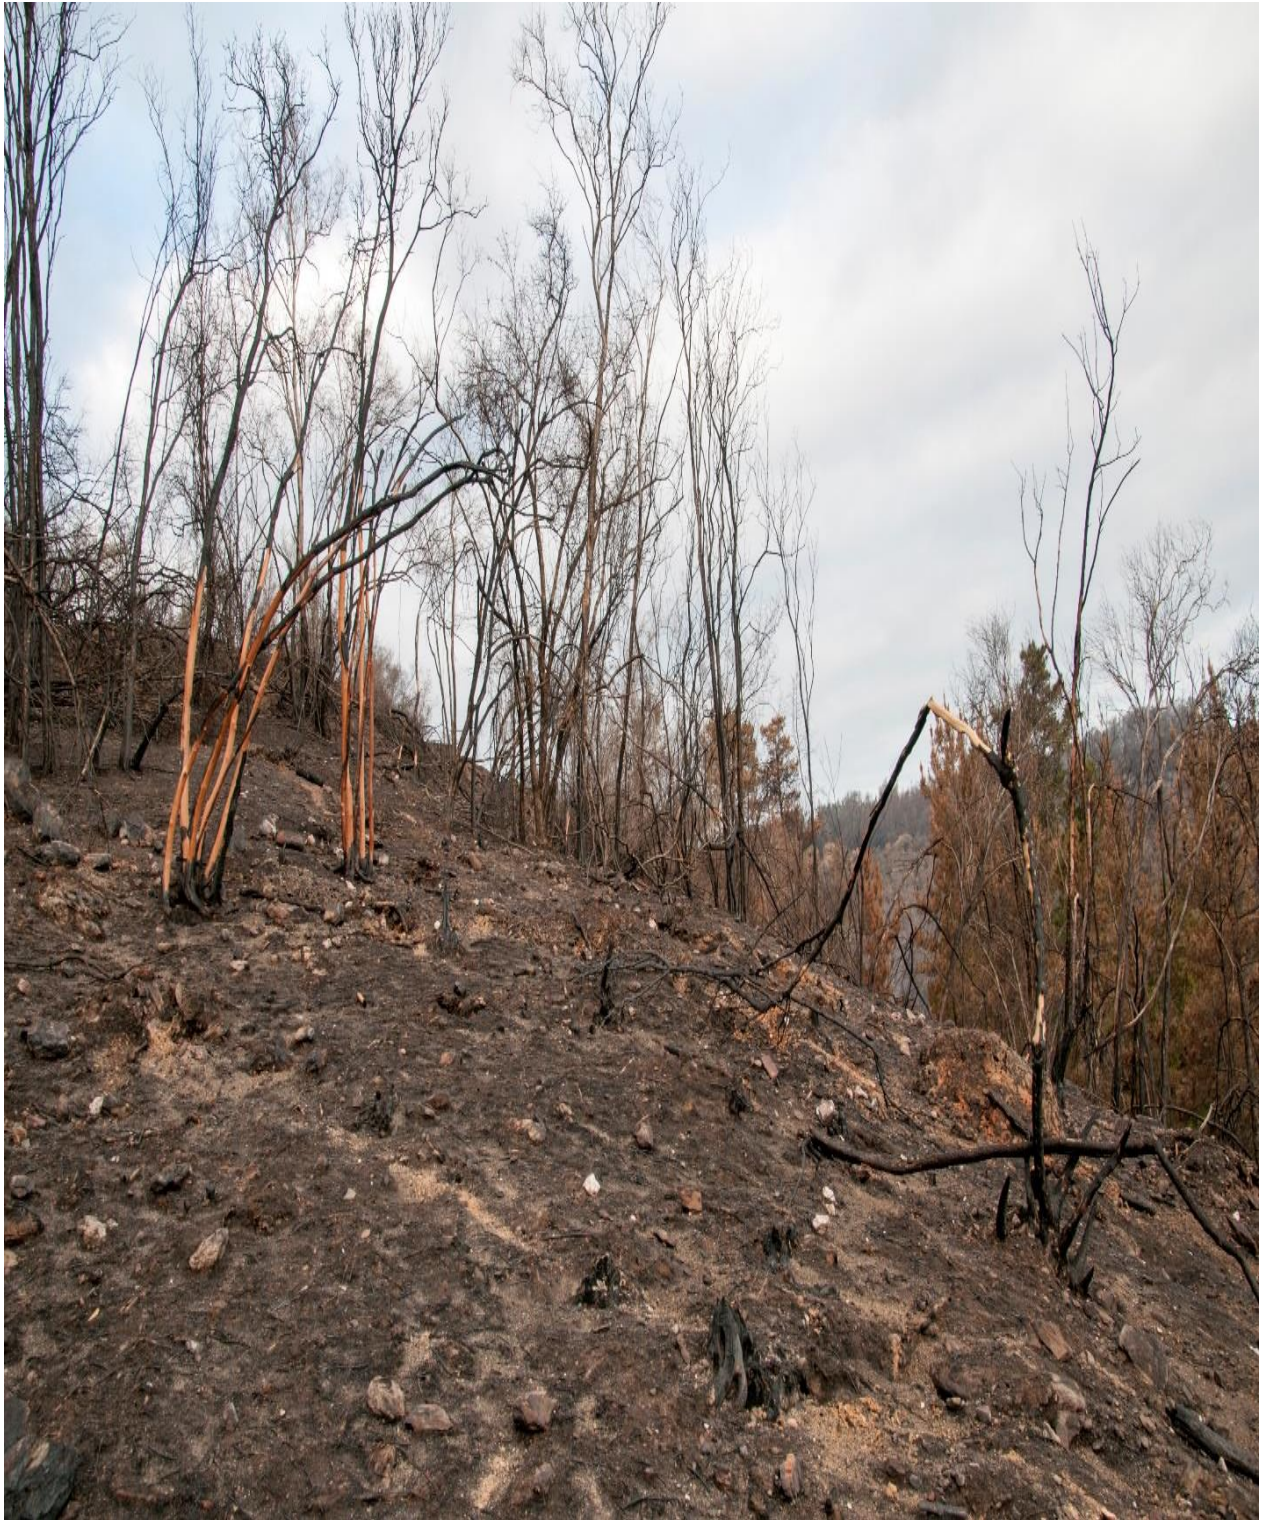
Figure 69: Fire damage from the uphill side.

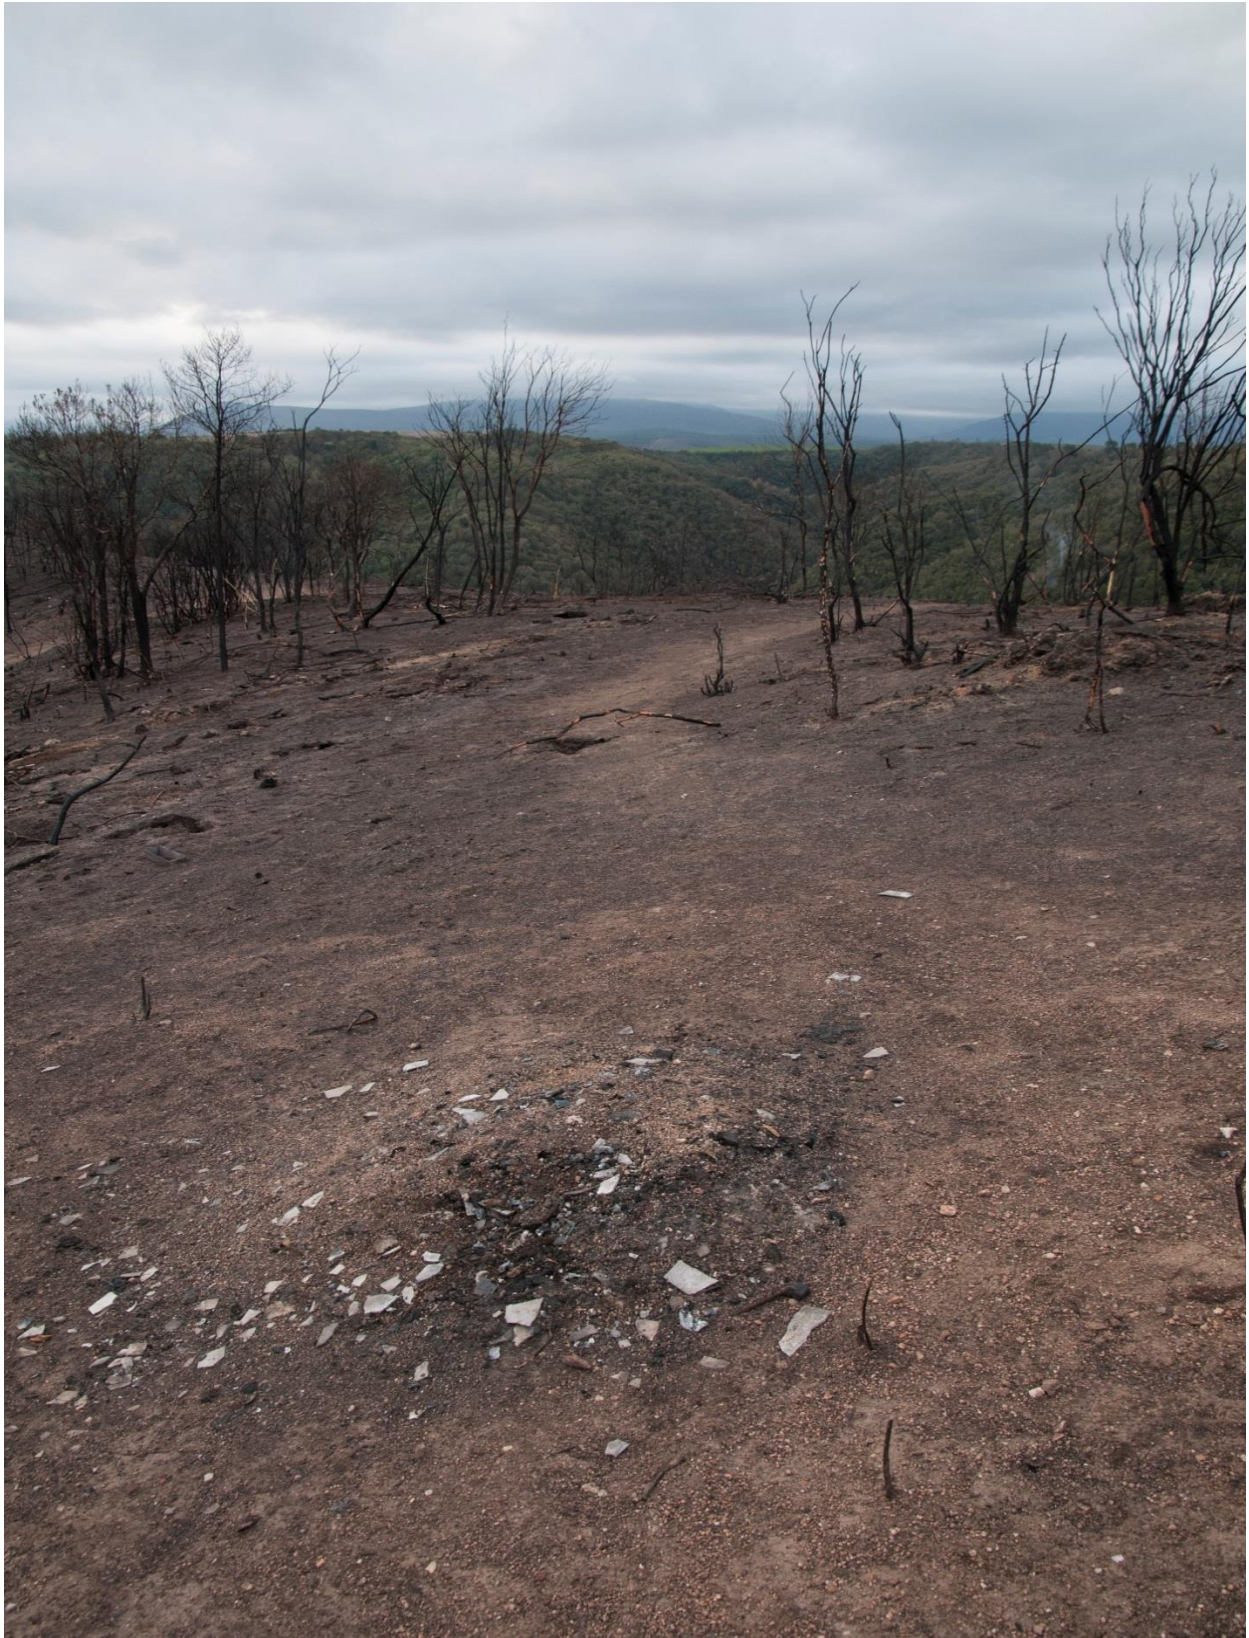
Figure 72: Remains of a fire.

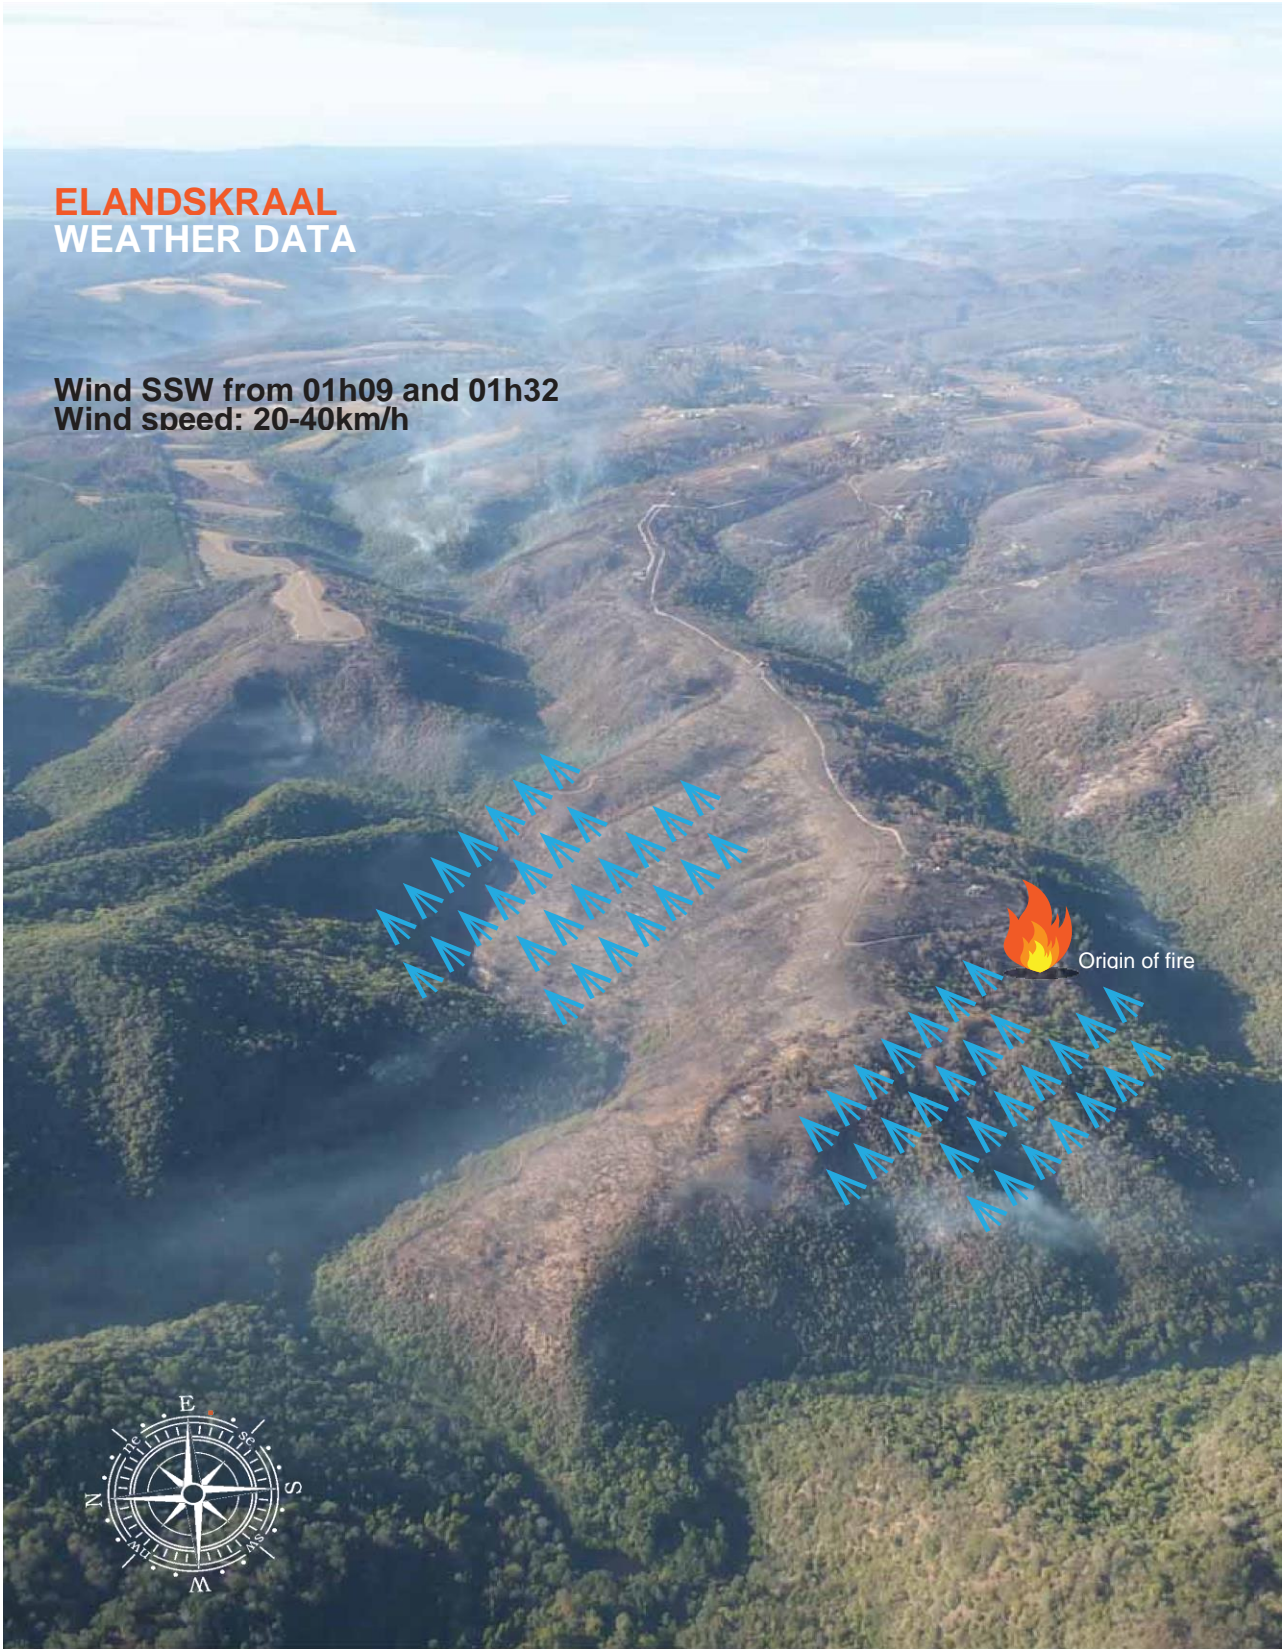
1. Figure 78 shows where the fire originated at the bottom of the V Section.
2. Wind data indicate the wind was from the South-South- West between 01h09 and 01h32 and at speeds of 20 to 40 km/h. Figure 79 simulates this wind direction and the spread of the fire. The burn scar on the ground supports this wind direction and fire spread.

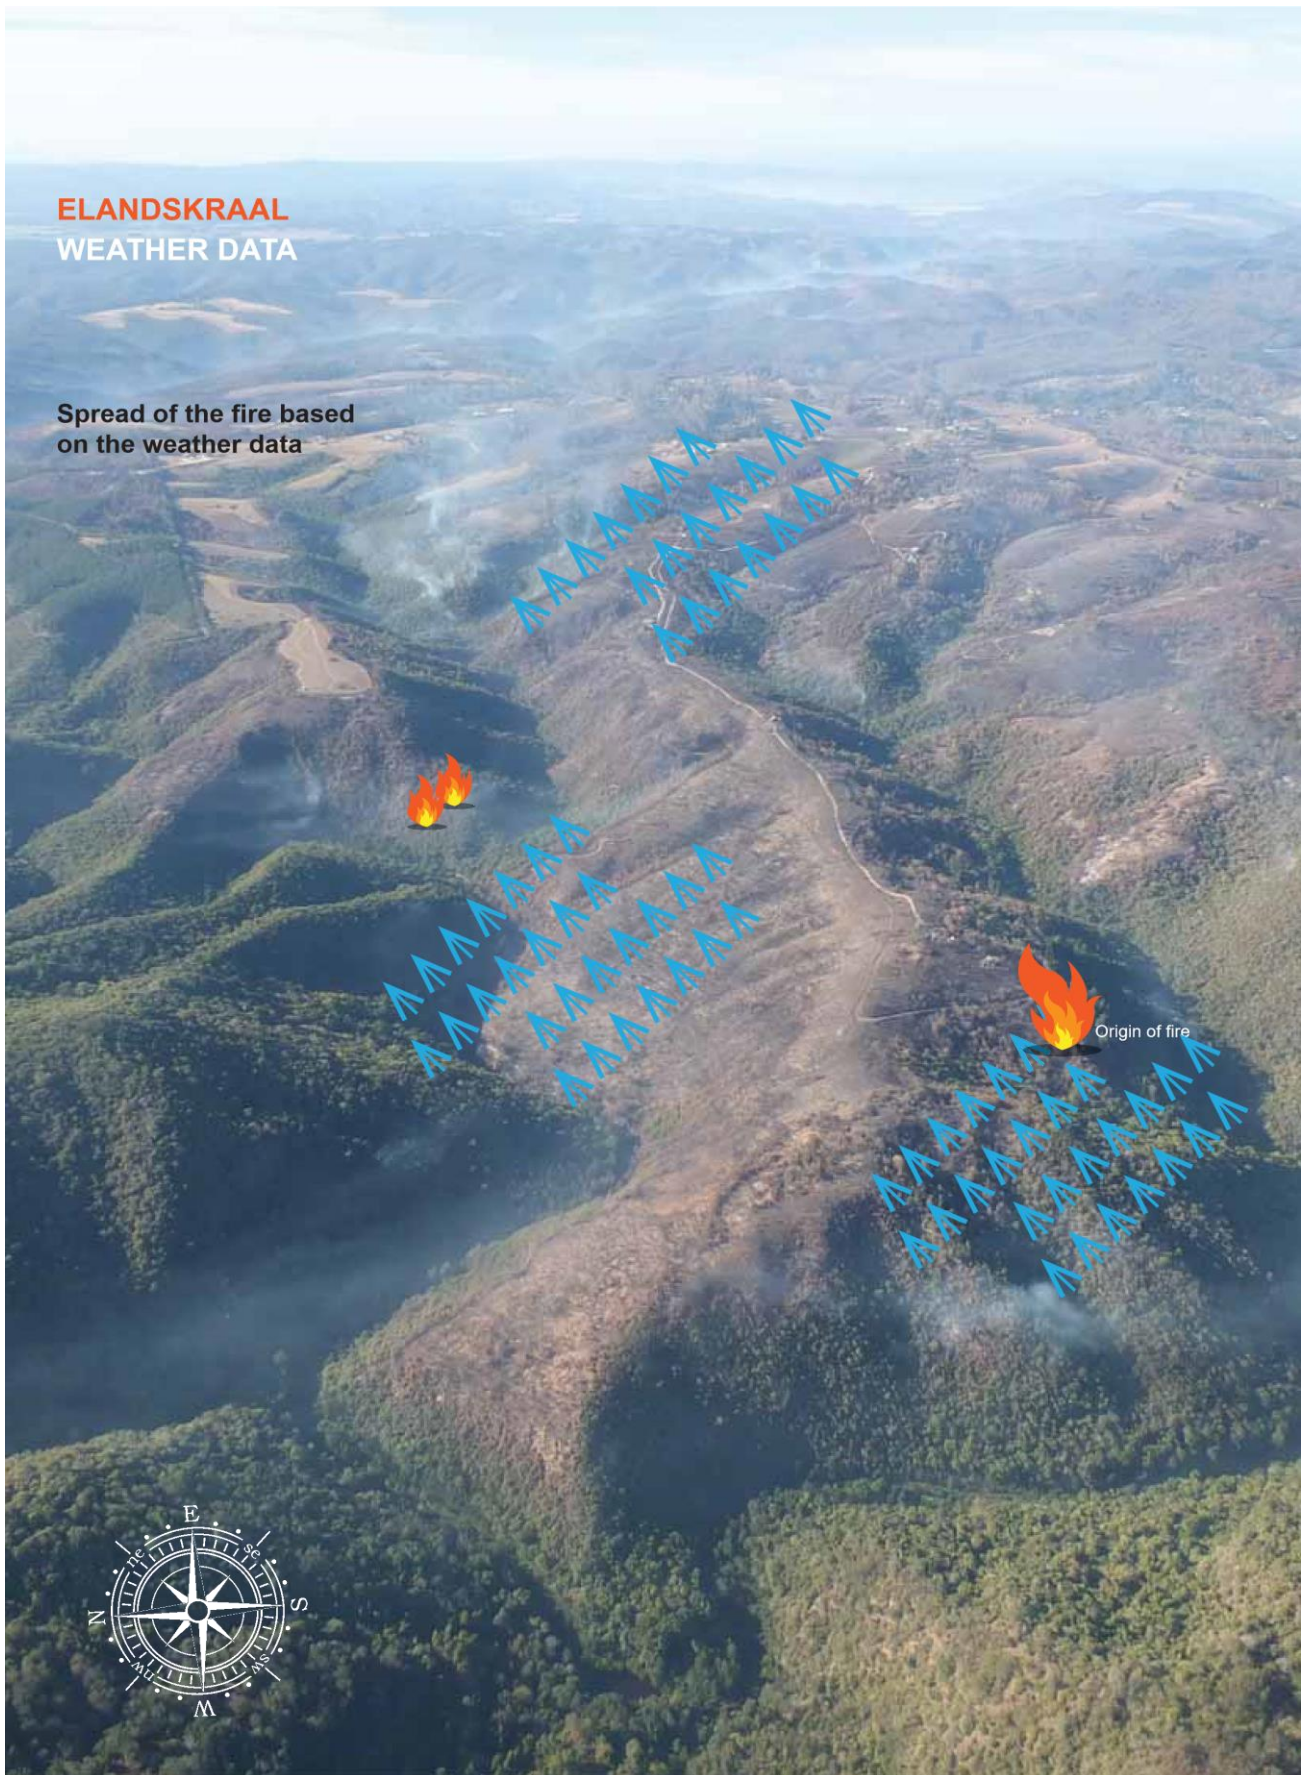
Figure 79

Spread of the fire based
on the weather data

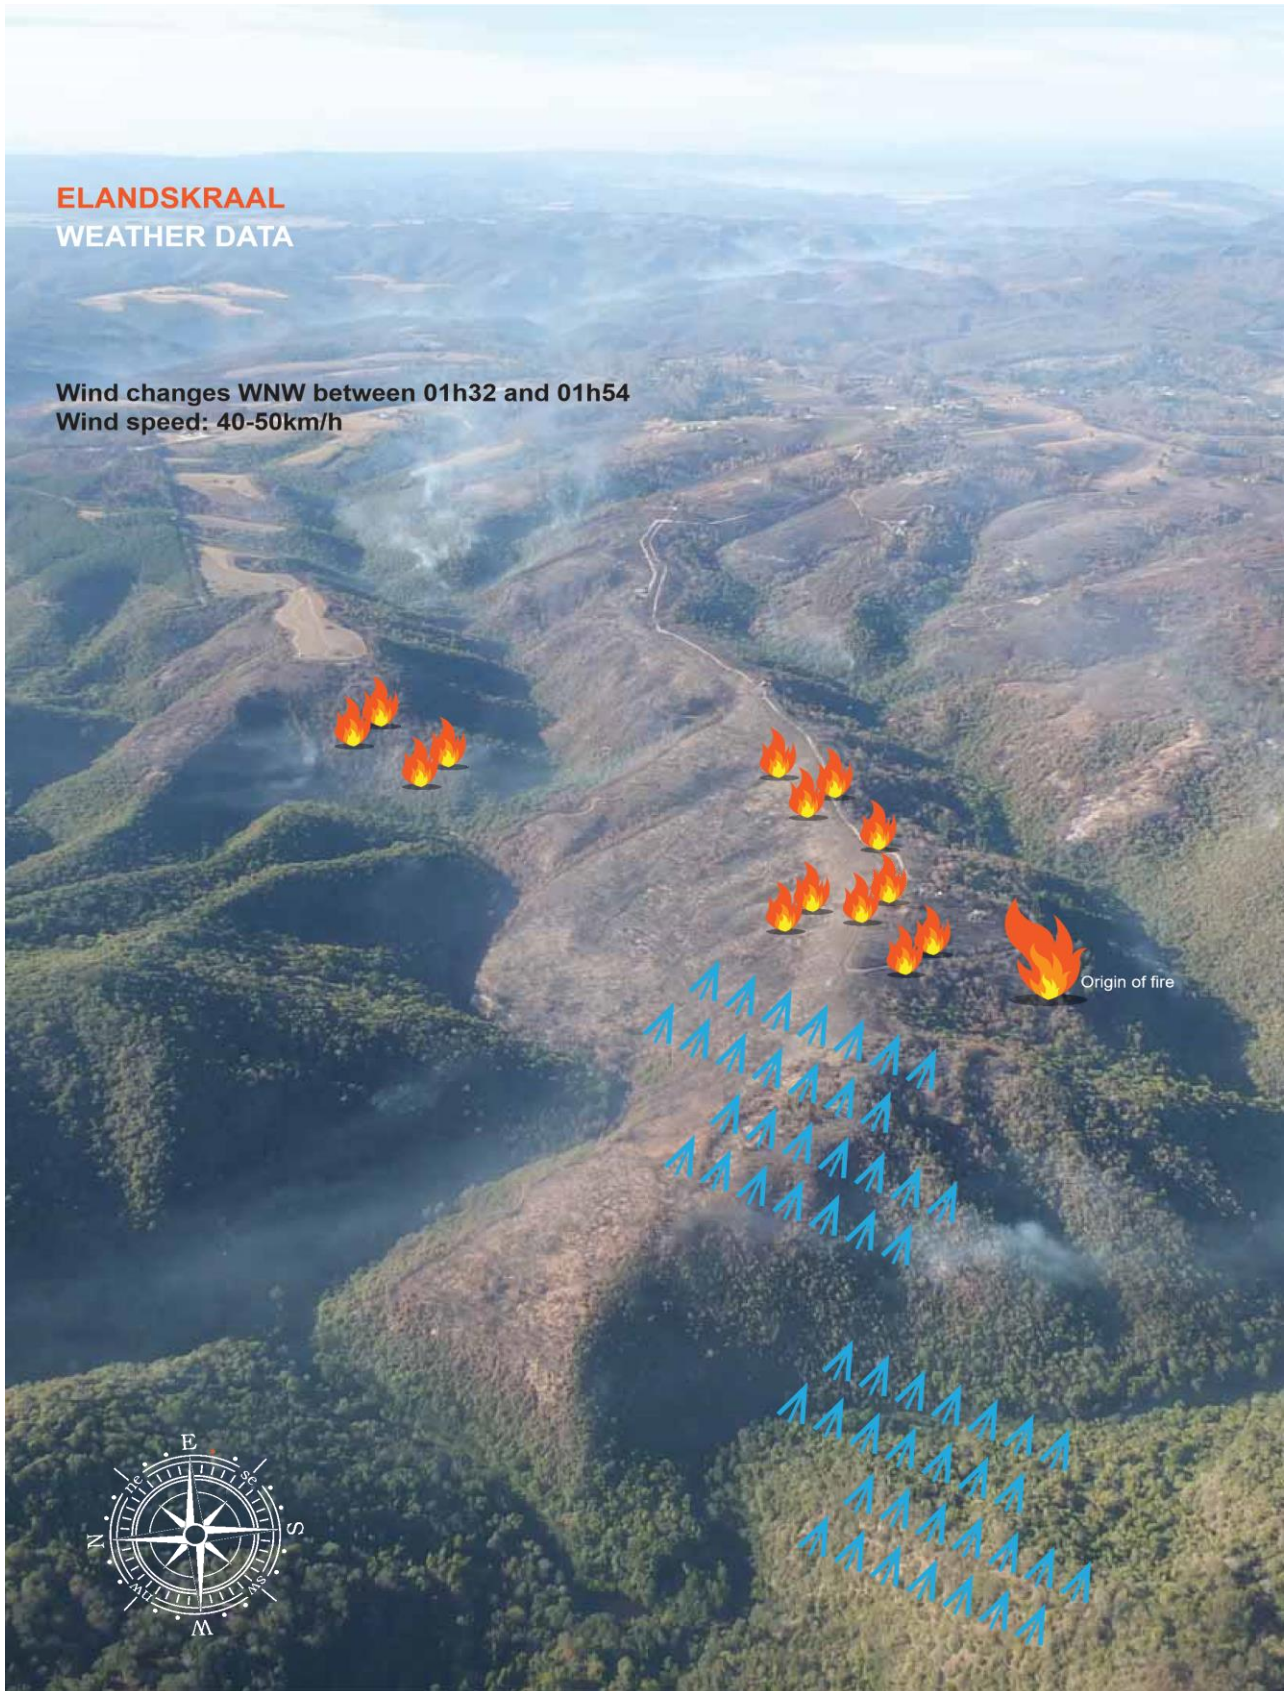
Wind changes WNW between 01h32 and 01h54
Wind speed: 40-50km/h

3. Figure 80 simulates how the fire spread from its origin to below the ploughed lands. A fire spreading to below the ploughed lands can only happen with the wind blowing from the South-South-West; and the fire starting and spreading from the origin as indicated in Figure 78. The burn scar on the ground supports the path of fire spread to below the ploughed lands with the wind from the South-South-West.

I can find no plausible explanation for a fire to have started in Area 1 (V Section) by means of a fire “spotting from Area 3 or any other area. The wind direction does not support this. Figure 80 shows fire spread with the wind coming from the South South West between 01h09 and 01h32. Clearly the fire could not have spotted to Area 1 with this wind.
