Report of the Chief Fire Officer:

Knysna Fire and Rescue Service on the Fire origin and possible cause in the Elandskraal area:

Knysna on 07 June 2017

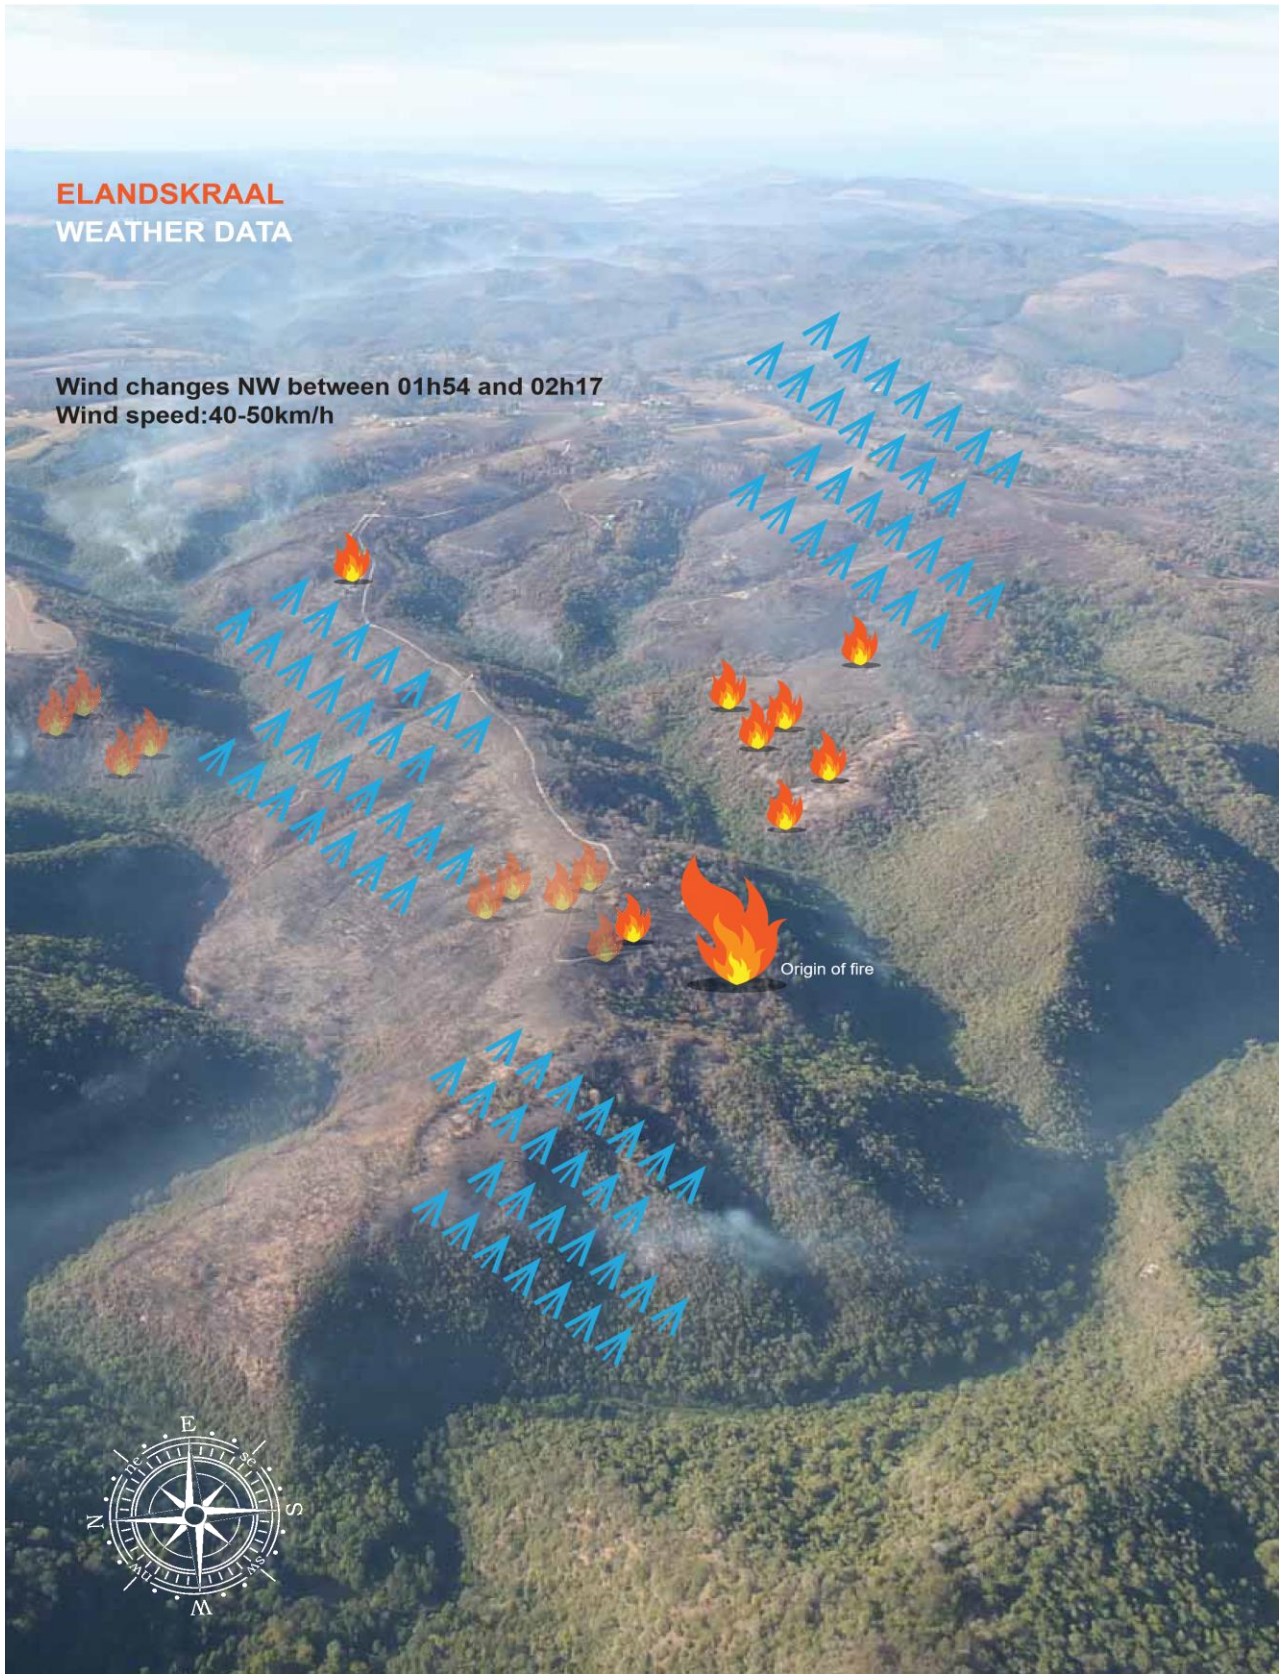
Wind changes NW between 01h54 and 02h17
Wind speed: 40-50km/h

4. Figure 81 simulates the spread of fire when the wind changed and came from the West-North-West and at speeds from 40 to 50 Km/h. The burn scar of the area supports this fire spread.

Figure 81 shows the wind from the West North West direction between 01h32 and 01h54. Had Area 1 been ignited with this wind spreading the fire to it then the burn scar of area 1 would have shown a burn spread consistent with the wind from the West North West. The fire could thus not have spotted from area 3 to Area 1 with a West North West wind spreading it. The burn scar shows a pattern of fire spread with a South South West wind behind it.

Figure 81 shows the burn scar below the ploughed lands. When one analyse the wind pattern which prevailed in the Elandskraal area then the only possibility for the fire to spread to this area is with the wind coming from the South South West. Has the fire originated at Area 3 then the fire spread from a South South Westerly wind would have been towards the area indicated in figure 78. One then would have found an entirely different burn scar if the fire firstly spread to this area, and secondly, had it spread from this area with the changing winds. The property visible in Figure 78 would have either been affected or threatened. However, we do see from the burn scar that this property is totally unaffected and was under no threat from fire.

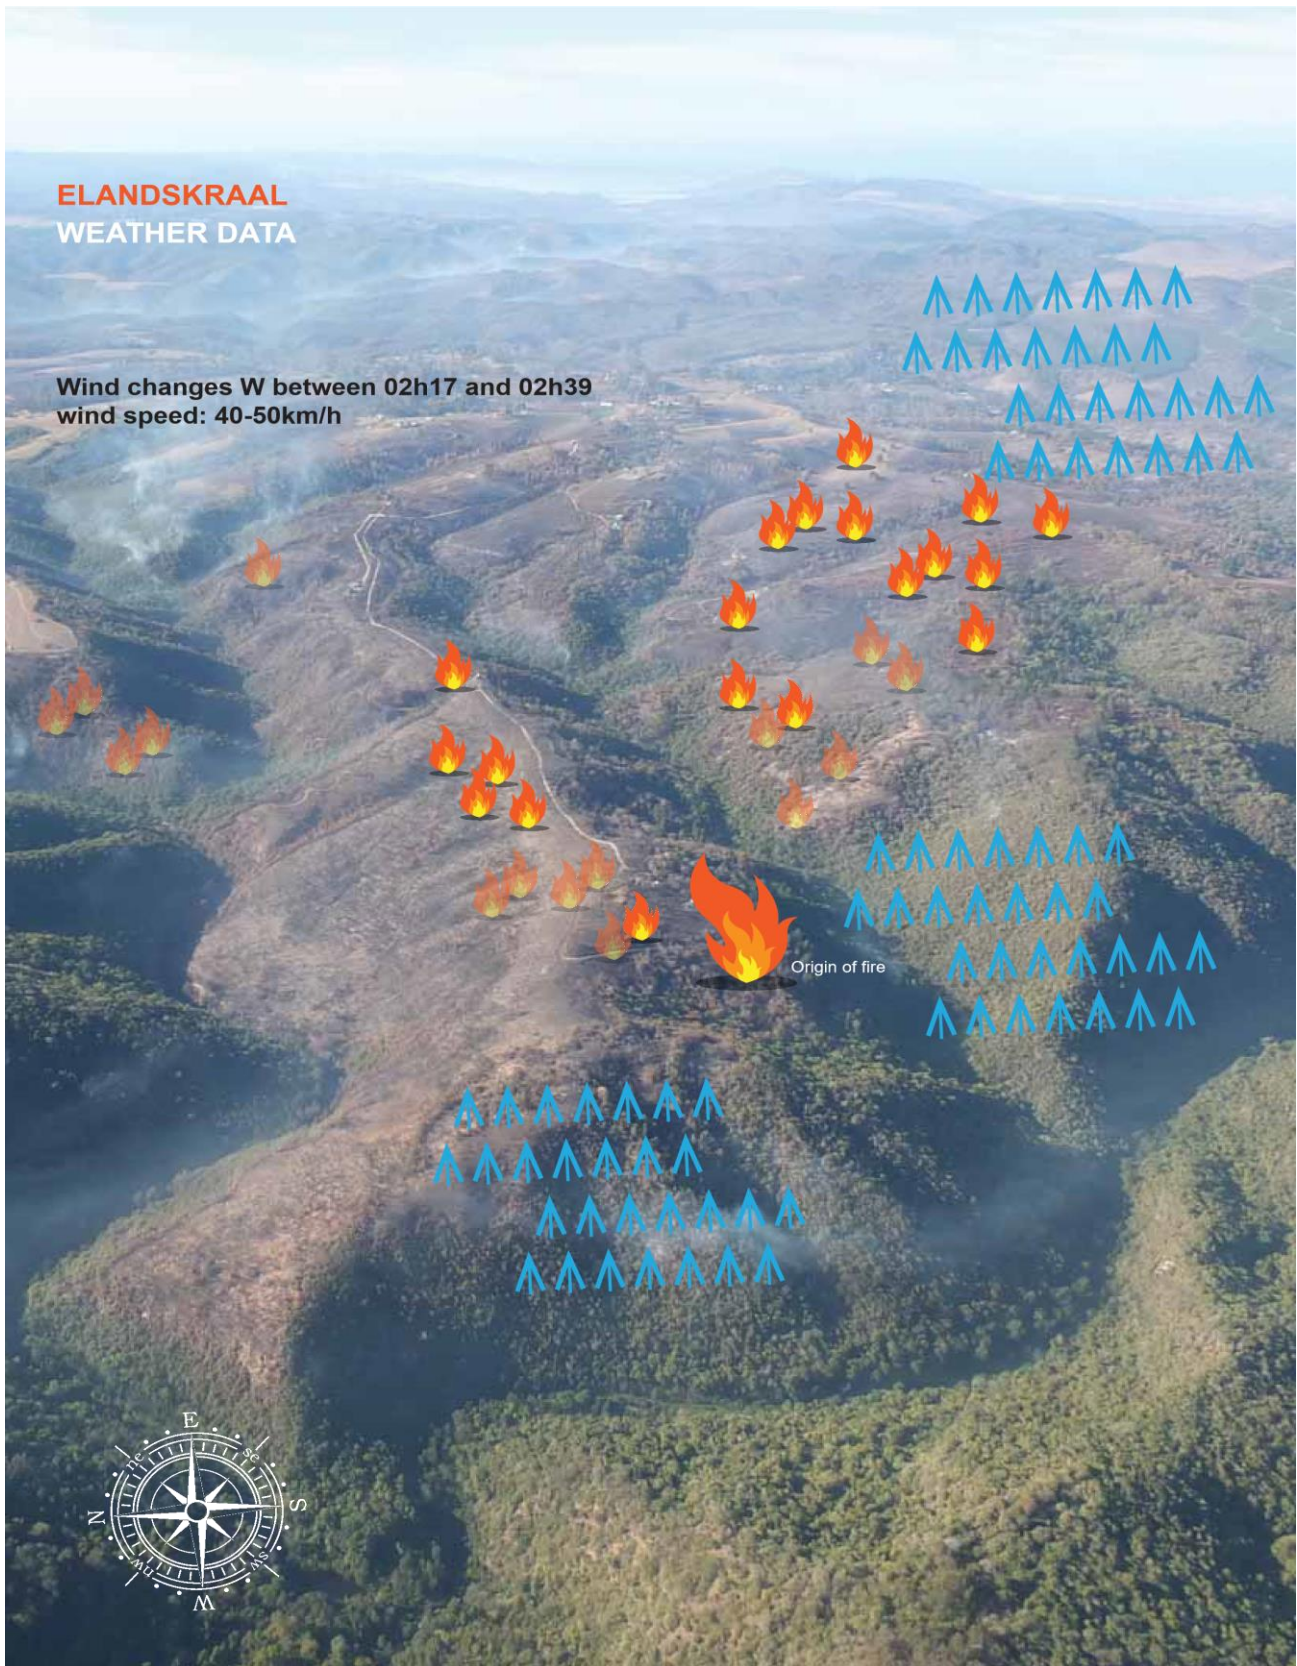
Wind changes W between 02h17 and 02h39
wind speed: 40-50km/h

5. Figure 82 simulates the fire spread when the wind came from the North-West between 01h54 and 02h17 and at speeds between 40 and 50 km/h. this change in the wind direction, and the speed of the wind caused it to “spot” towards the South-East. This wind caused the fire to spot and spread along two ridges. The burn scar shows where the fire spotted in two places and from there spread in a South Easterly direction.

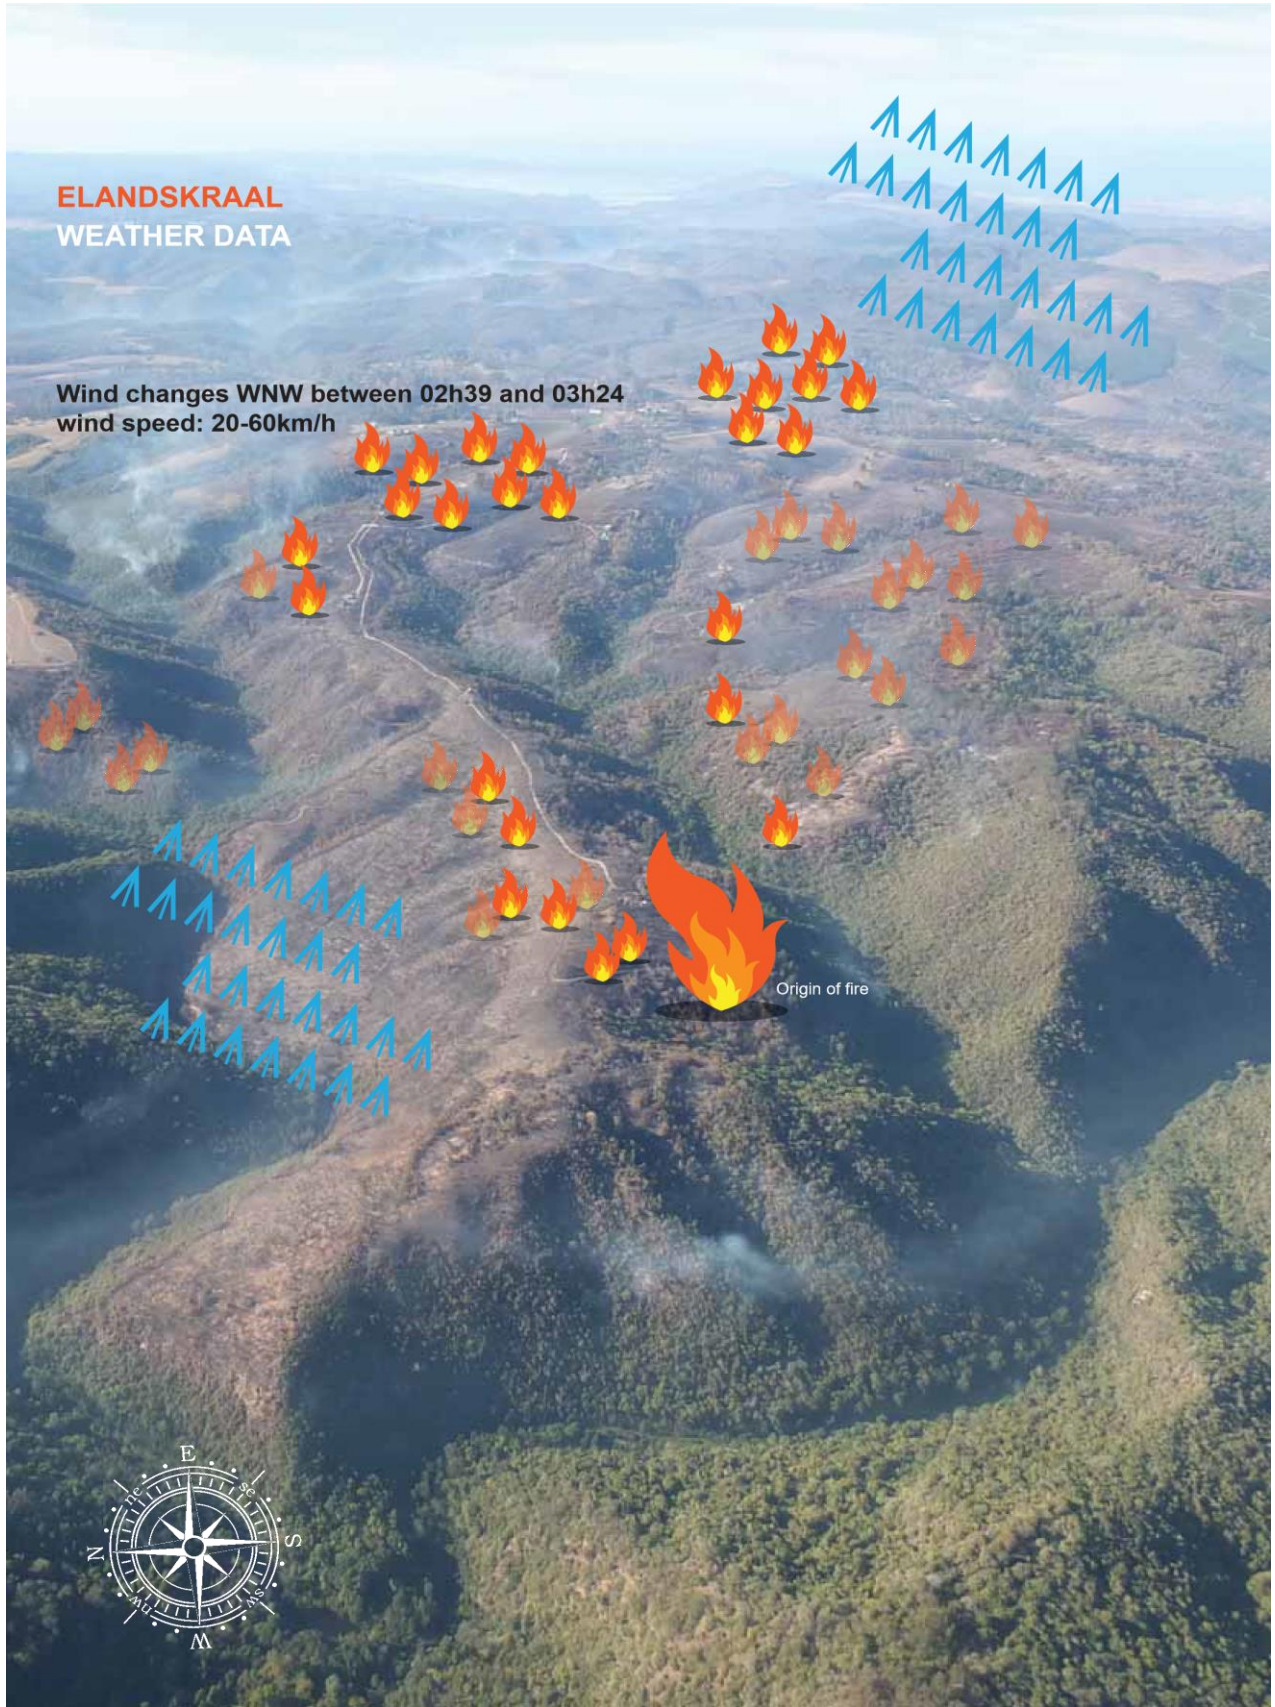
6. Figure 83 simulates the spread of the fire when the wind was from the West between 02h17 and 02h39 and at speeds between 40 and 50 km/h. The burn scar shows clearly the spread of the fire being fanned by a Westerly wind.

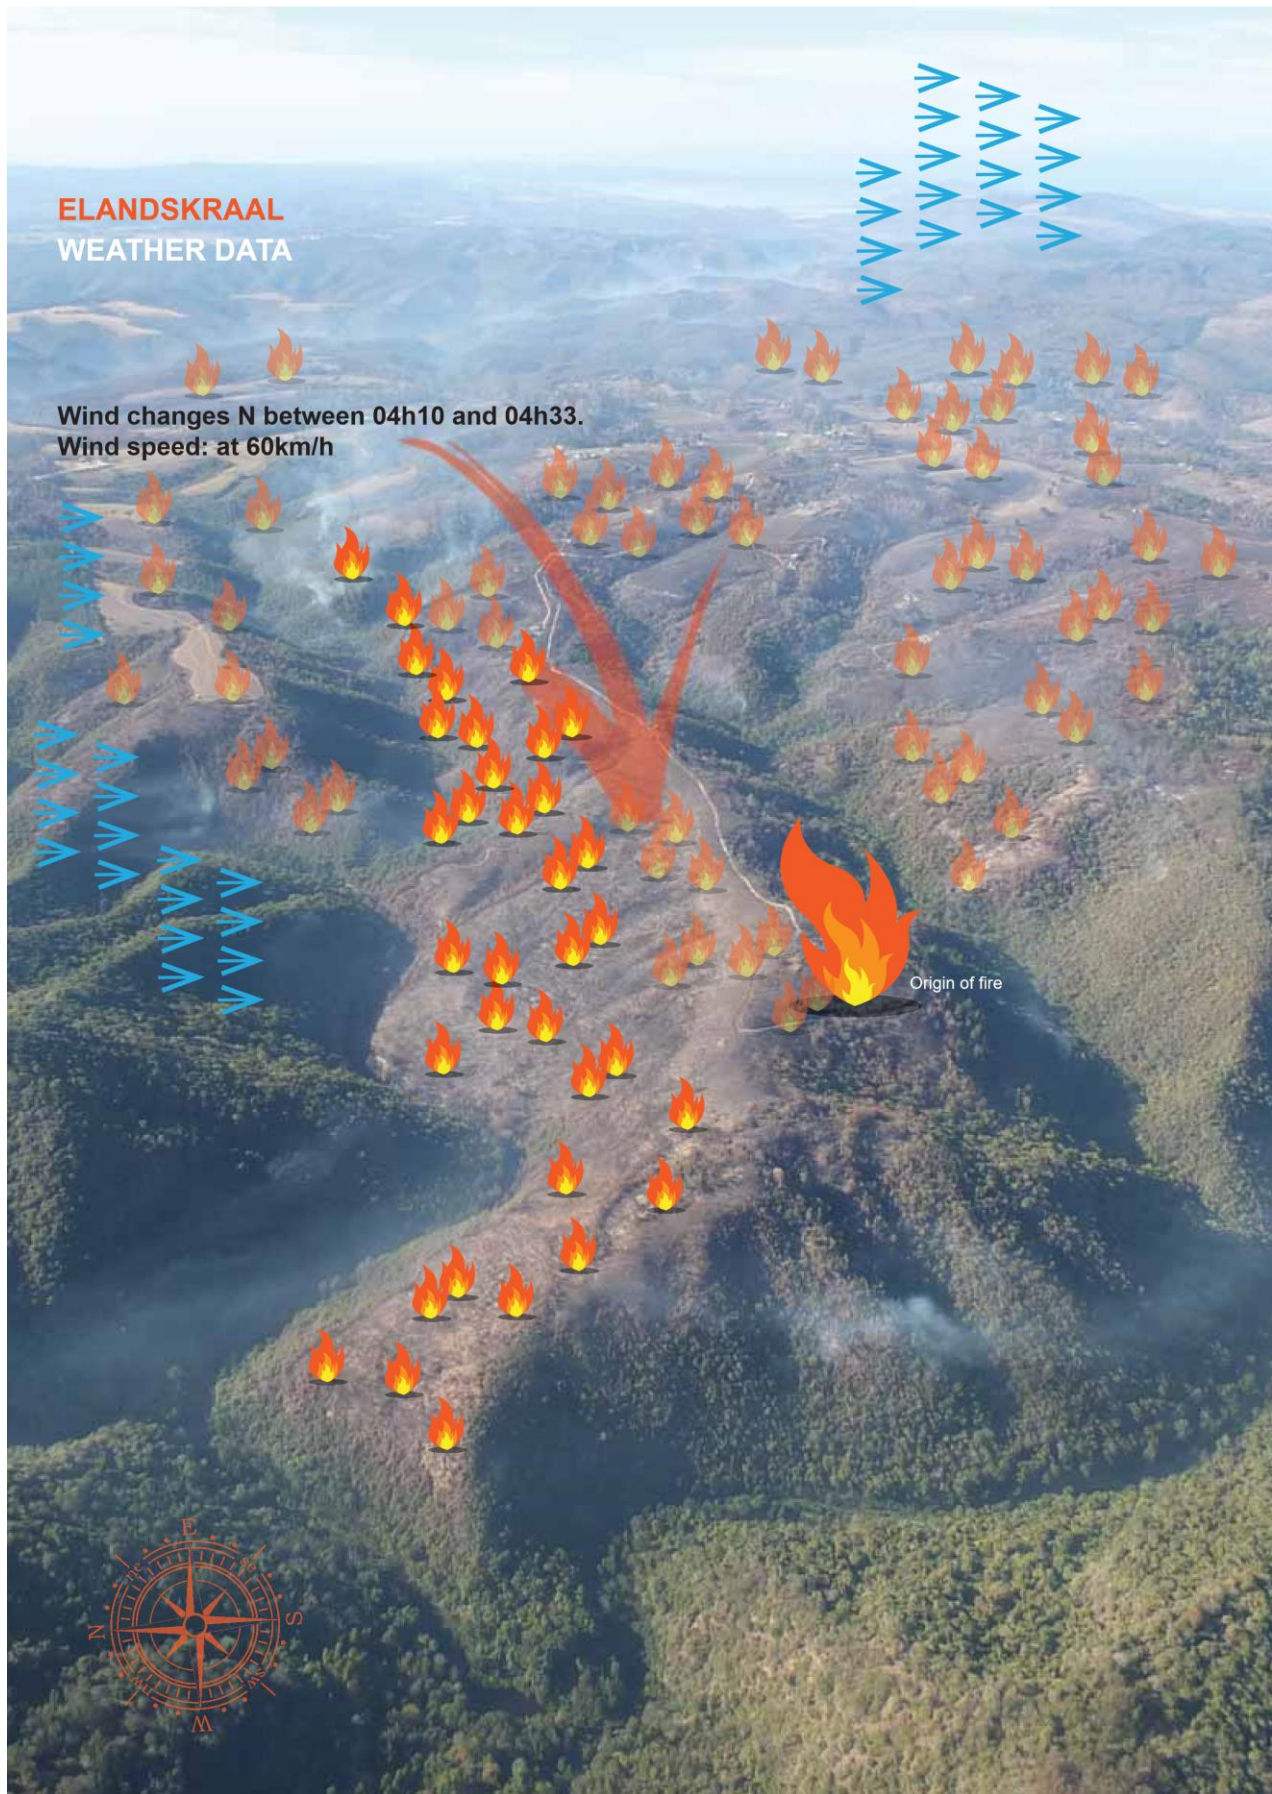
8. Figure 85 simulates the fire spread when wind came from the North-West as speed up to 60 km/h. By this time the two separate front joined as one big front.

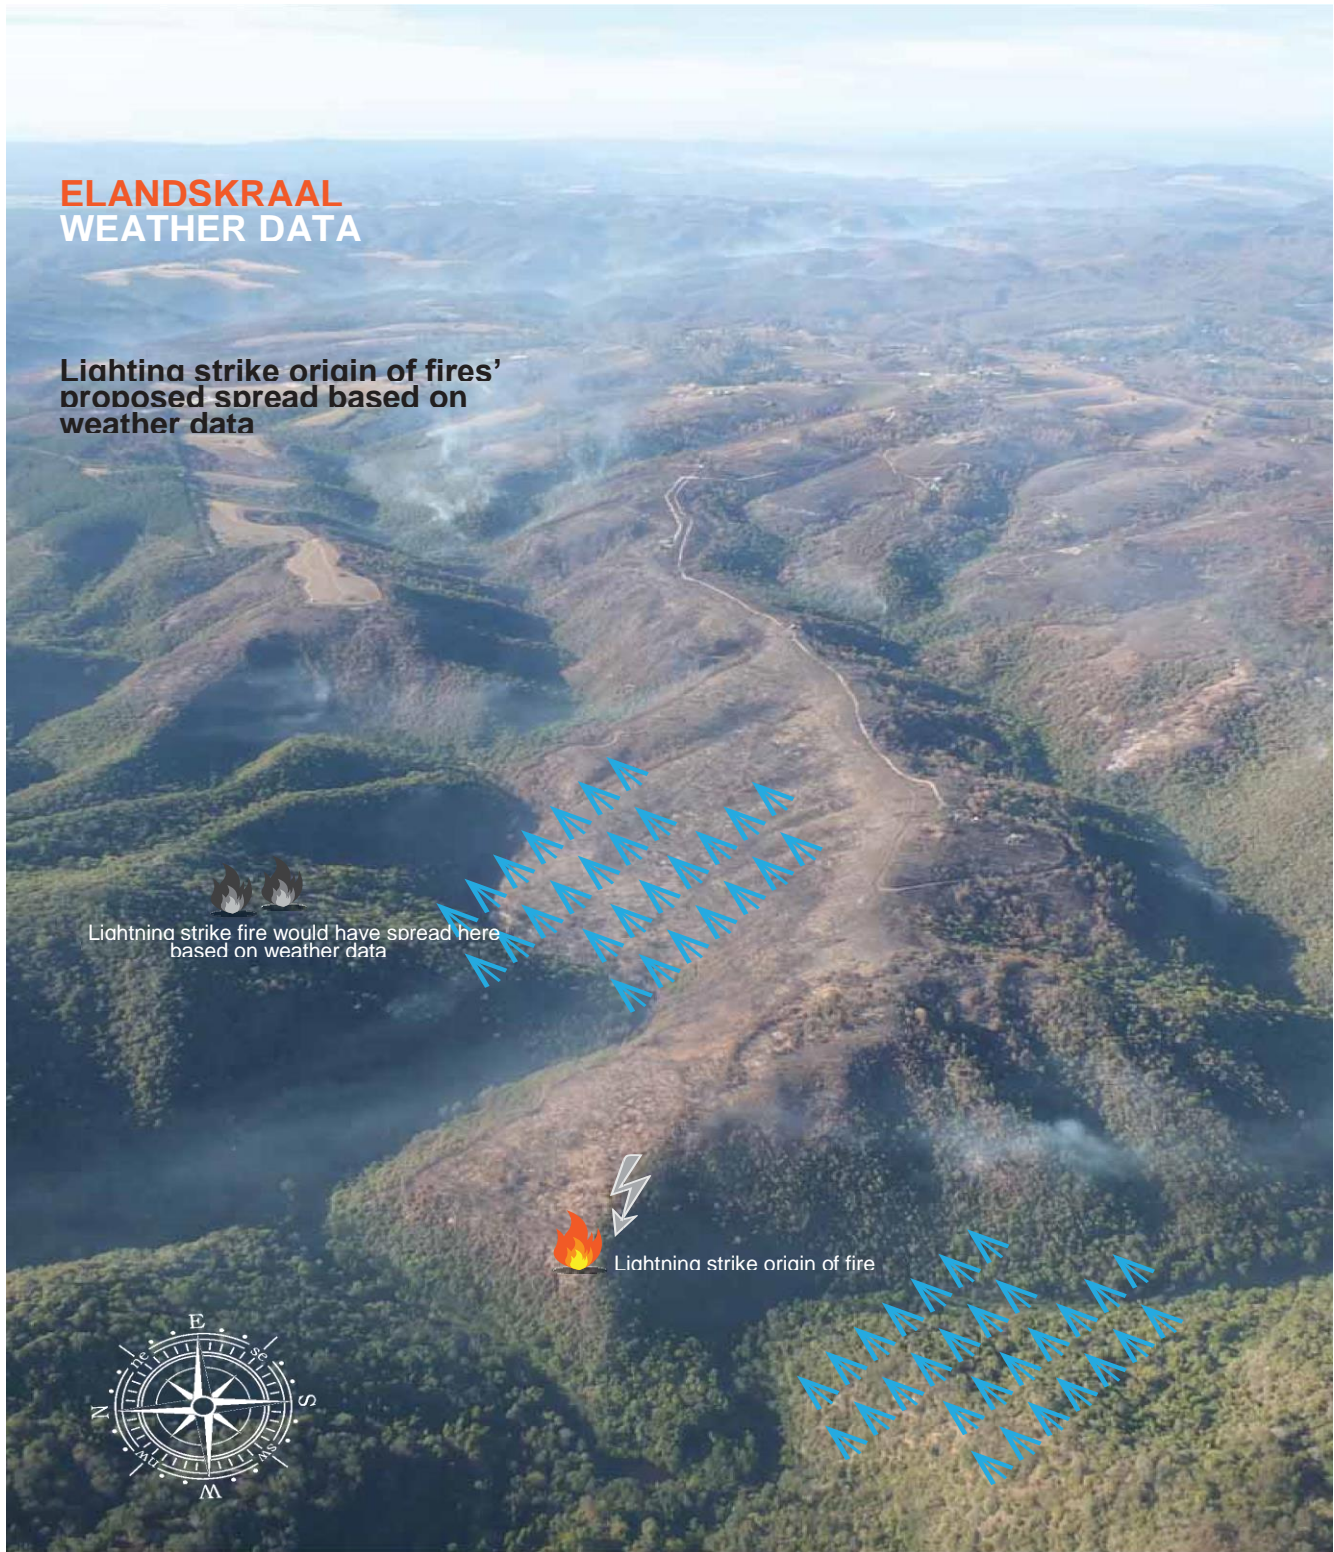
causing burn scars from the east and downslope. This accounts for the inverted V pattern seen in the area and the die out pattern. Figure 86 simulates this wind from the East and fire spread. The burn scar, remaining fuel, poles and structures in this area supports the wind from the North changing to an Easterly vector.

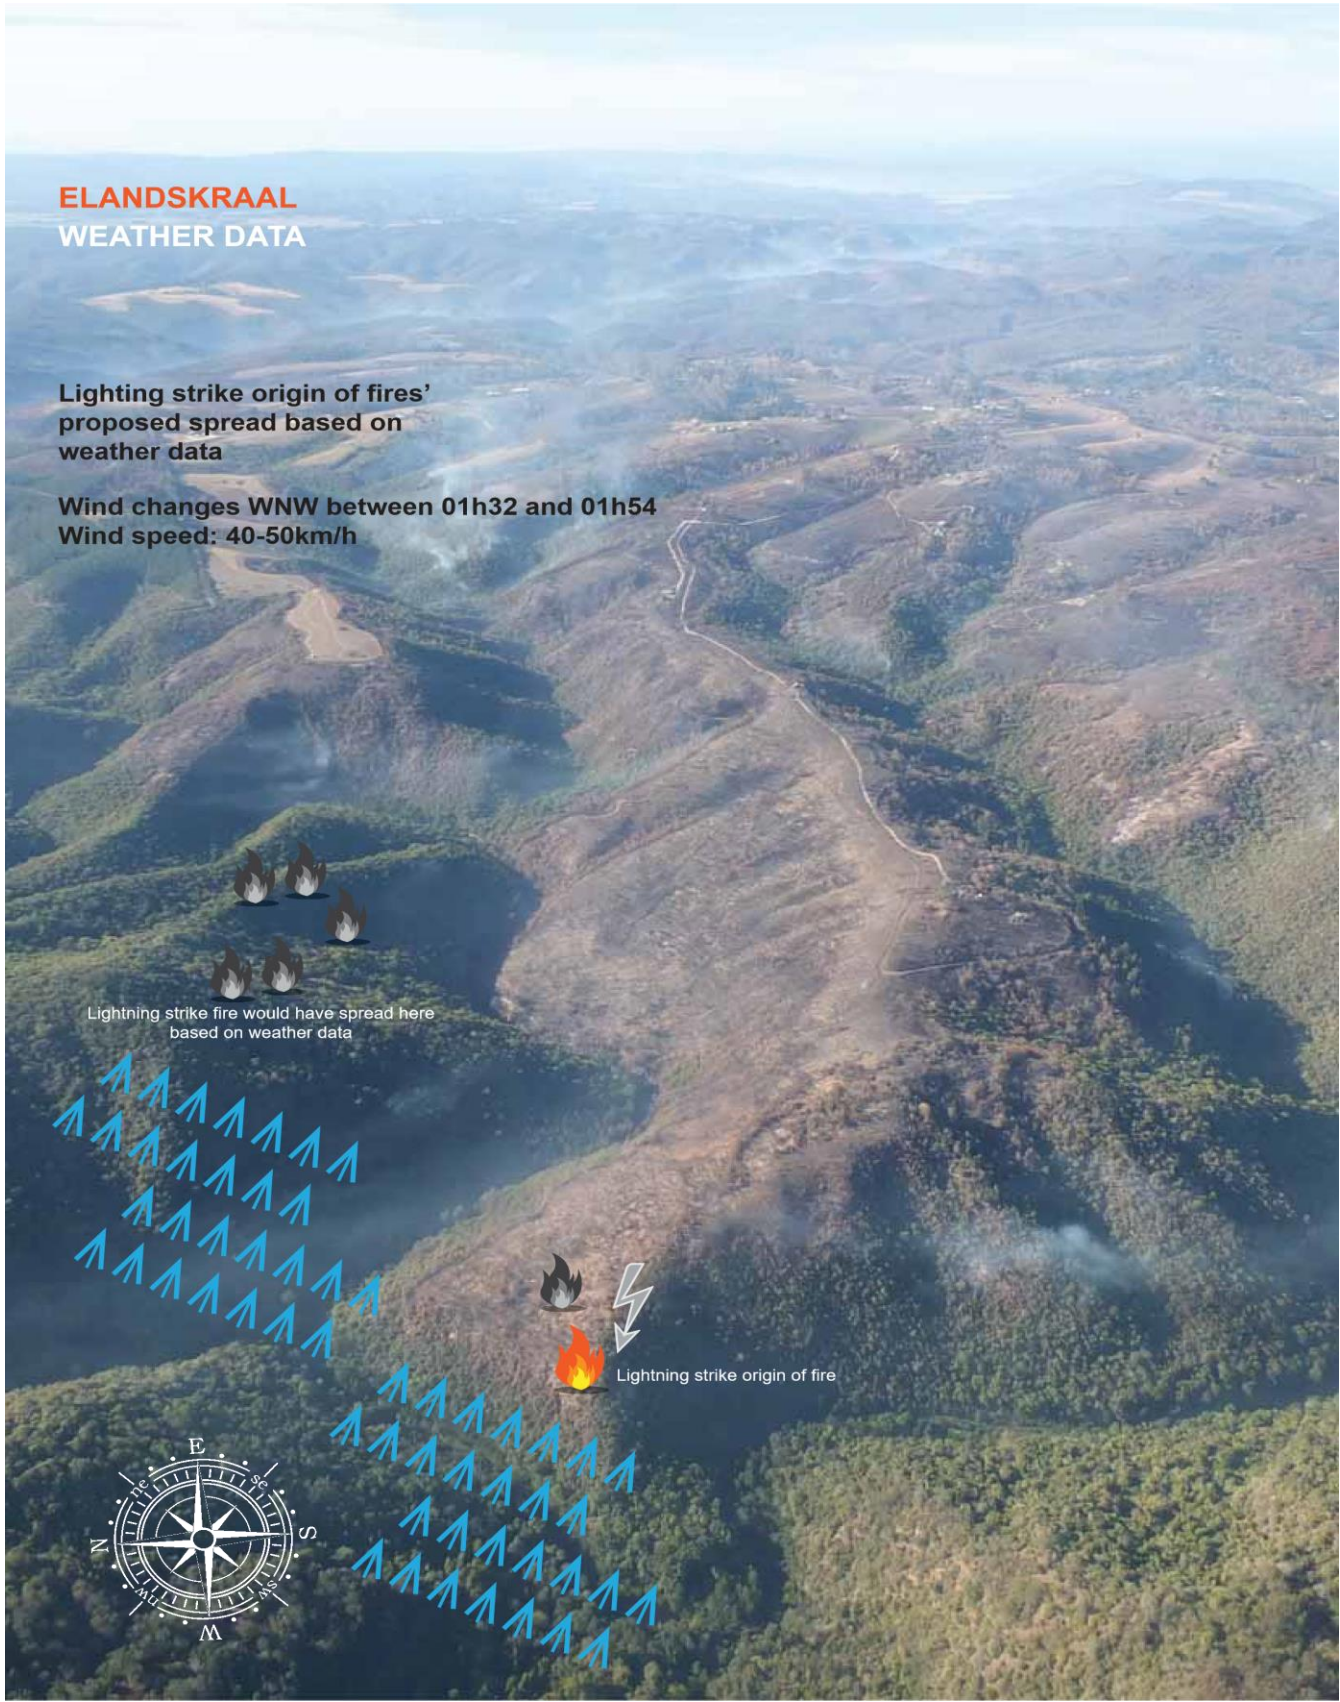
**Lightning strike origin of fires'
proposed spread based on
weather data**

**Wind changes WNW between 01h32 and 01h54
Wind speed: 40-50km/h**

1. Figure 88 show the wind direction in Elandskraal between 01:09 and 01:32. The wind came from the South-South-Westerly direction.
2. Had the fire originated at the lightning strike position as shown in Figure 88, then the SSW wind would have caused it to spread towards the opposite ridge, as indicated.

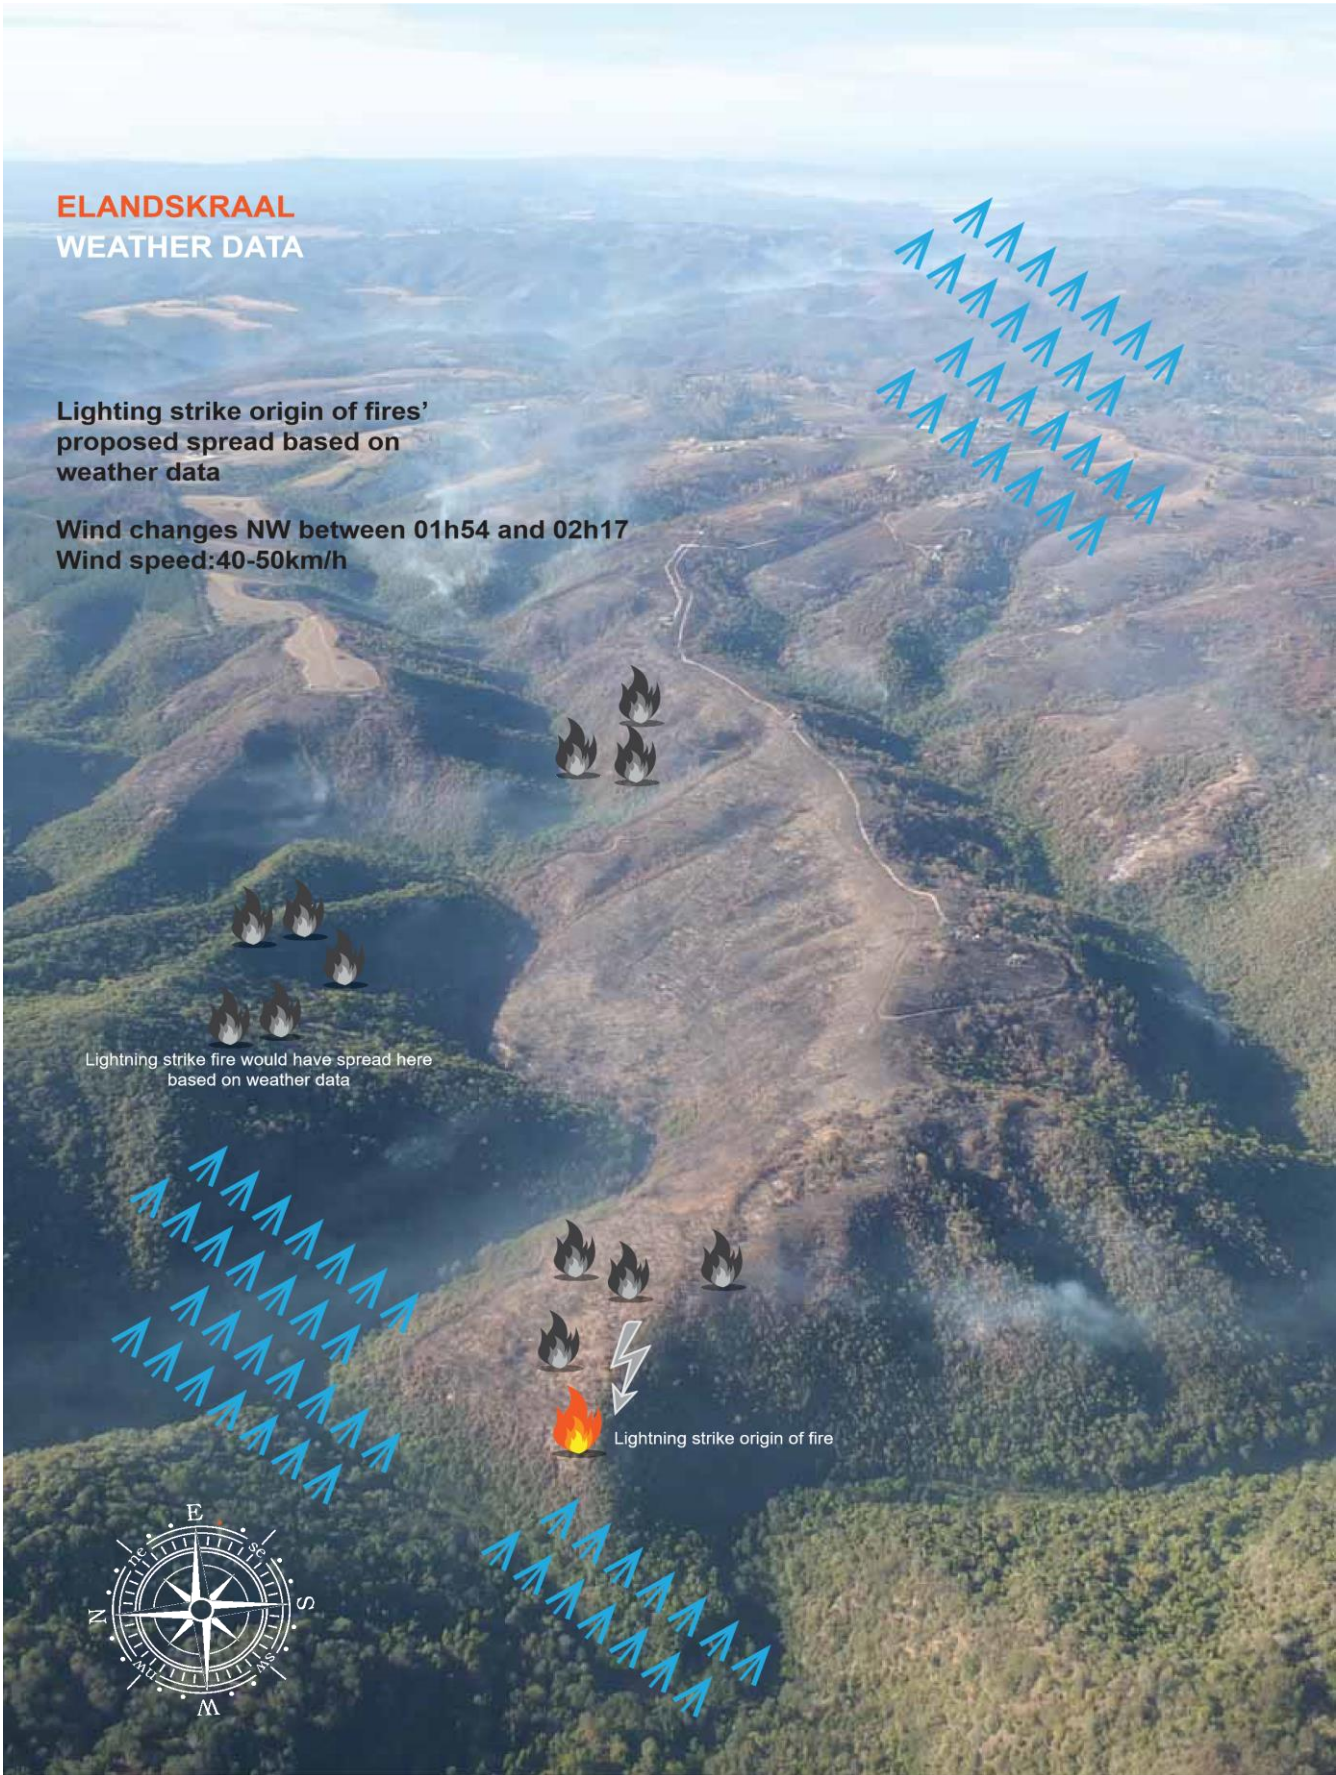
Lightning strike fire would have spread here based on weather data

Lightning strike origin of fire

4. Figure 89 show the wind direction in Elandskraal between 01h32 and 01h54. The wind came from the West-North-West direction.
5. Had the fire originated at the lightning strike position as shown in Figure 88 and it spread as indicated, then one would find a burn scar on this ridge. Yet we find no burn scar to support this fire spread.

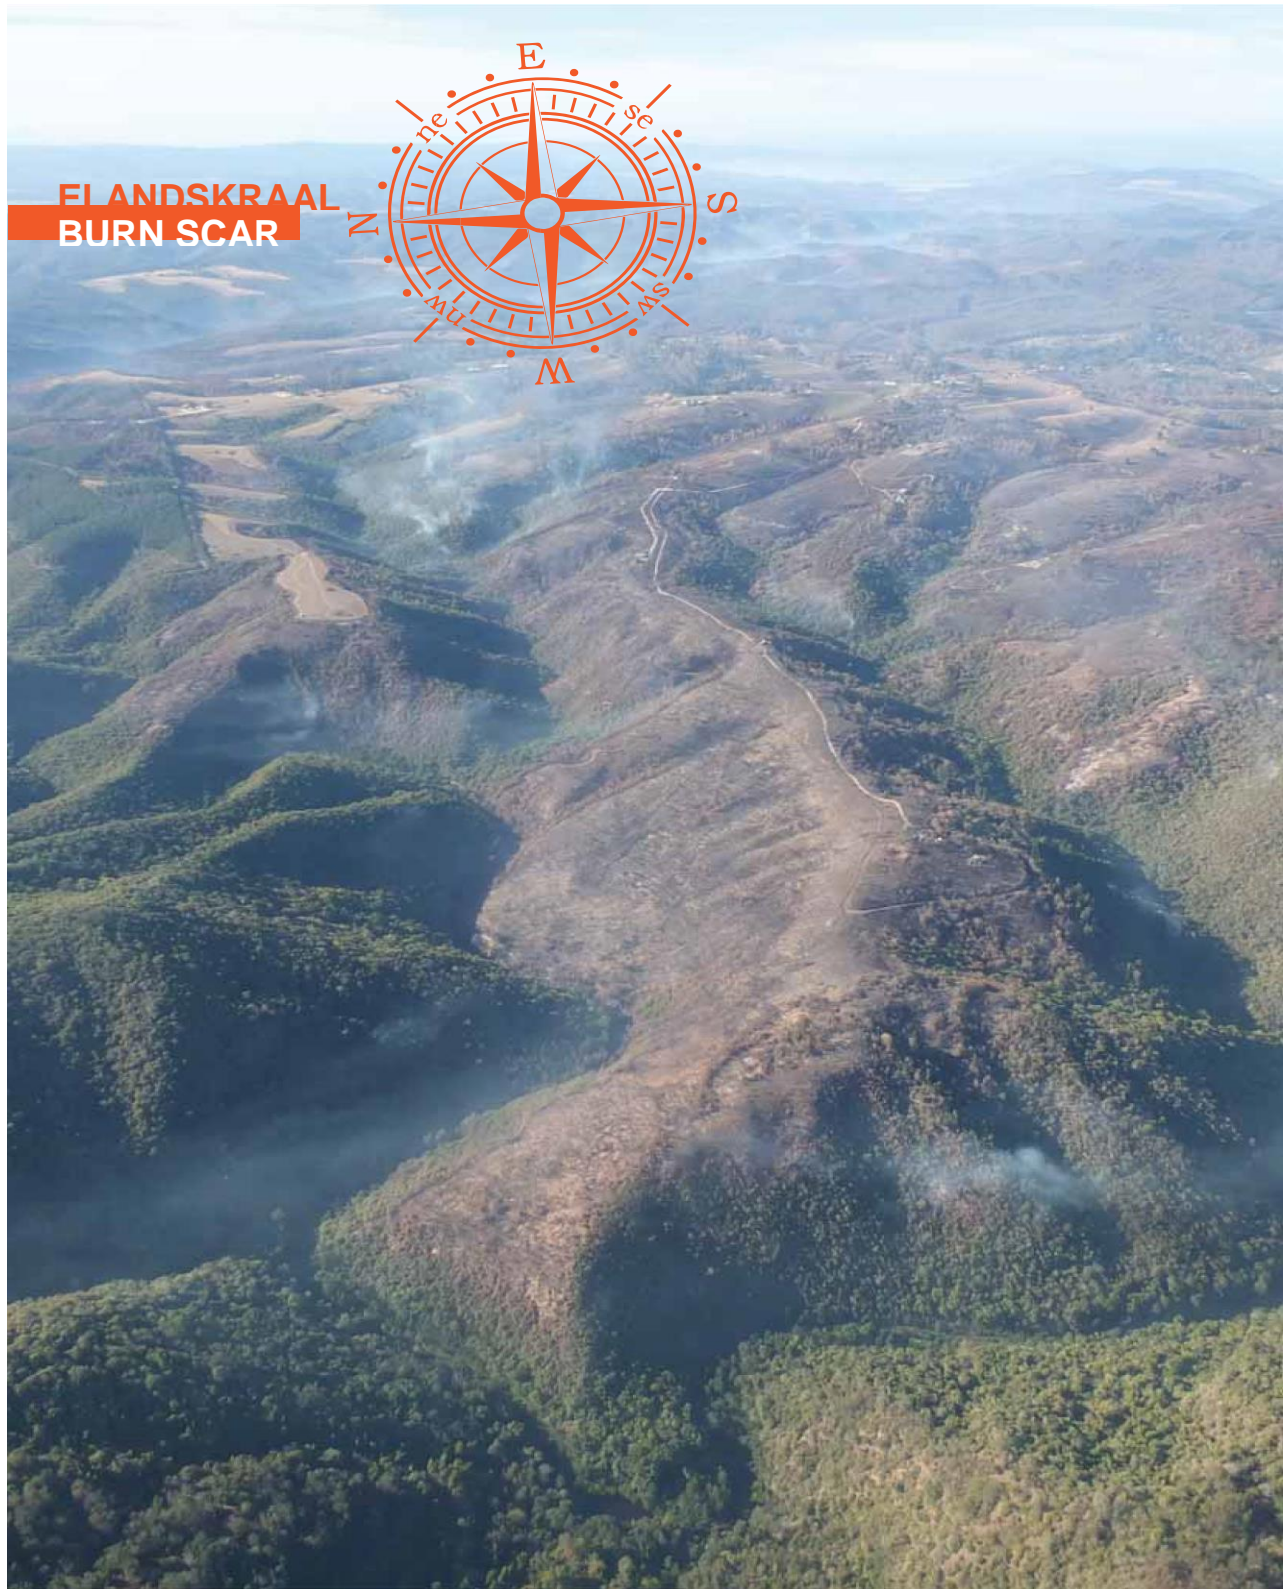
6. Figure 90 shows the wind direction in Elandskraal between 01h54 and 02h17. The wind came from the West-West direction.
7. Had the fire originated at the lightning strike position as shown in Figure 88 and it spread as indicated in Figures 88 and 89 then the next spread would have been as indicated in Figure 90. With this spread the fire would have missed the first building in its path (Figures 75 and 76) or damage to this building would have been most severe on the North West side. However, damage to the building is most severe from the South Western side.

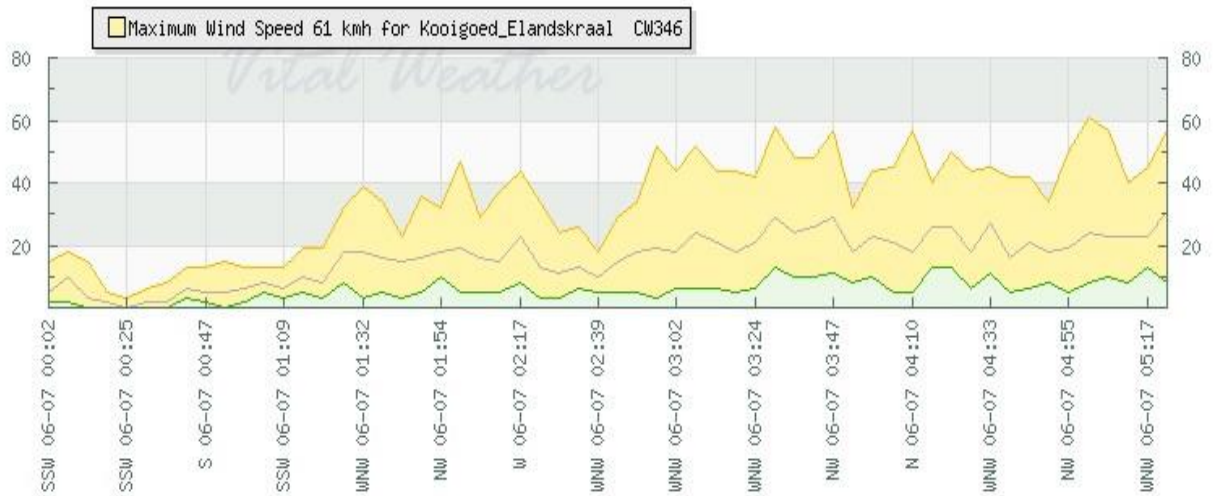
Figure 87: The wind data from report in public domain

A graphic representation below shows the wind experienced in the Elandskraal area from 01:09 during the morning of 7 June 2017. Weather data is contained in a report in the public domain. This data is not in dispute.
